# PRELIMINARY INSPECTION T-33 MONUMENT WOODHAVEN PARK

Winnipeg, 5<sup>th</sup> April 2018  
Michel Paradis, NDT Technician.  
Brian Miller, NDT Technician.

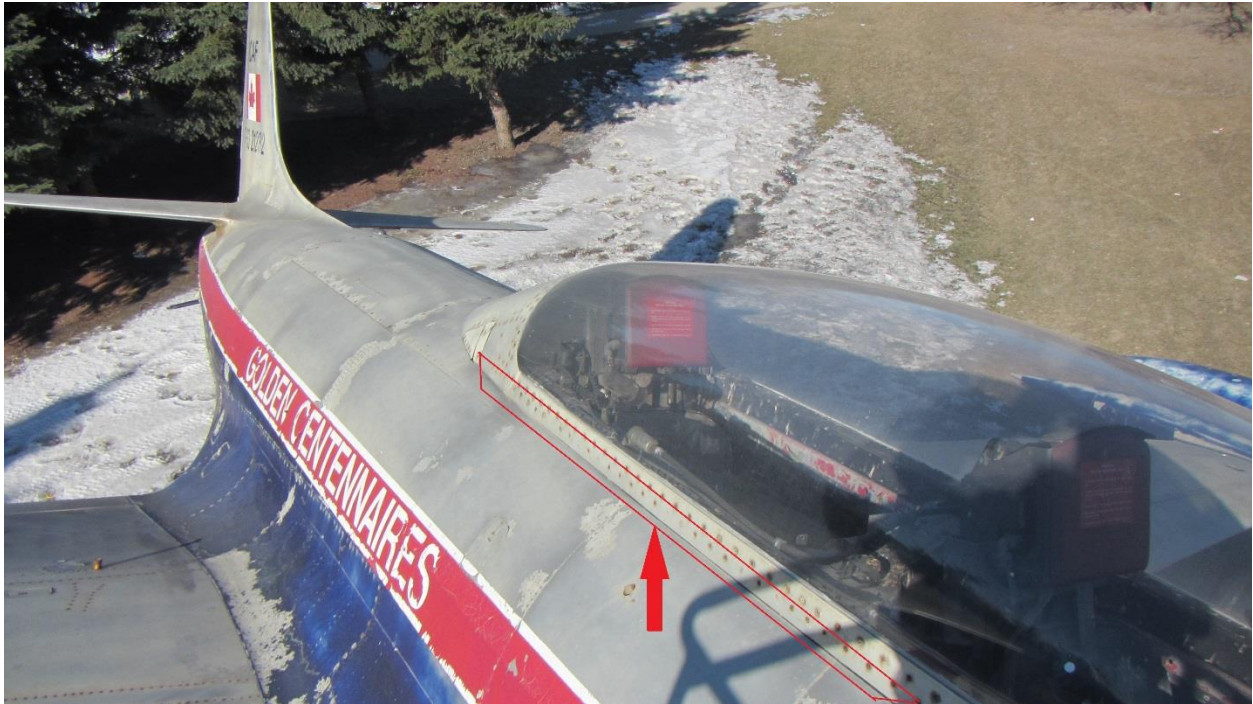
Fig.1

Crazing present in the canopy. Can be polished or consider painting. A sizeable gap was observed between the canopy frame and the fuselage. Consider sealing it to prevent water ingress. (Fig.1)

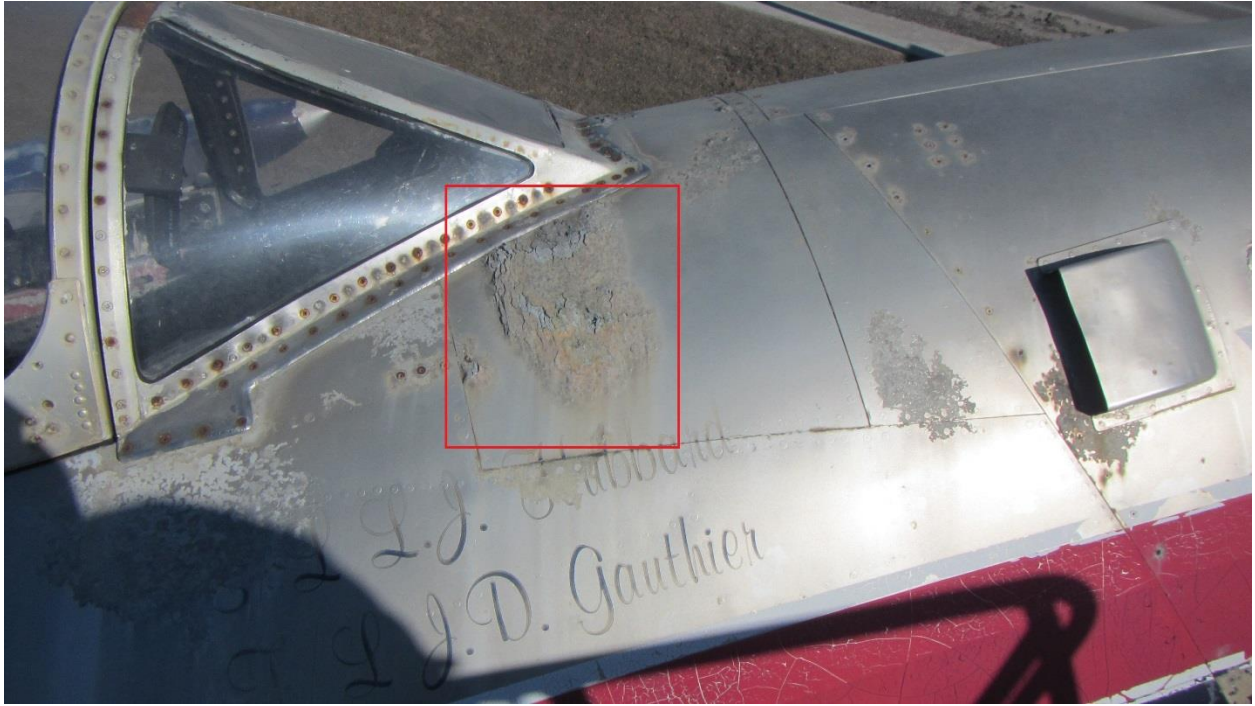
Fig.2

Blistering observed in the paint forward of windscreen, right hand side. Tap tested it, metal still solid underneath. (Fig. 2 & 3)

Oxidation forming on and around exposed rivets. Steel rivets were used on aluminum skin, corrosion is the result. (Fig. 2)

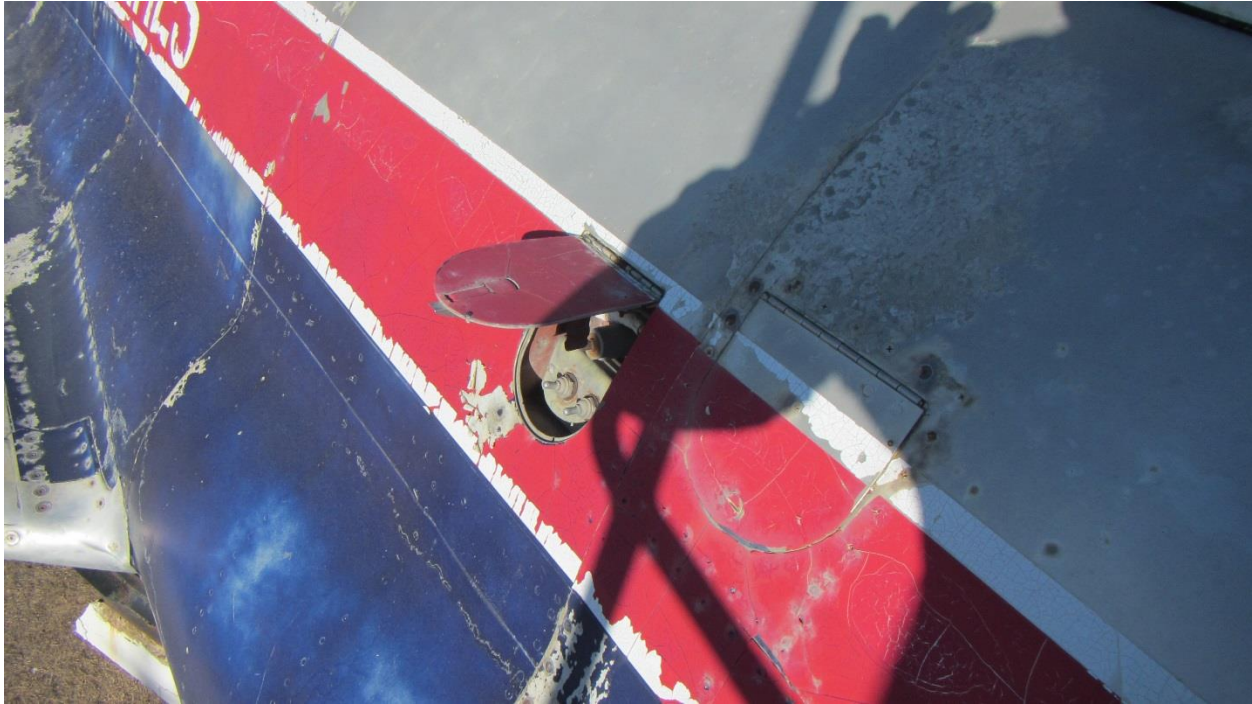
Fig. 4

Canopy switch panel was left open. We recommend screwing & sealing any loose panels and fixtures closed. (Fig.4)

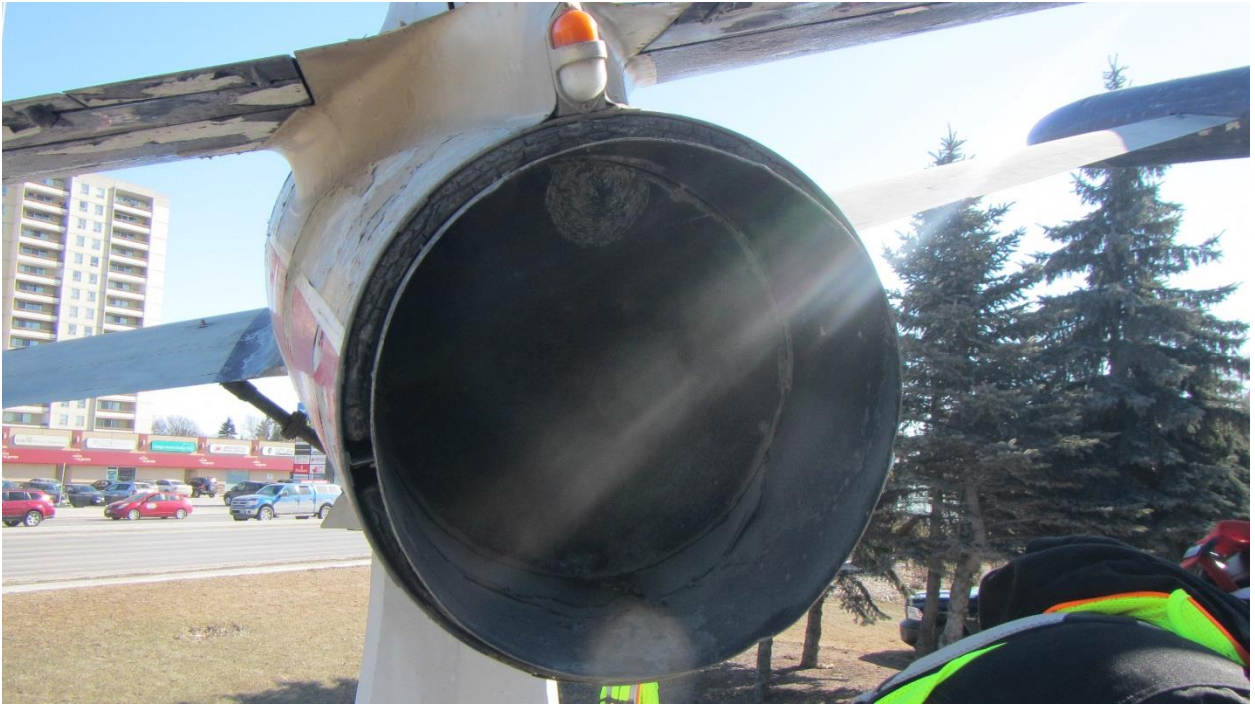
Fig.5

Large gap between exhaust pipe and fuselage (Fig.5)

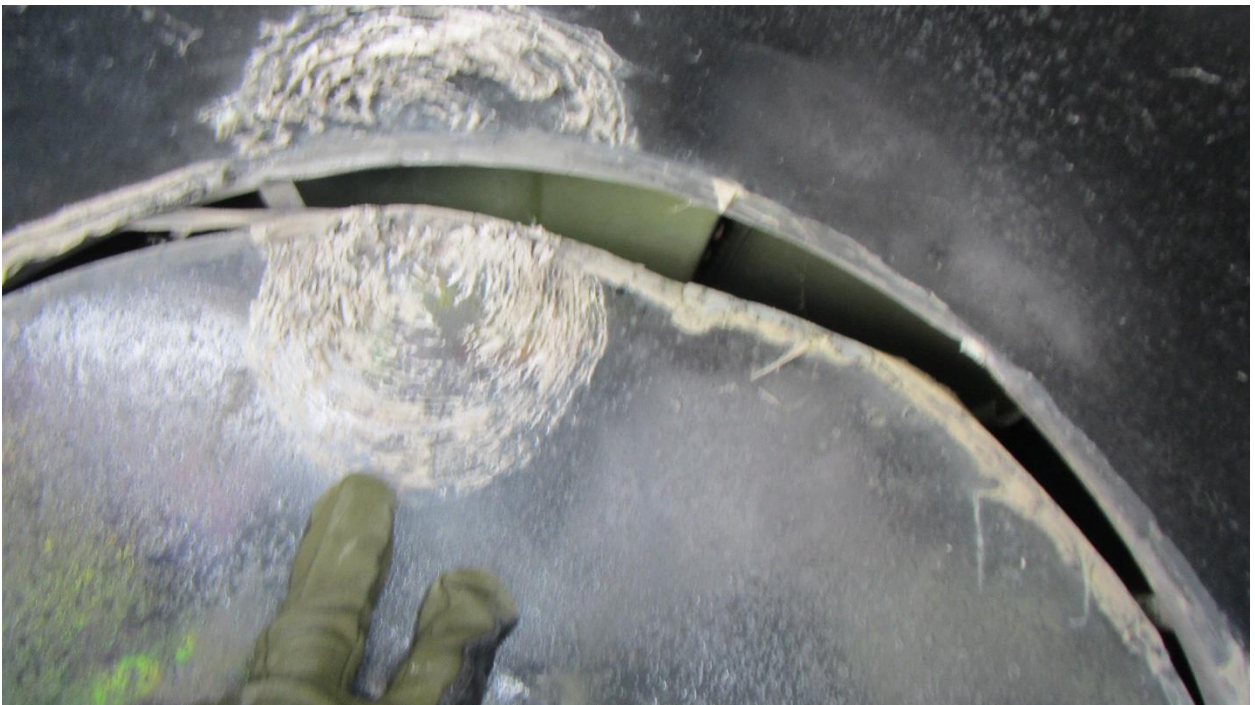
Fig.6

Exhaust plug no longer secured. Evidence of wasp/hornets' nest present. (Fig.6)

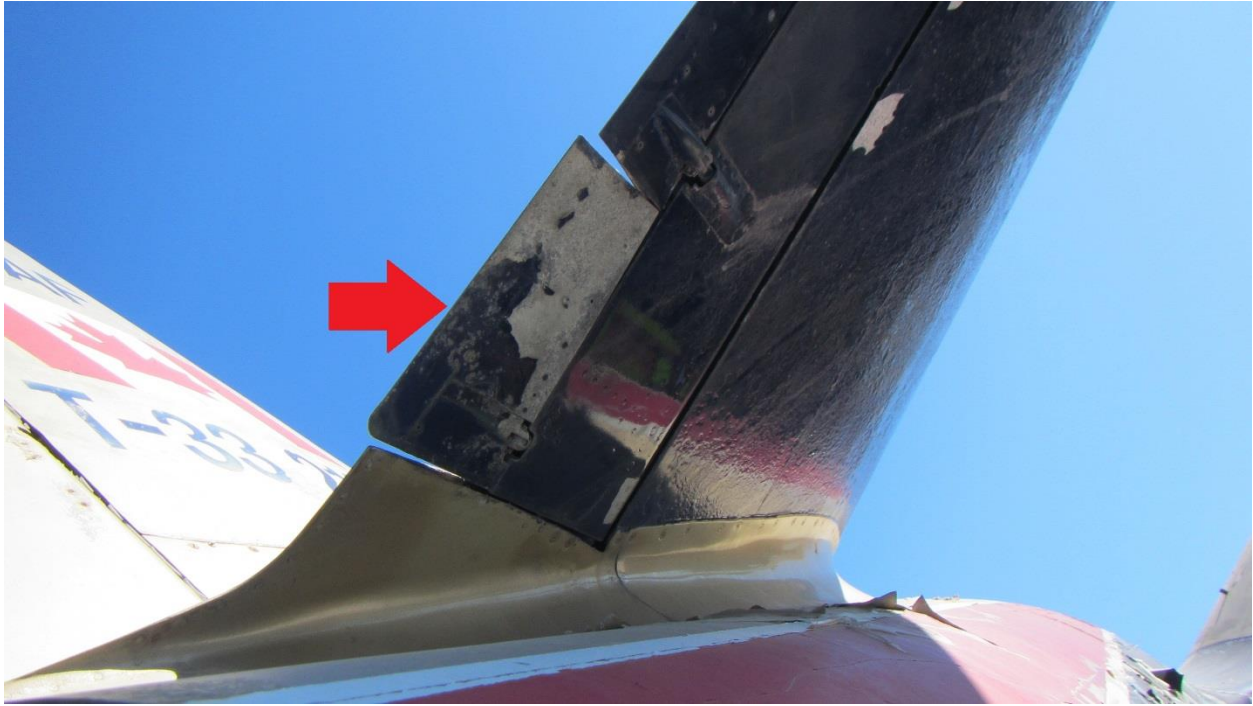
Fig.7

Trim tab unsecured. (Fig.7)

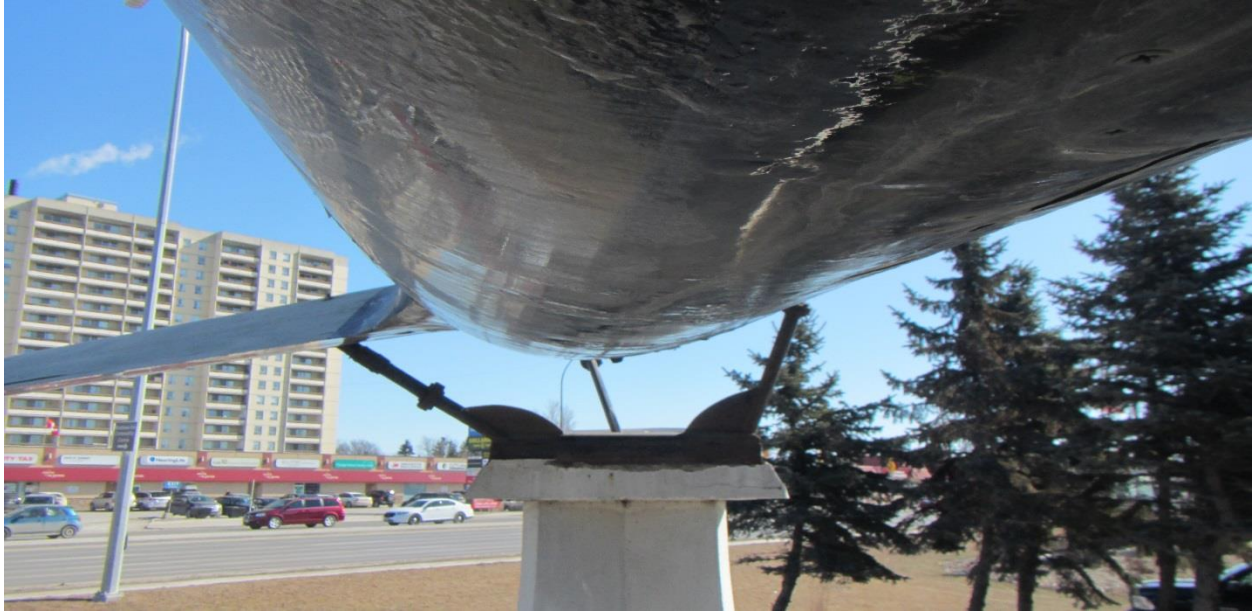
Fig.8

Blistering observed in the undercarriage paint. (Fig 8 & 9)  
Skin panel missing fasteners on right hand side. (Fig.10)

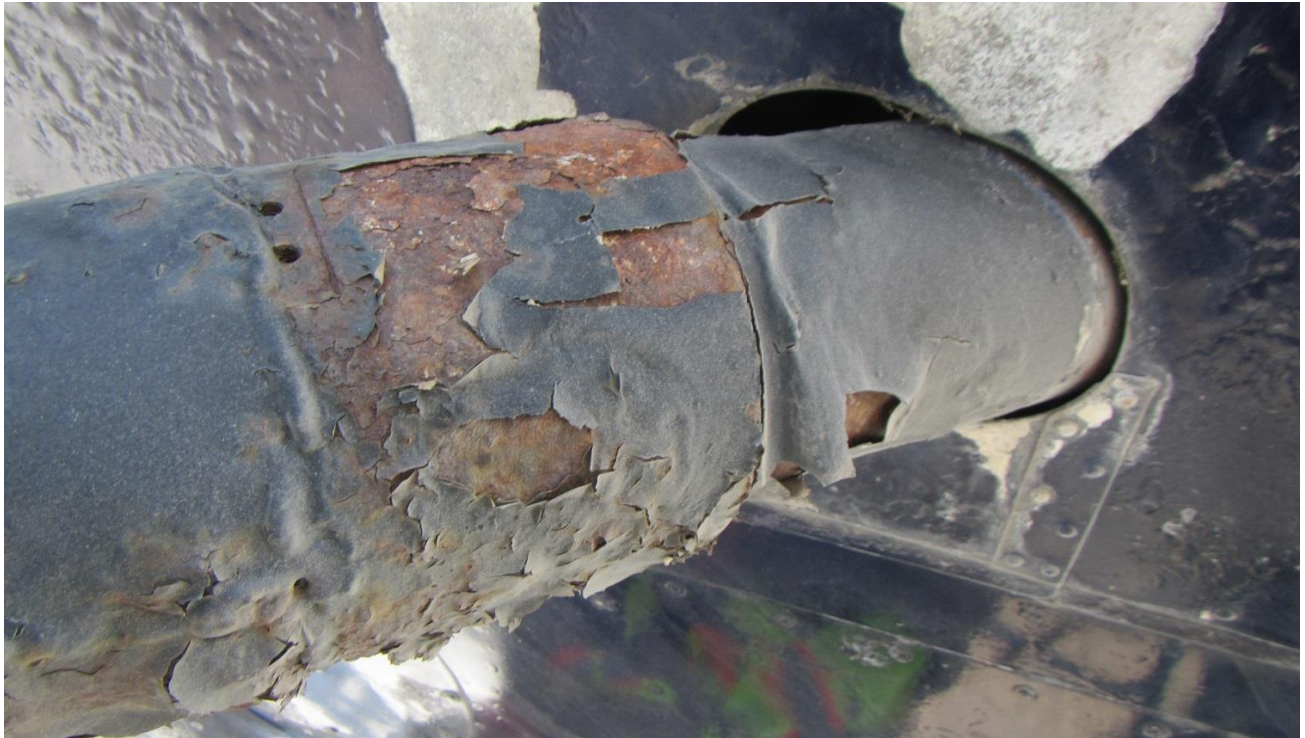
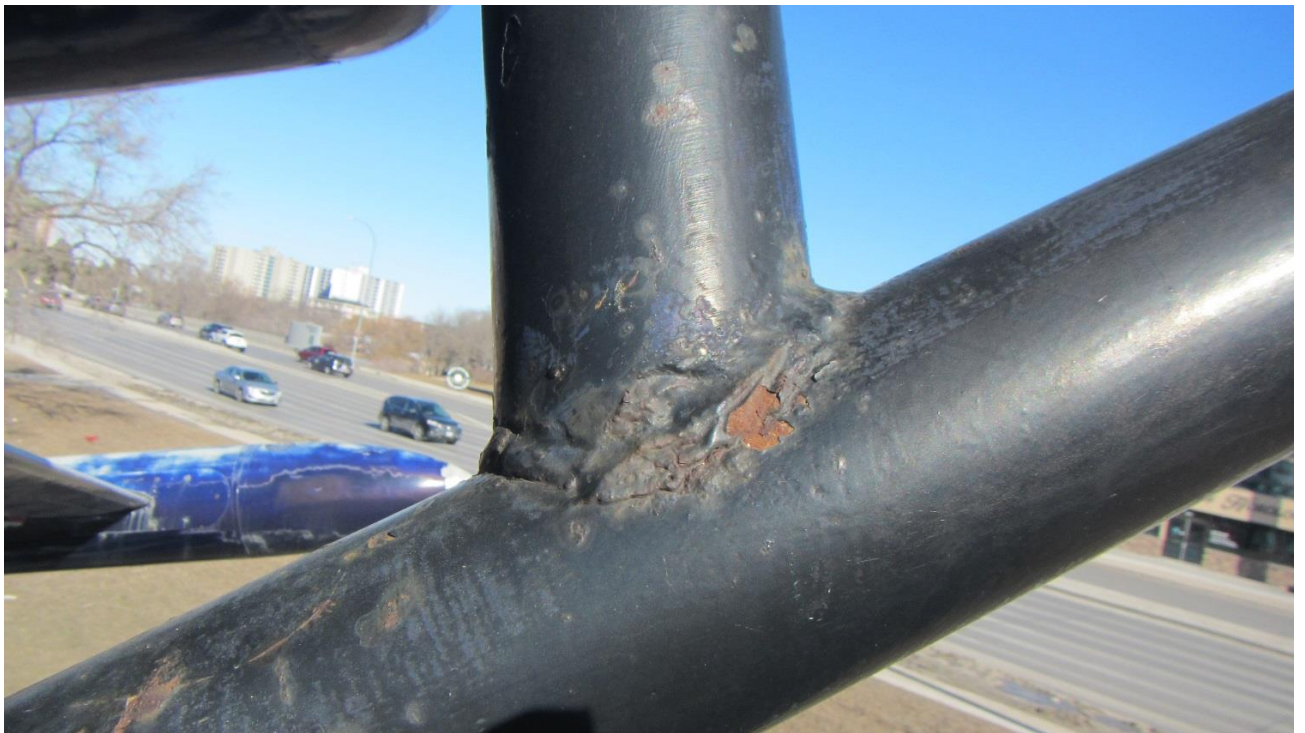
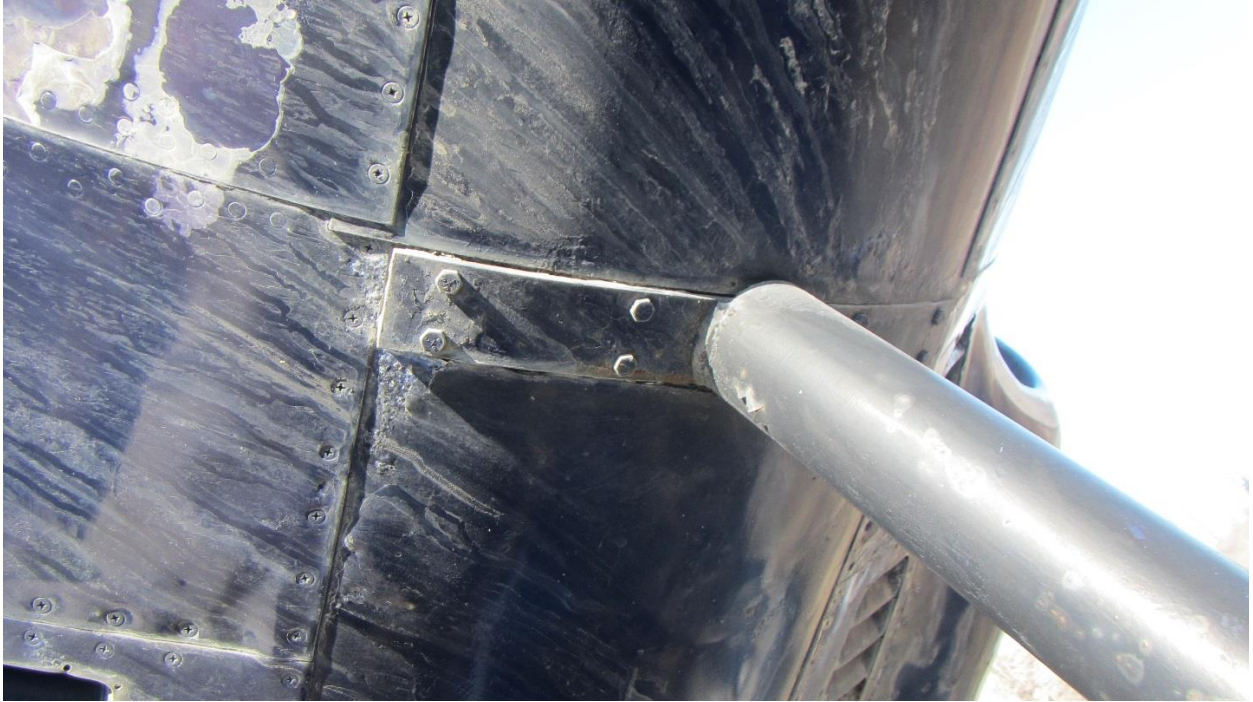
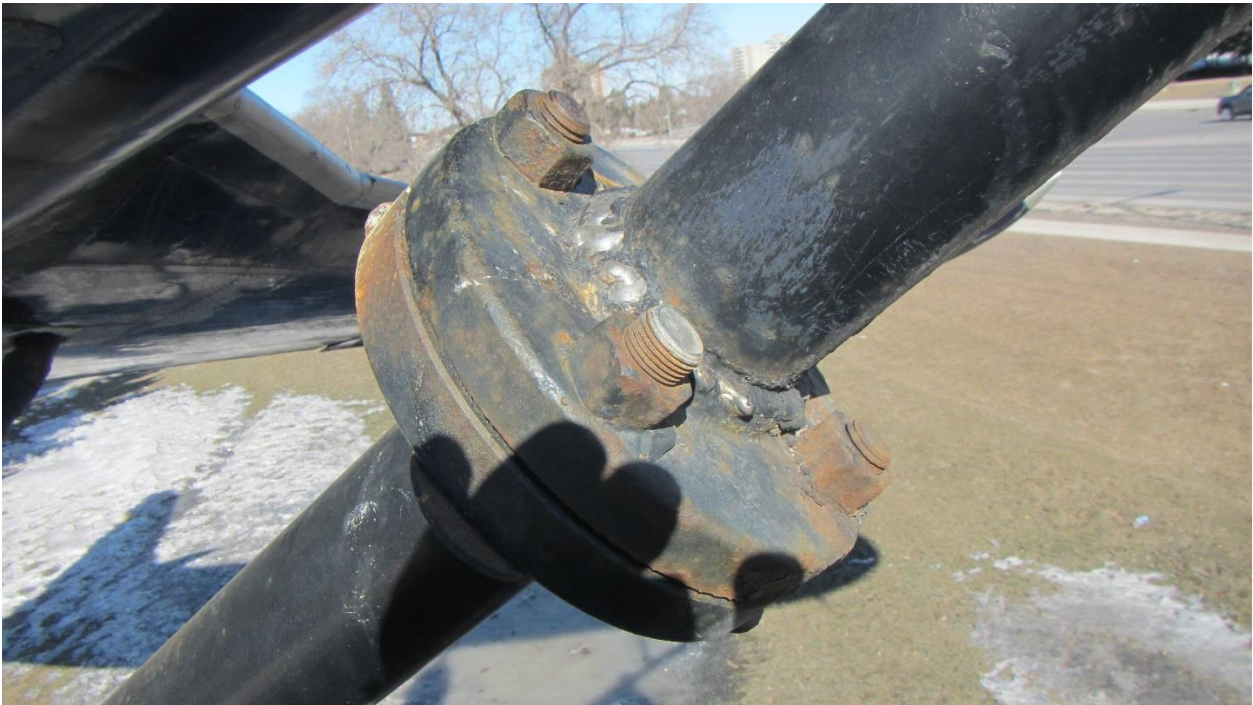
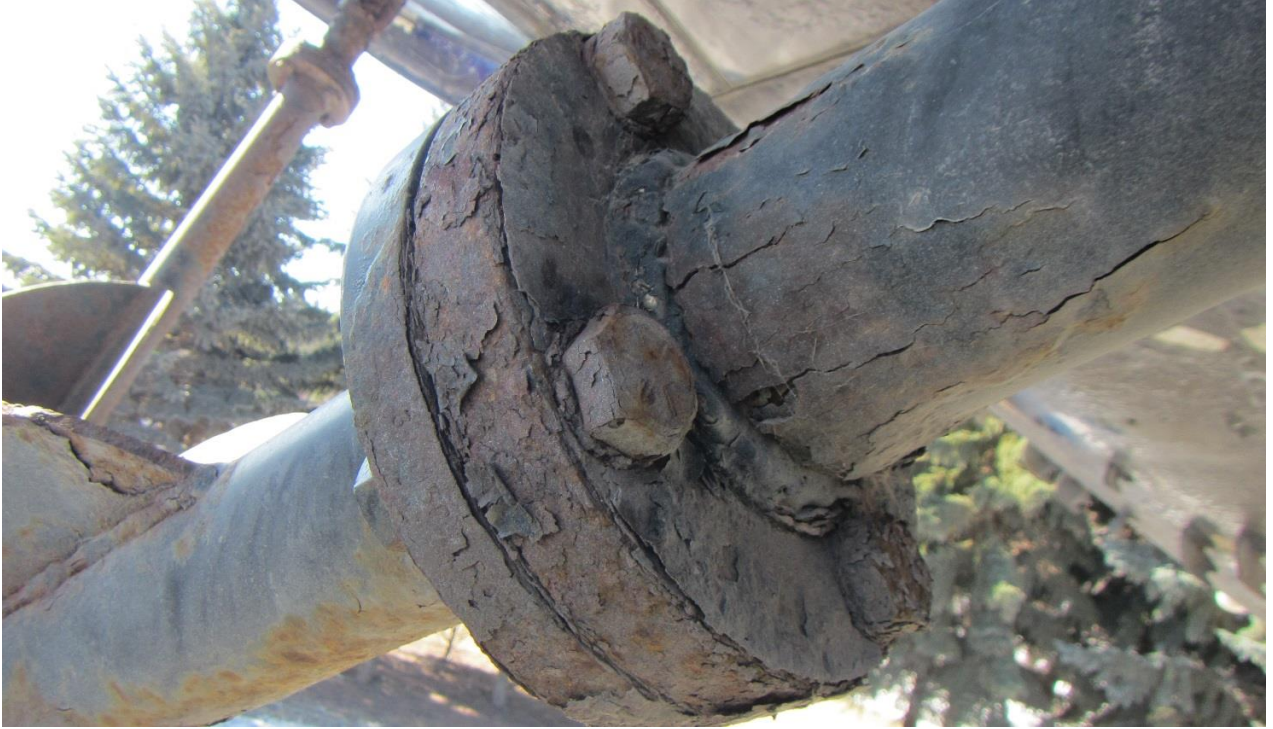
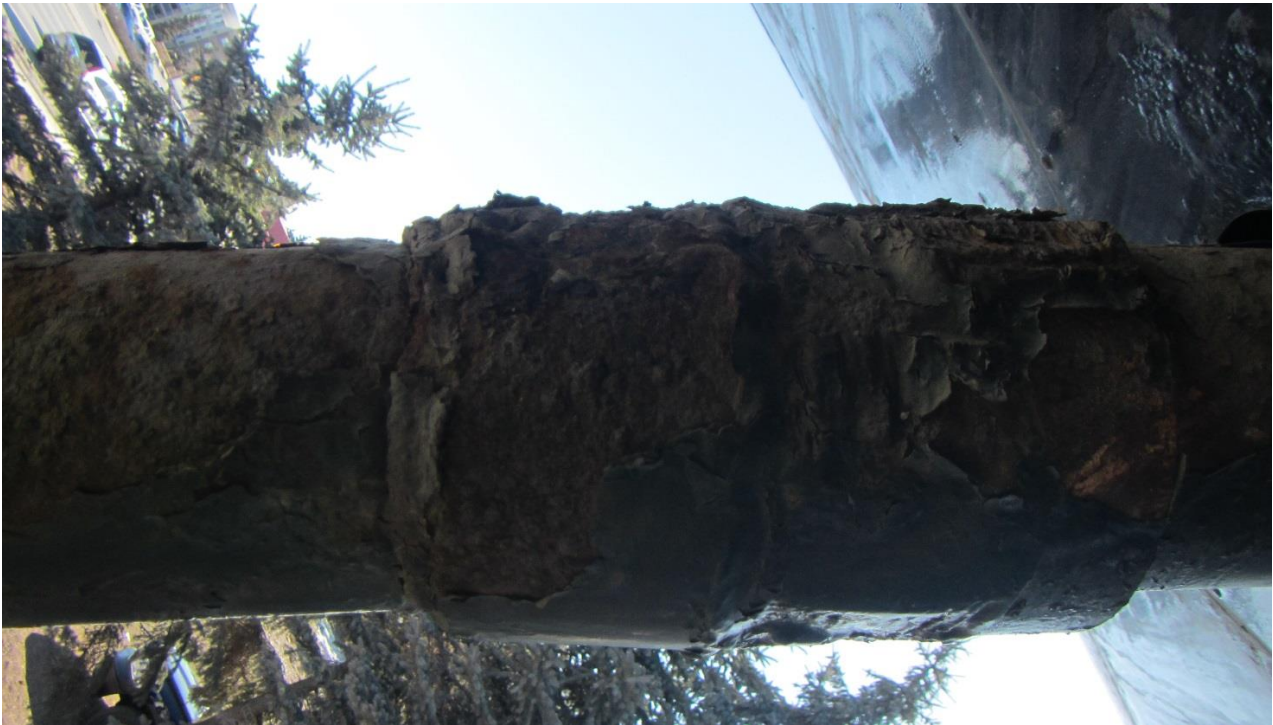
The external portion of the aircraft mounting system show mild to severe corrosion indicated by the paint peeling and scale. We recommend a supplementary Non-destructive inspection with the magnetic particle inspection technique. 100 % coverage with more attention on all welds. We recommend a replacement of all attachment hardware (bolts and nuts).

Note: The mounting system shall be complete stripped of paint and loose scale prior any magnetic particle inspection.

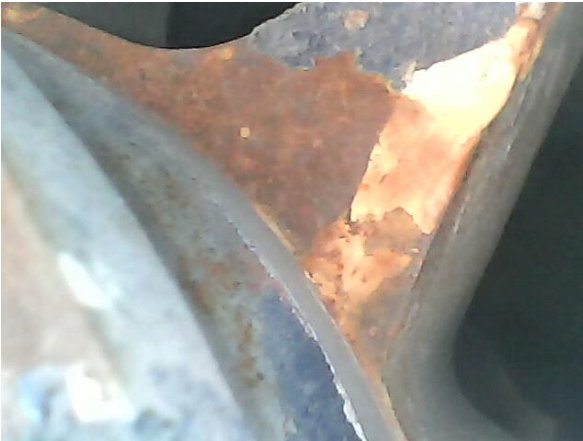
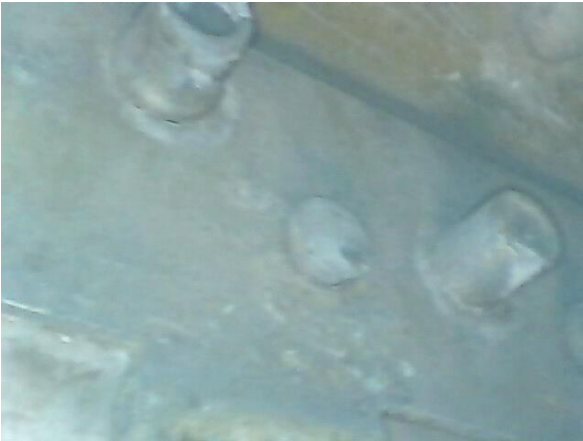
Front mount showed on fig.17 & 18

A hand held borescope was used to gain access to internal structures. Superficial corrosion was evident on all surrounding areas of the mounting attachment points. Unable to gain total access to perform a thorough inspection.

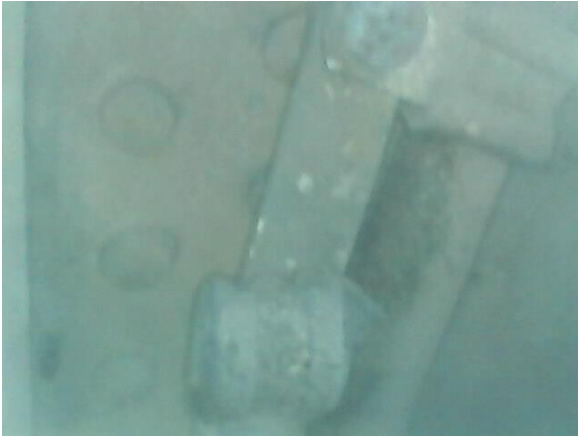
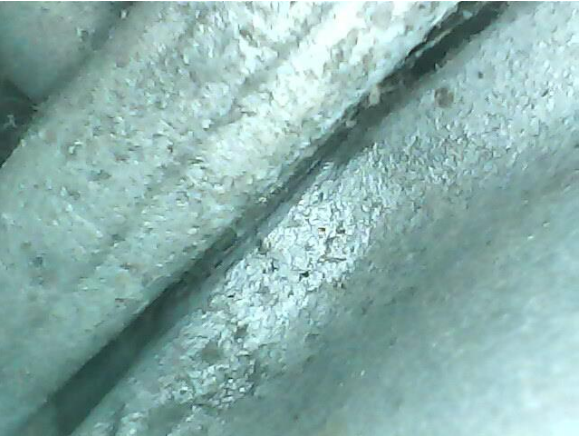
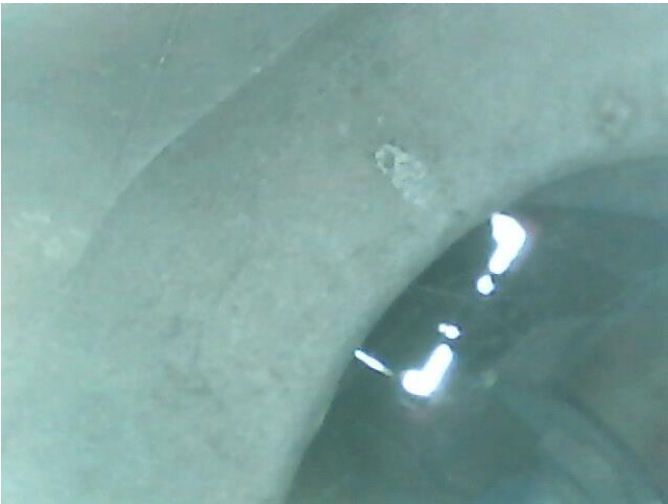
Left hand side mount showed on fig.19, 20 & 21

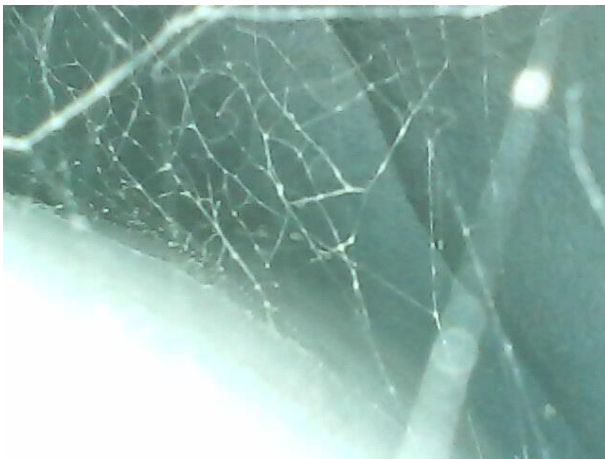
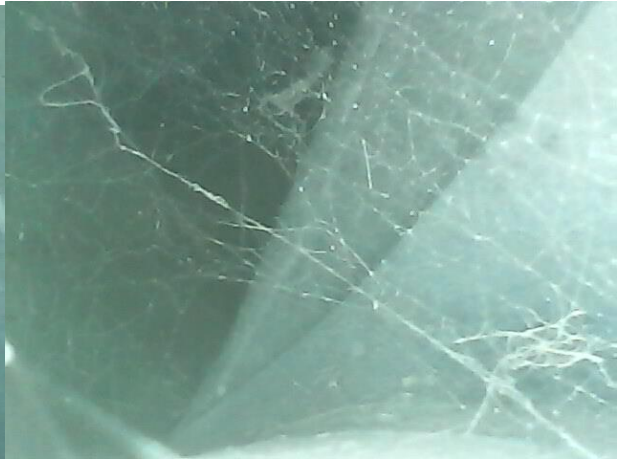
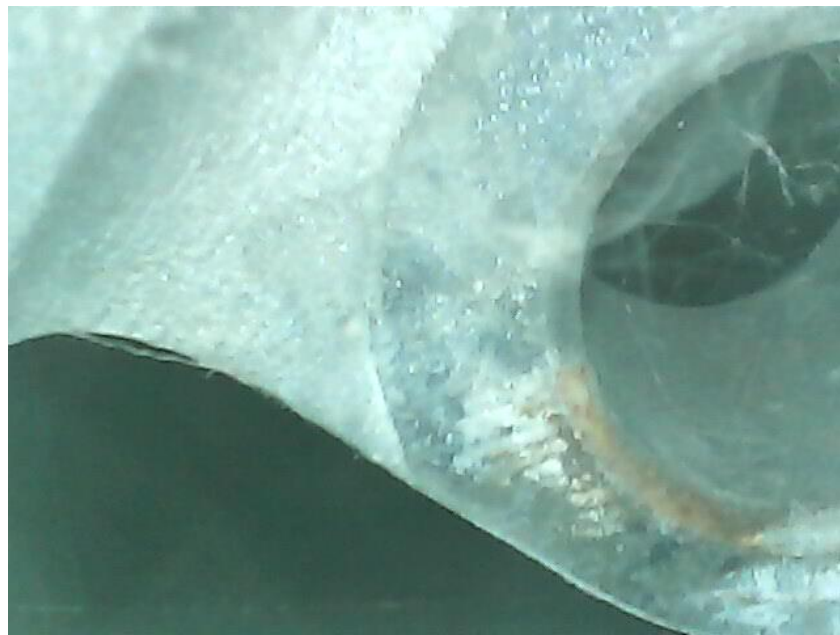
Right hand side mount showed on fig 22, 23 & 24.
