Extreme Rain Event – July 17, 2005

Prepared by: Water and Waste Department
July 21, 2005

Appendix B - St. Norbert Flooding – July 17, 2005

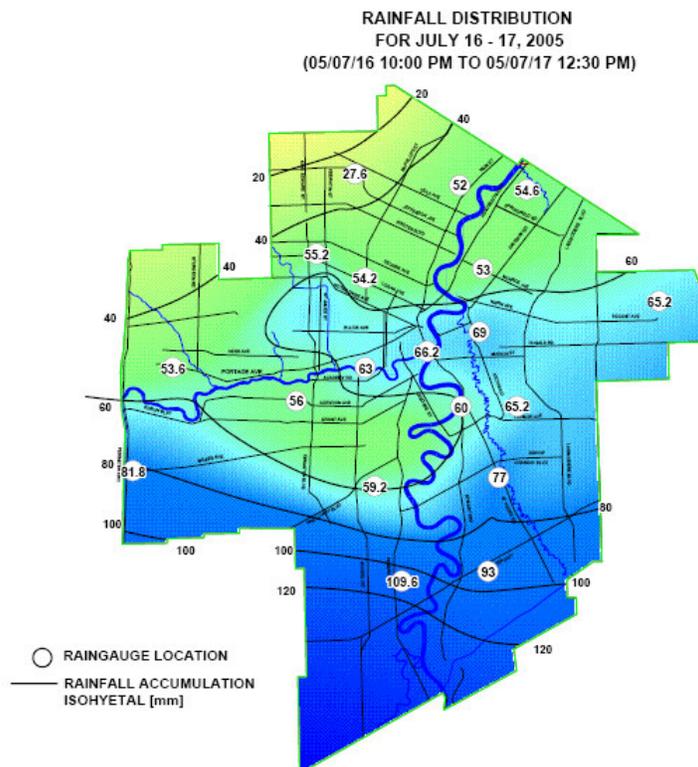
Figure 1 Rainfall Event

The rainfall was significant throughout the City from 40 mm in the North West to 100 mm or more in the south area of Winnipeg. A complete report on the rainfall is included as Appendix A. Figure 1 below shows the rainfall pattern. As shown in Appendix A, at one gauge in Fort Richmond, in excess of 100 mm of rain measured, most falling within 45 minutes. This far exceeds the 100 year return frequency rainfall¹ for any point in Winnipeg. The combination of high river levels with extreme rain made for an exceptional event.

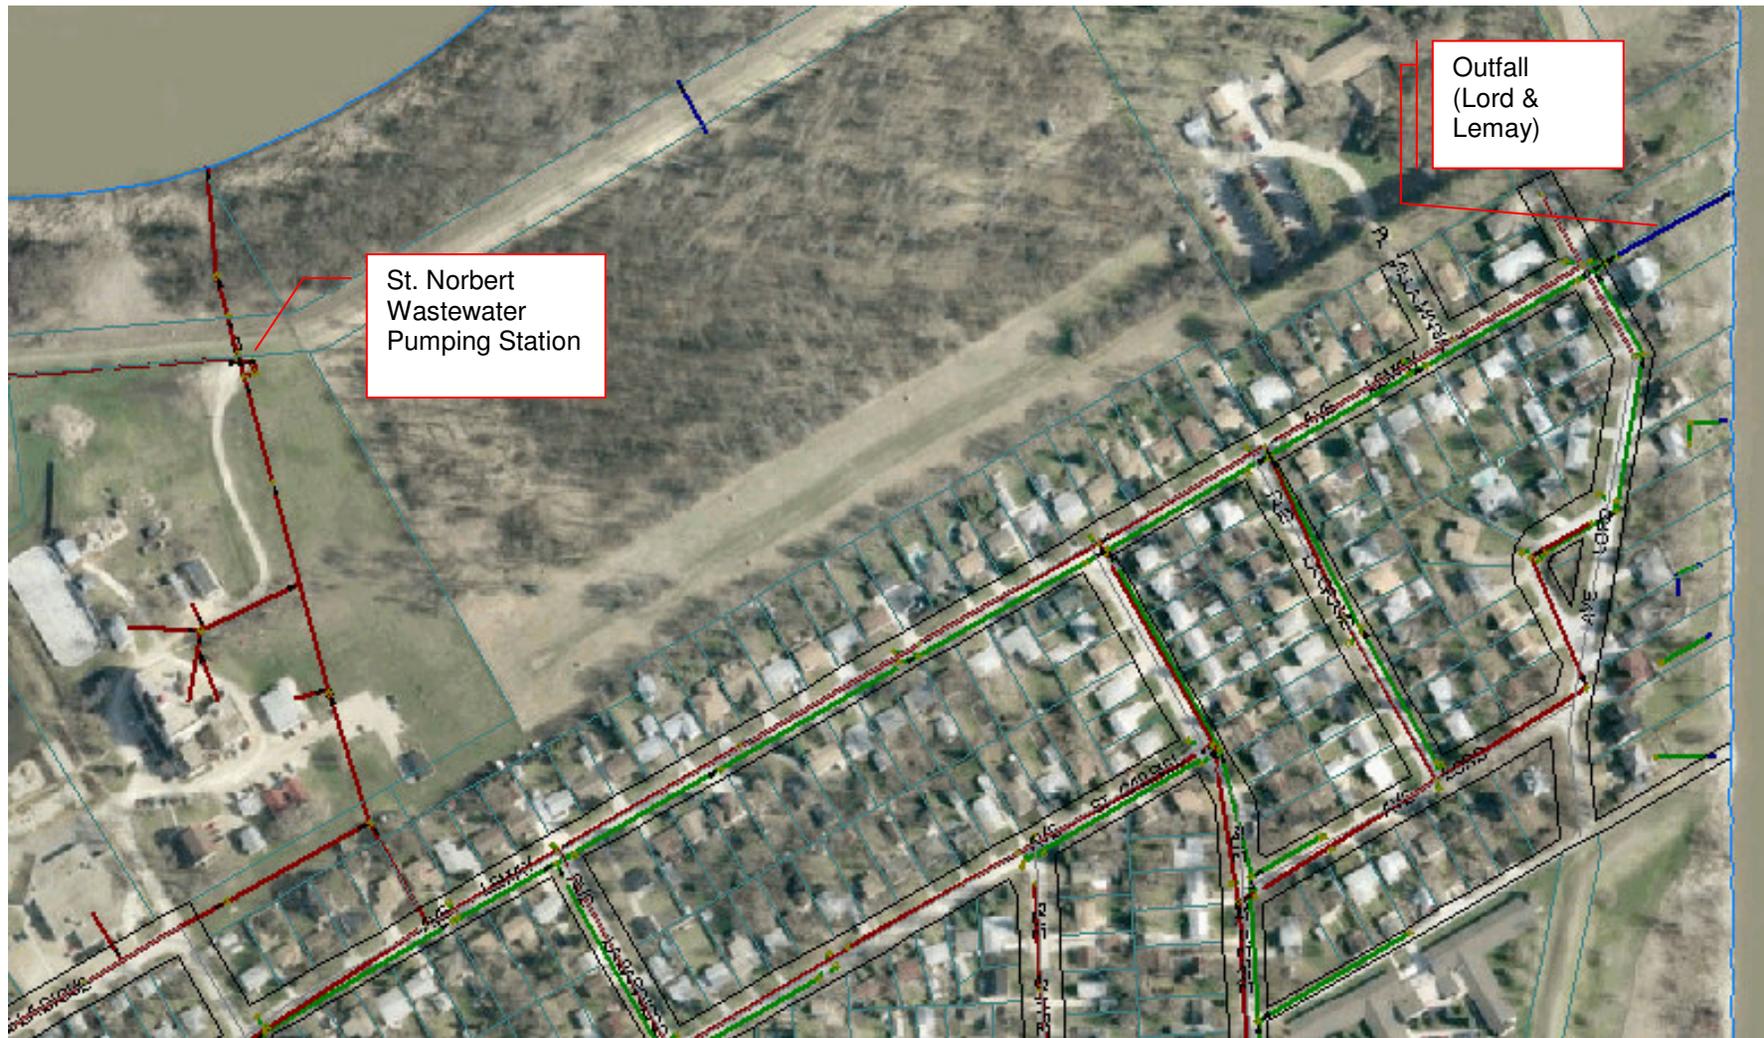
St. Norbert has a separate sewer system. Wastewater is conveyed to the St. Norbert / X-Kalay Wastewater Pumping Station near the river directly north of Lemay at the projection of LaBarriere Street as shown on the attached figure. This wastewater lift station serves St. Norbert both east and west of Pembina Highway south of Houde Avenue. The St. Norbert Lift Station is equipped with two sanitary sewage lift pumps which discharge to the interceptor on Pembina Hwy. The station is also equipped with a gravity overflow to the Red River through a flap and sluice gate. The gate chamber also has an electric pump to handle any overflow during times of elevated river elevations (9 foot James activation level).
