# **GEOTECHNICAL REPORT**

## Hartford Avenue - McGregor St / Salter St.

ATTENTION:  
PROJECT: Local Streets Package 24-R-05 (751-2023.5)  
Sanford, Winnipeg, MB

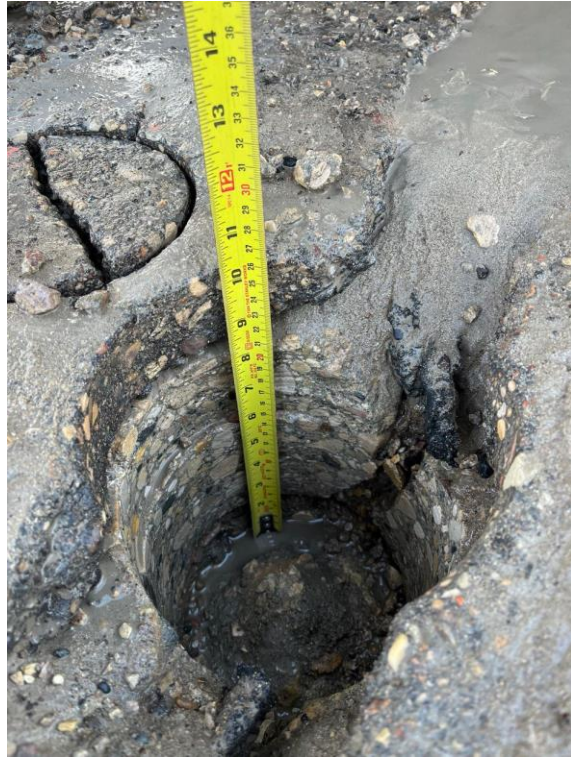
**Core 1 – Sanford (SBL)**

Figure 1. Core 1 pavement surface showing void existed between pavement and subsurface

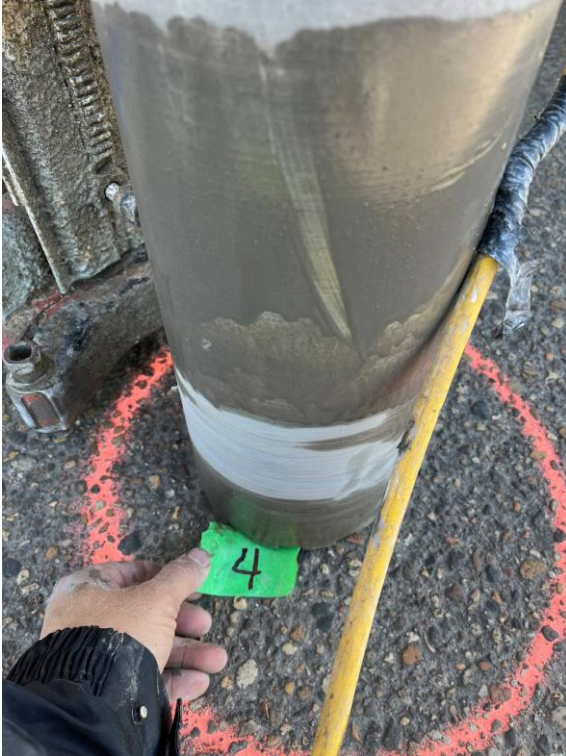
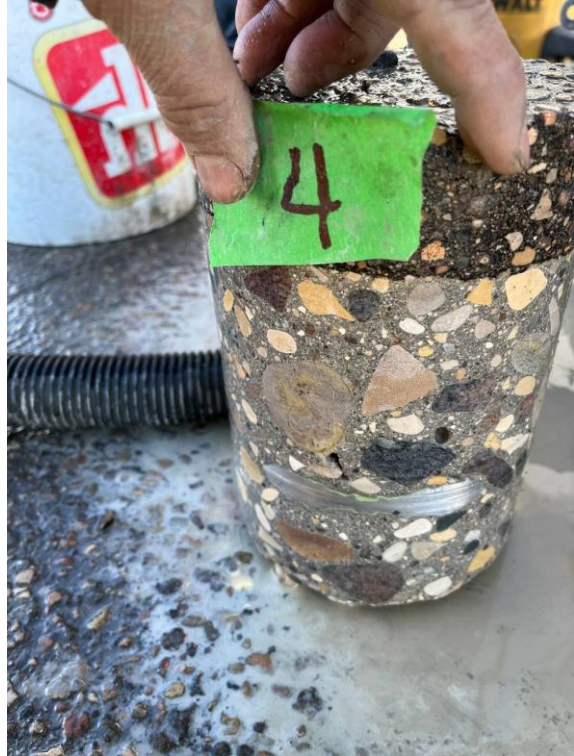
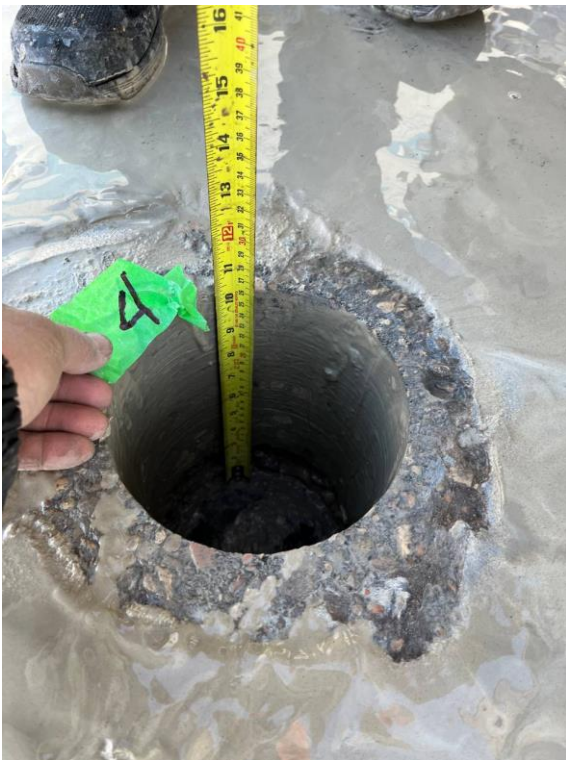
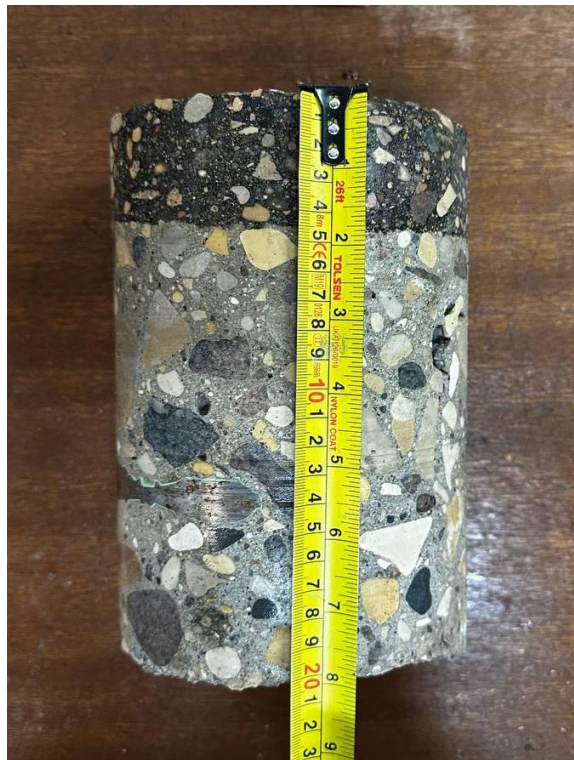
**Core 4 – Sanford (NBL)**

Figure 4. Photos showing Core 4 pavement for compressive strength test. Rebar present in concrete core. Compressive strength can not be done in this core.

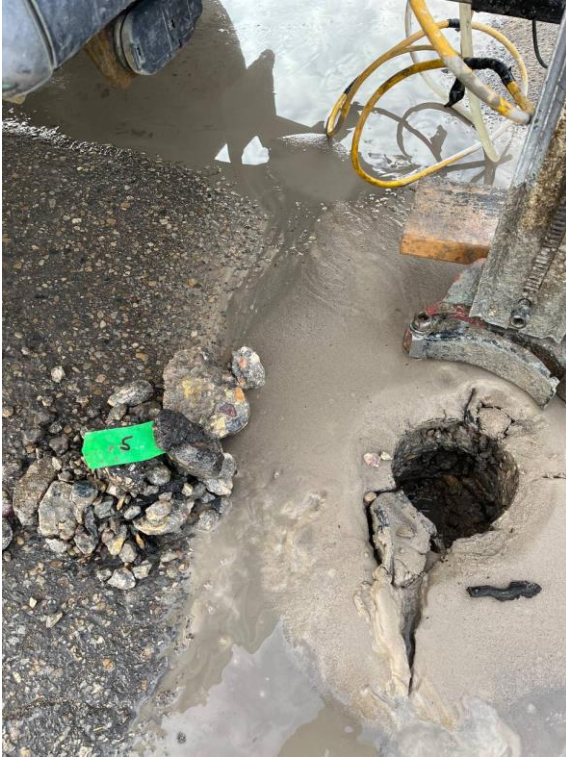
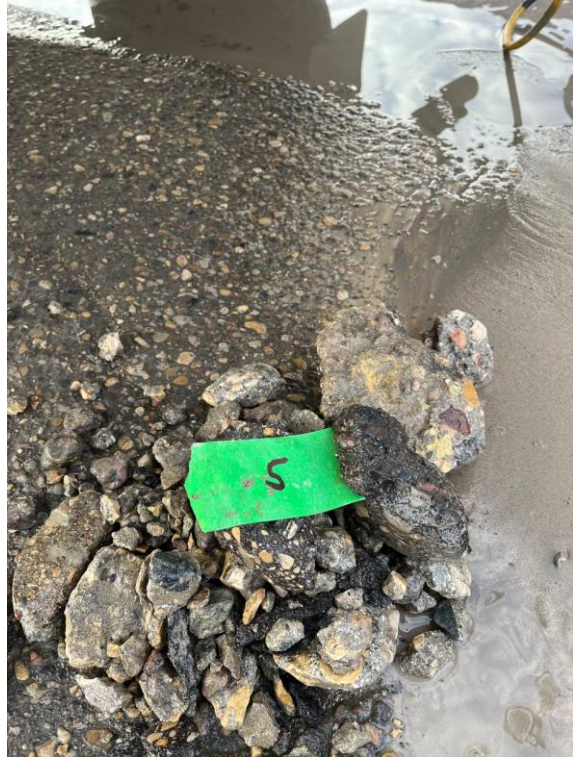
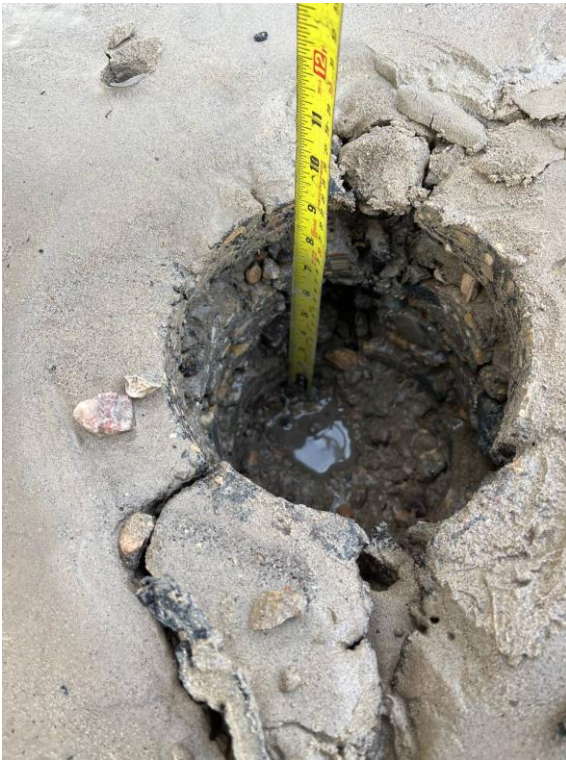
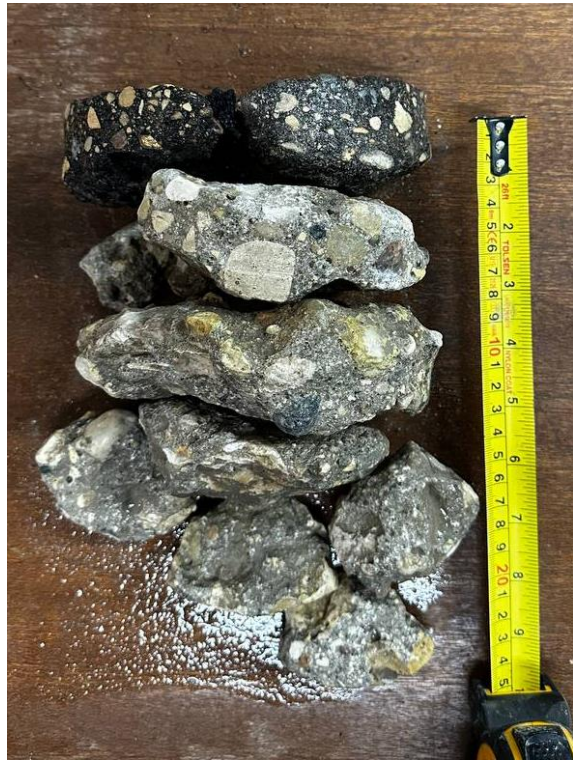
**Core 5 – Sanford (SBL)**

Figure 5. Photos showing Core 5 pavement showing deterioration of concrete and asphalt and void existed between pavement and base surface

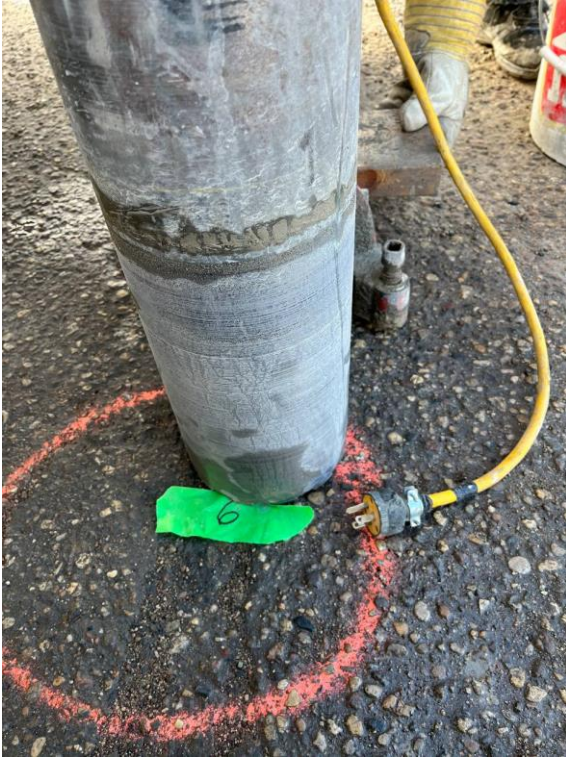
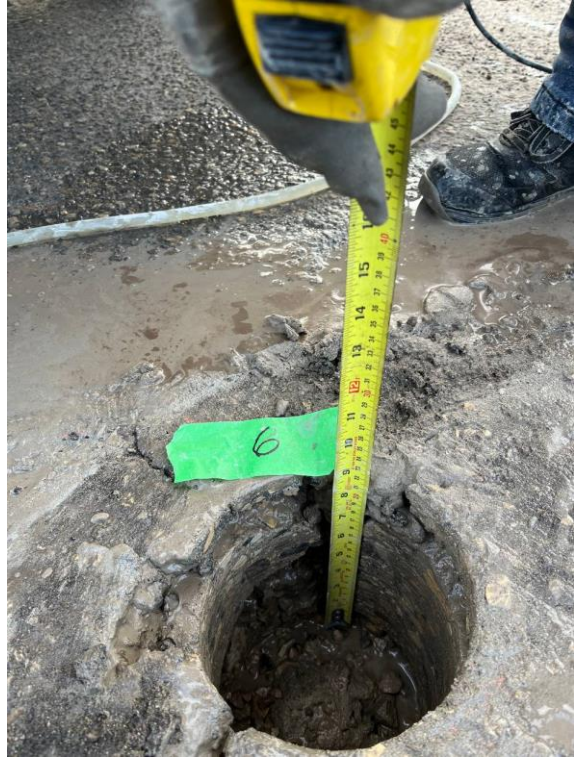
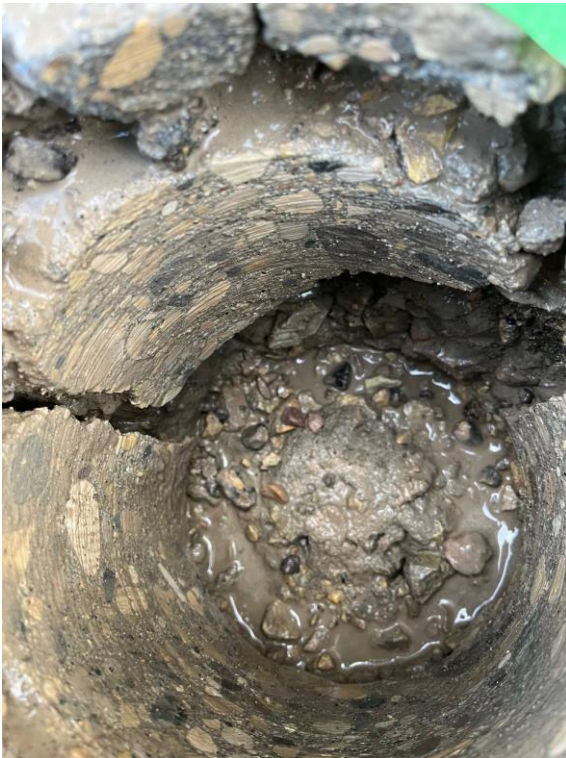
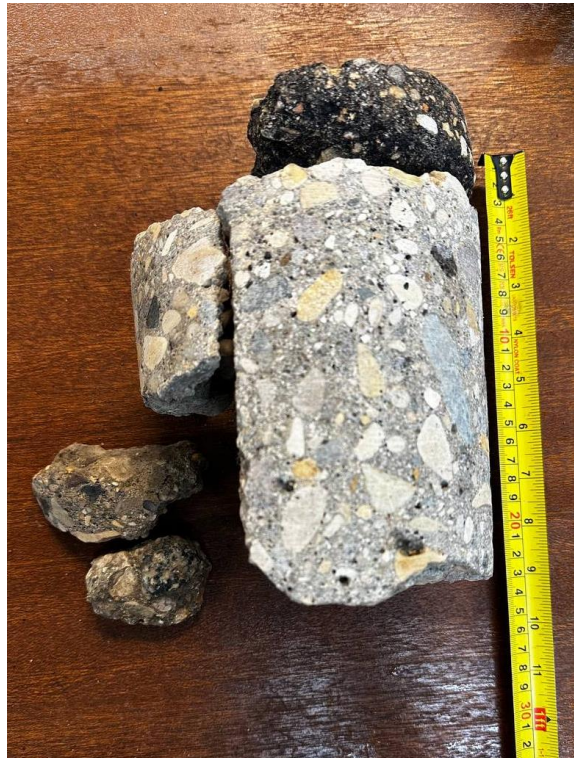
**Core 6 – Sanford (SBL)**

Figure 6. Photos showing Core 6 pavement showing void and deterioration of concrete at joint. Void existed between pavement and base surface

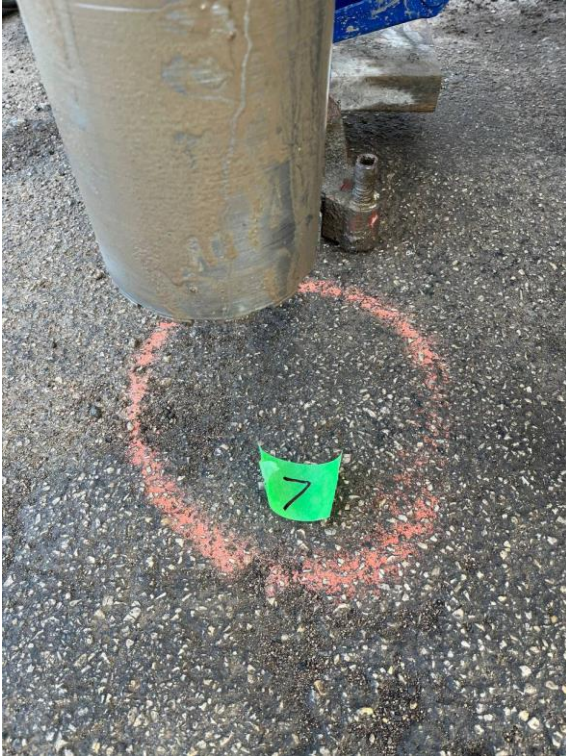
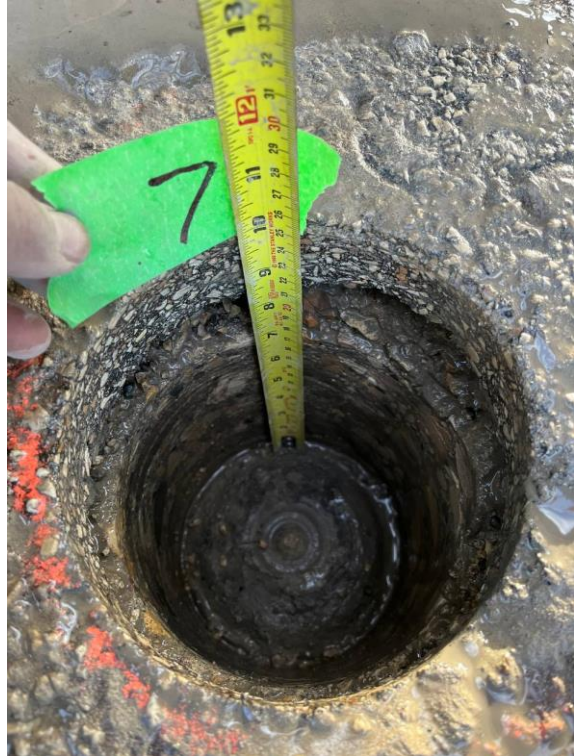
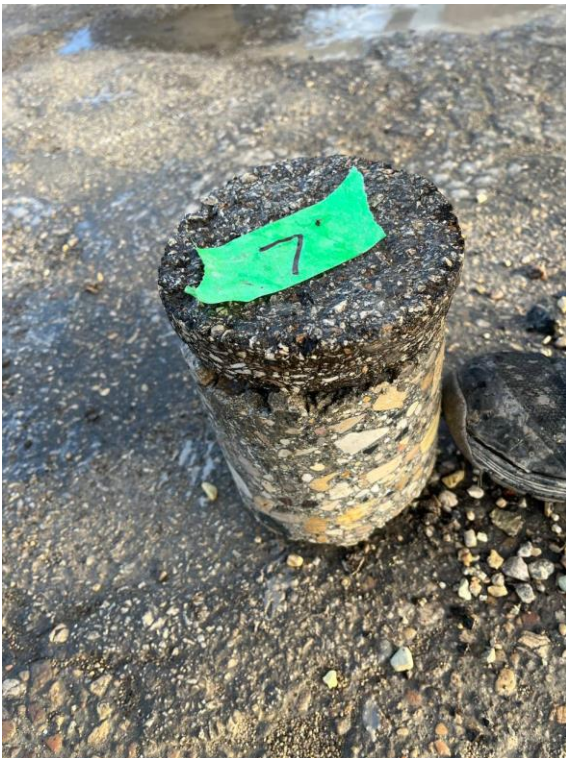
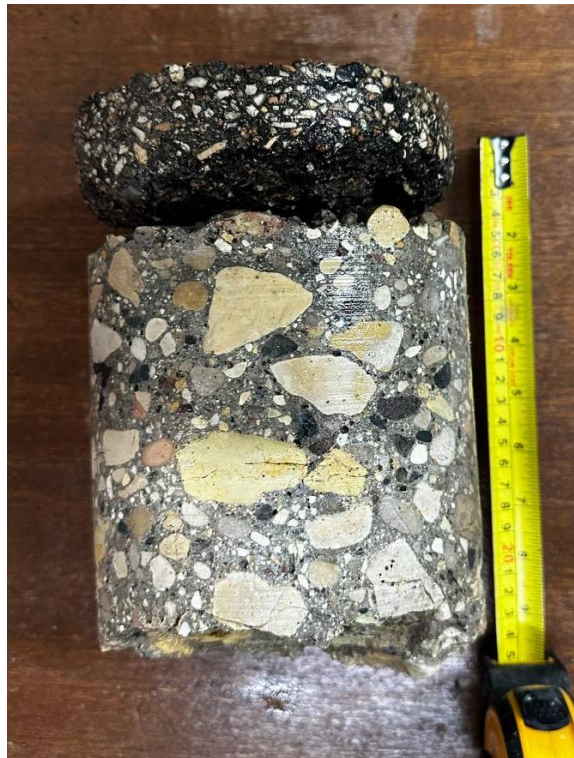
**Core 7 – Sanford (NBL)**

Figure 7. Photos showing Core 7 pavement showing void and gap between asphalt and concrete

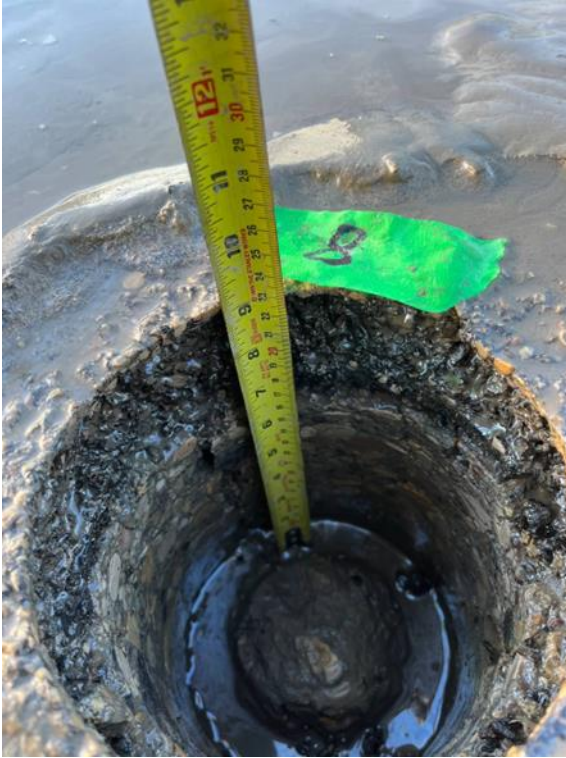
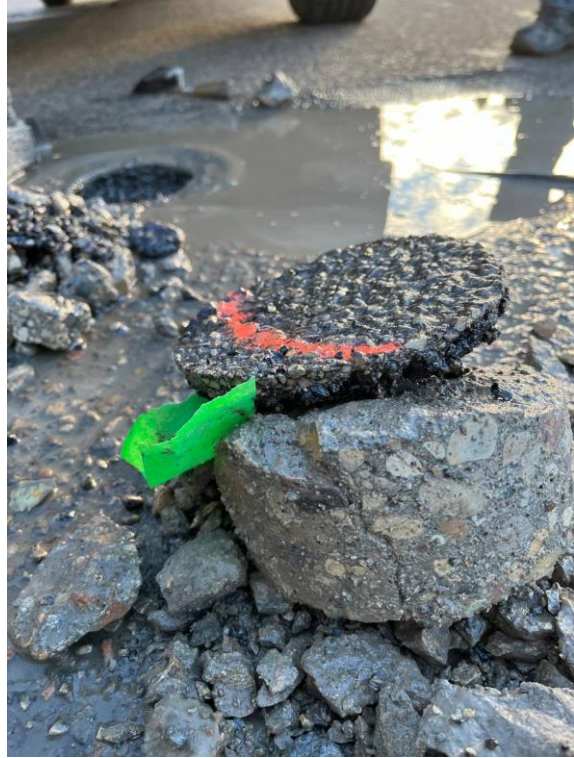
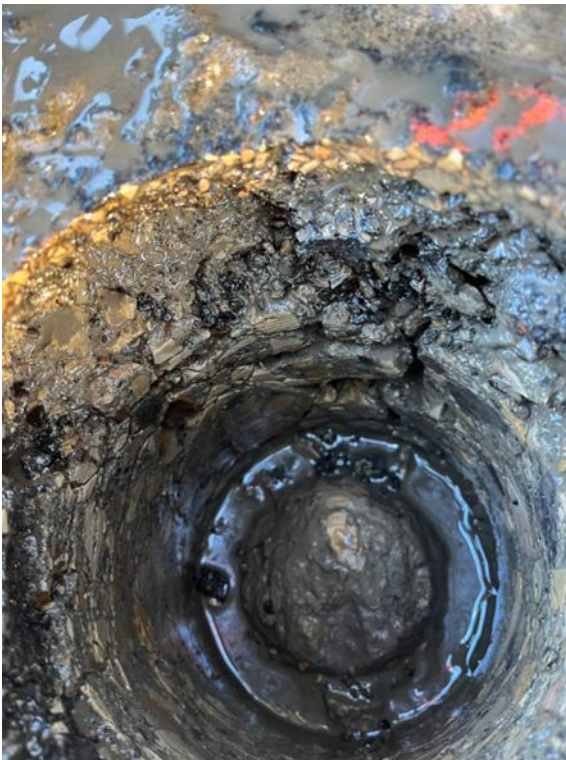
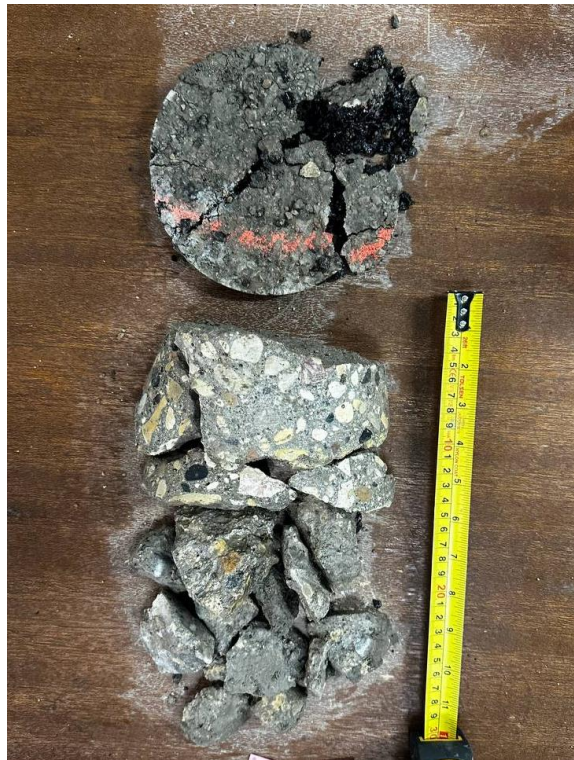
Core 8 – Sanford (NBL)

Figure 8. Photo showing Core 8 pavement showing cold mix asphalt and deteriorated concrete. Void existed between the pavement and base surface

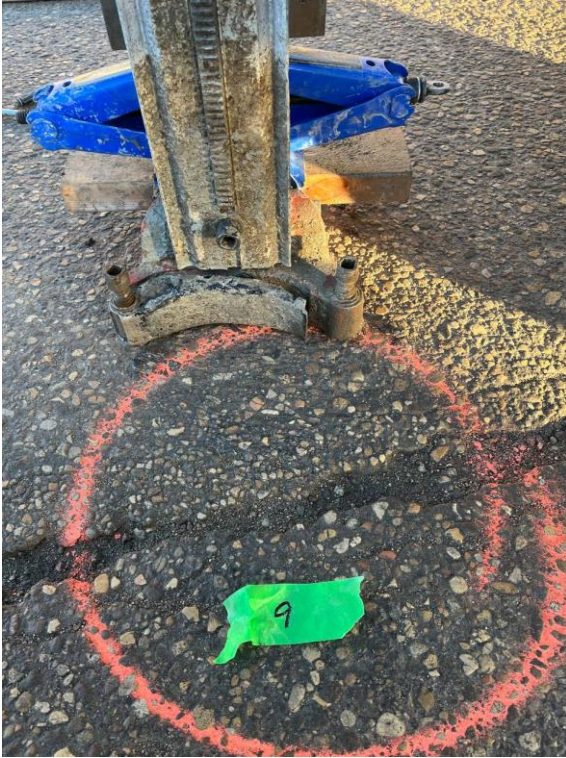
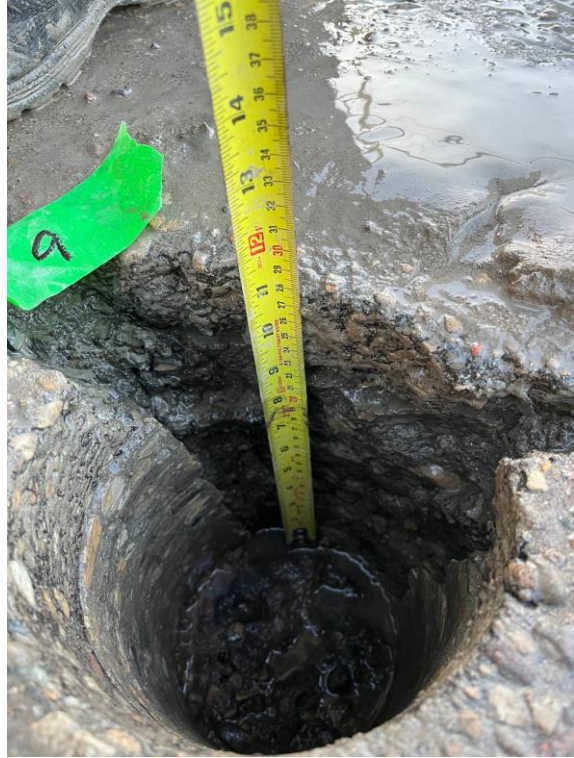
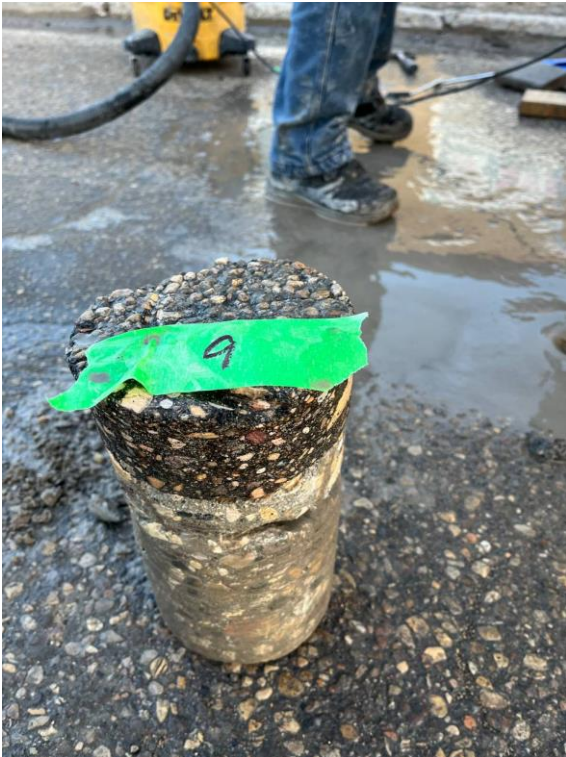
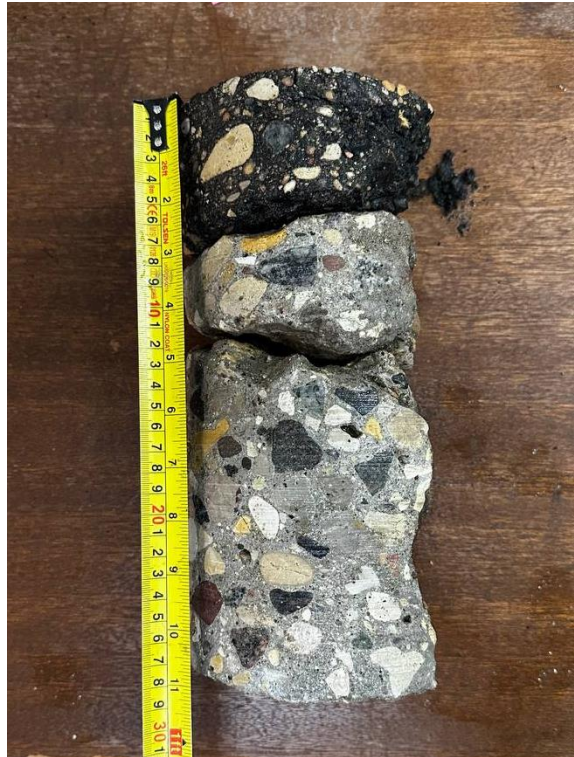
Core 9 – Sanford (NBL)

Figure 9. Photo showing core 9 showing deterioration of asphalt and concrete at joint

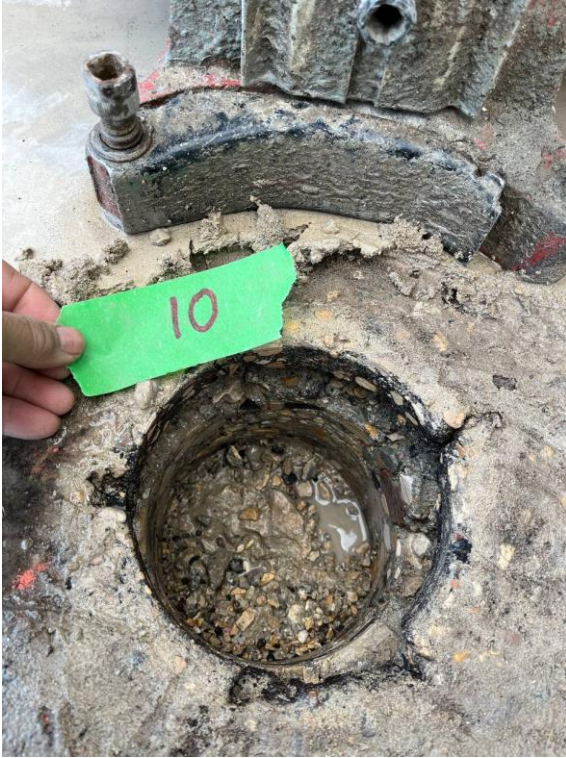
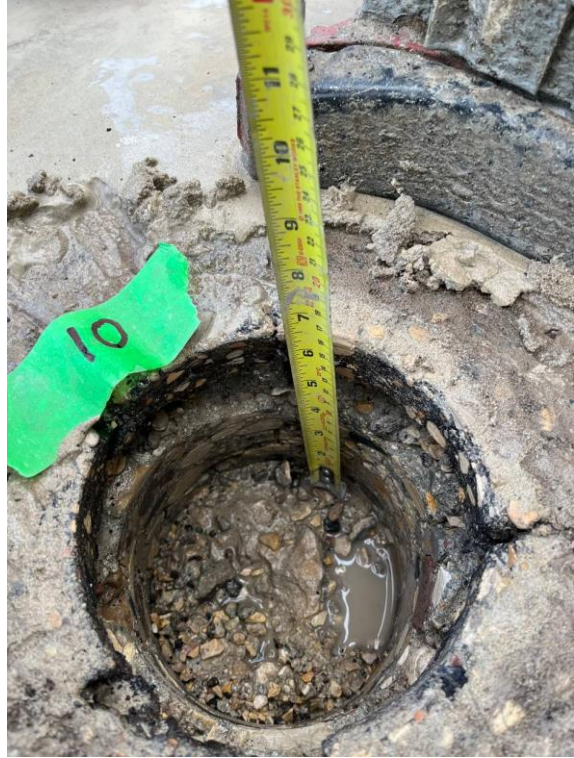
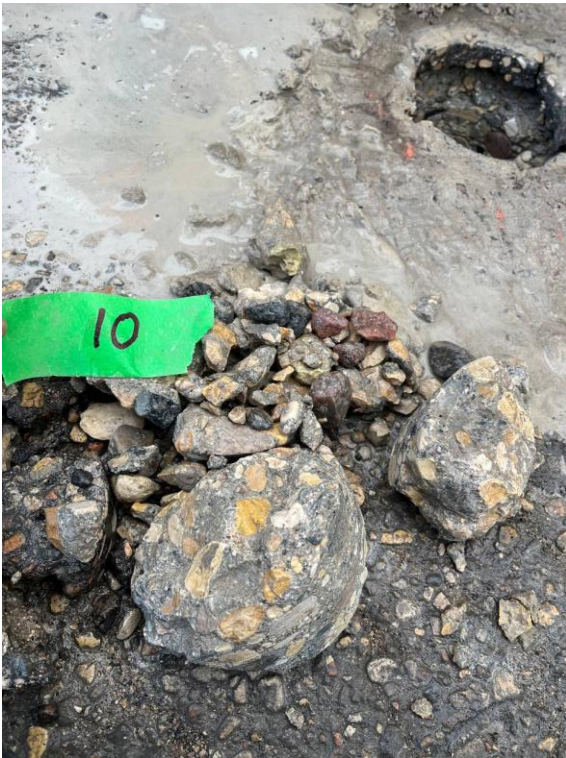
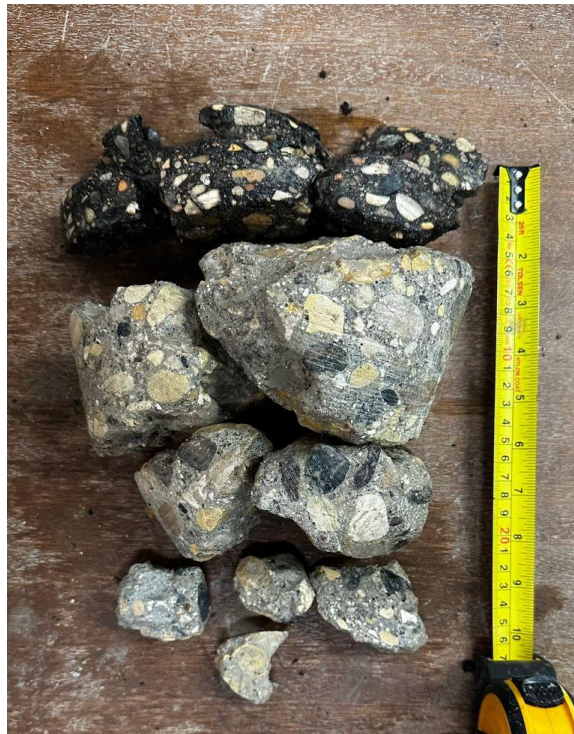
**Core 10 – Sanford (NBL)**

Figure 10. Photo showing core 10 showing deterioration and void space of asphalt and concrete. Void existed between the pavement and base surface

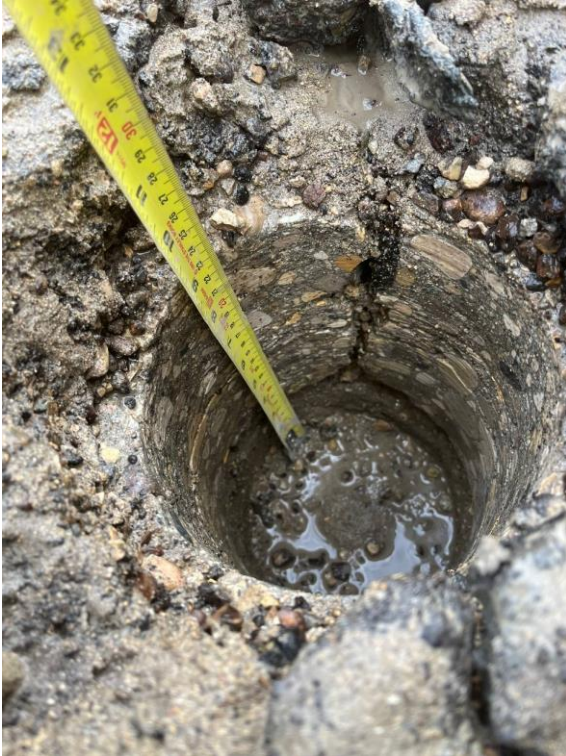
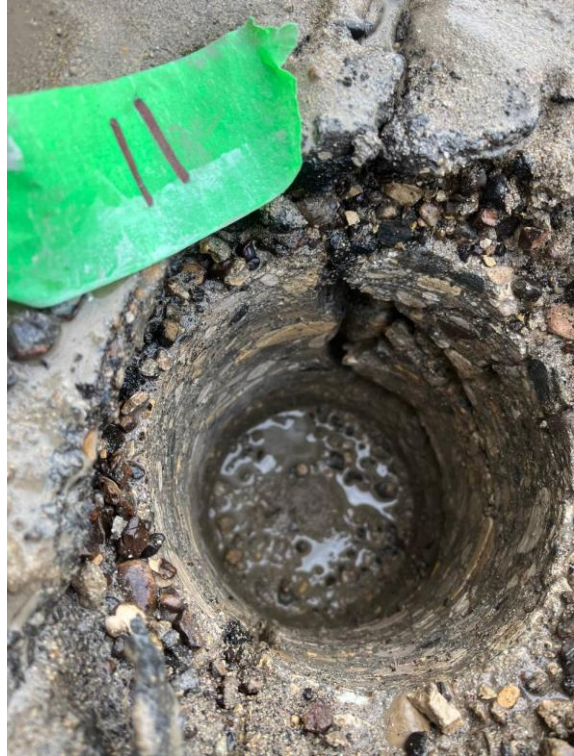
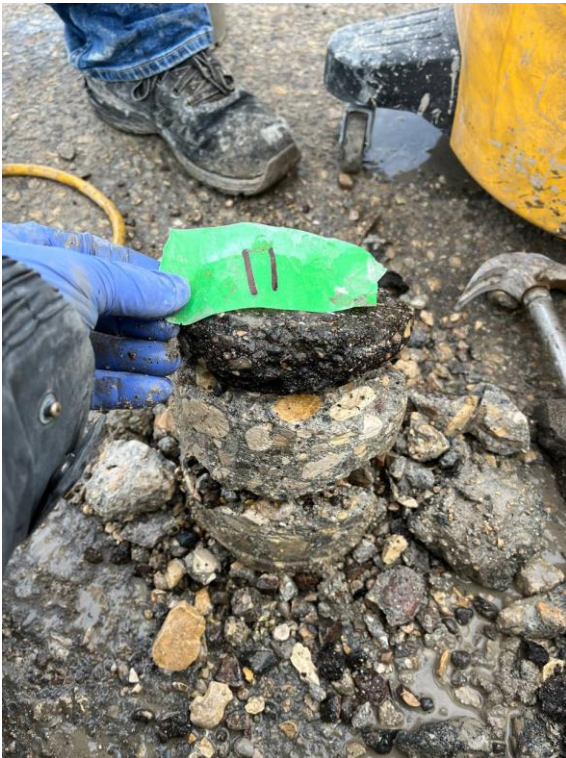
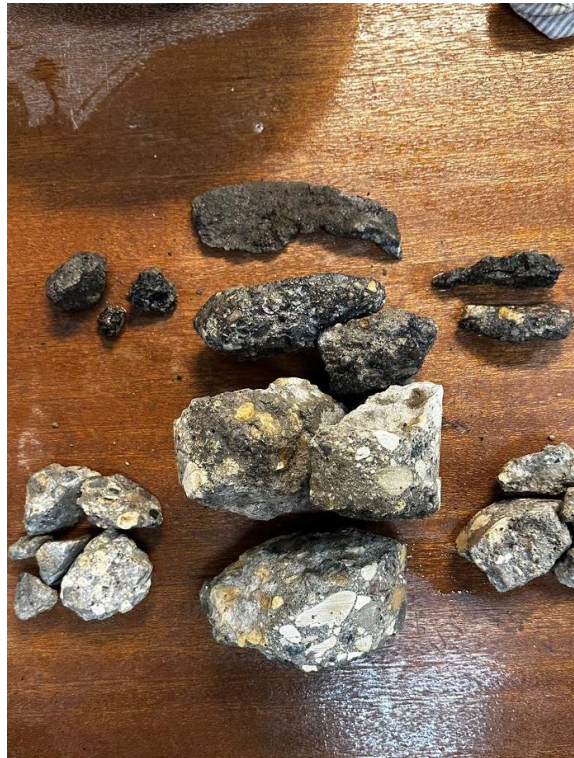
Core 11 – Sanford (SBL)

Figure 11. Photo showing core 11 showing deterioration and void space of asphalt and concrete at joint

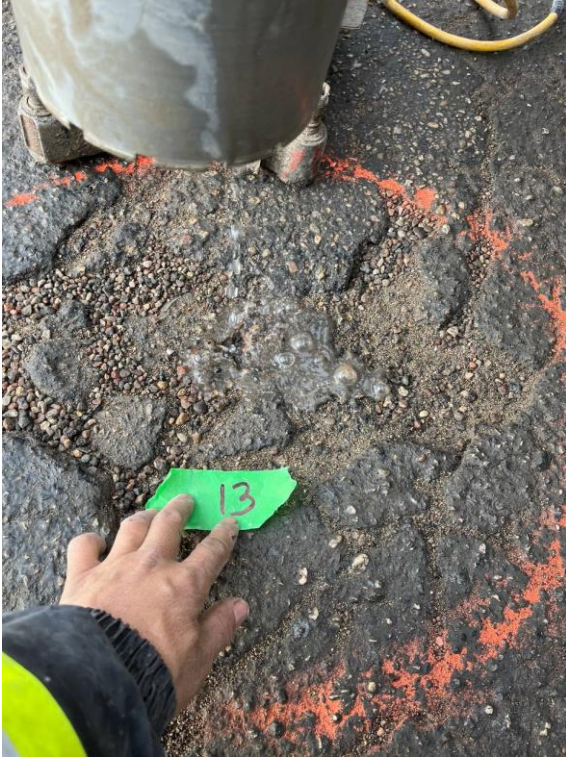
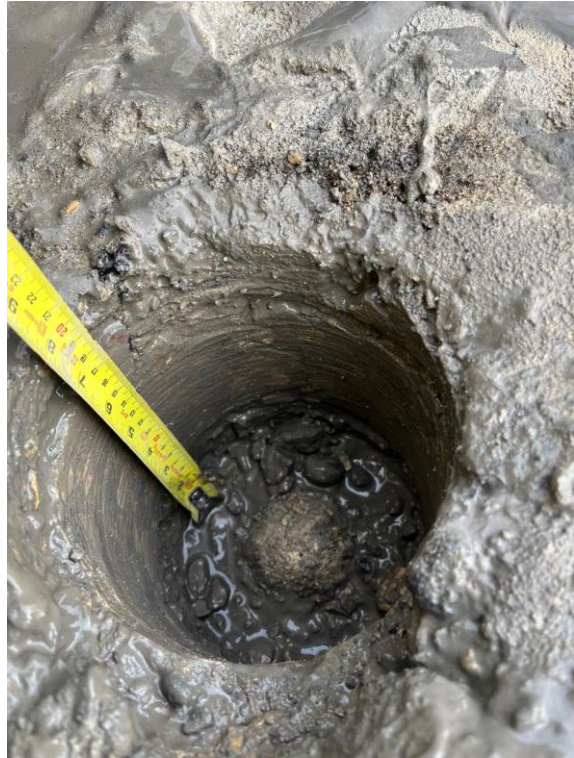
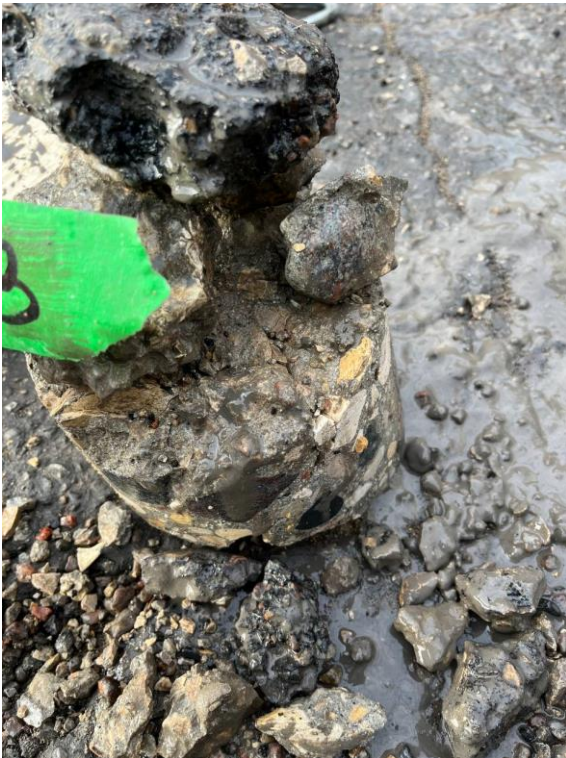
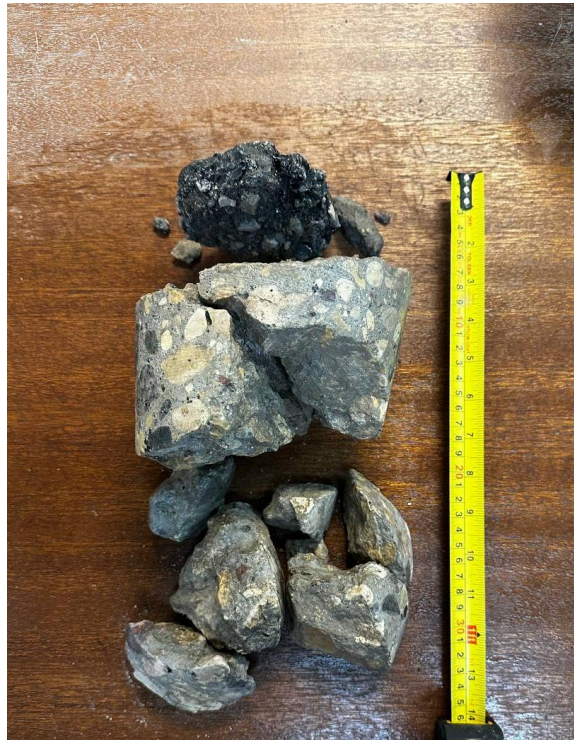
**Core 13 – Sanford (NBL)**

Figure 13. Core 13 showing deterioration of asphalt cold mix was present and concrete presented shear deterioration. Void existed between the pavement and base surface

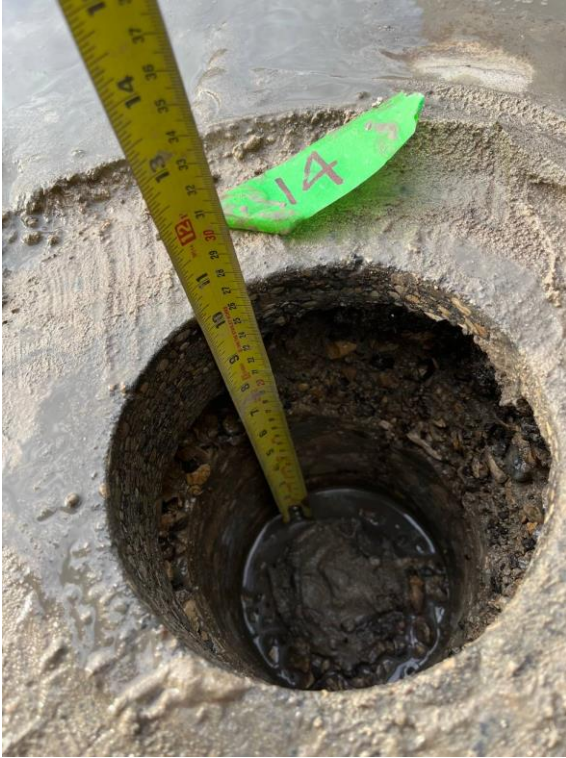
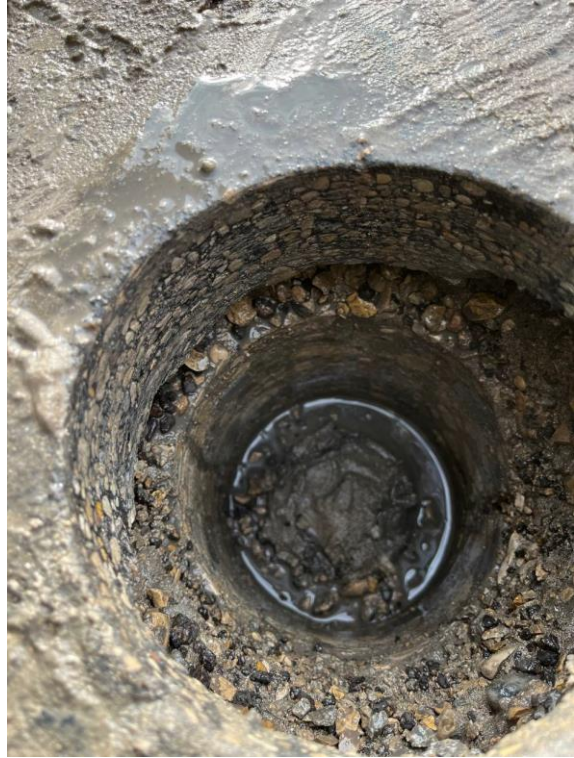
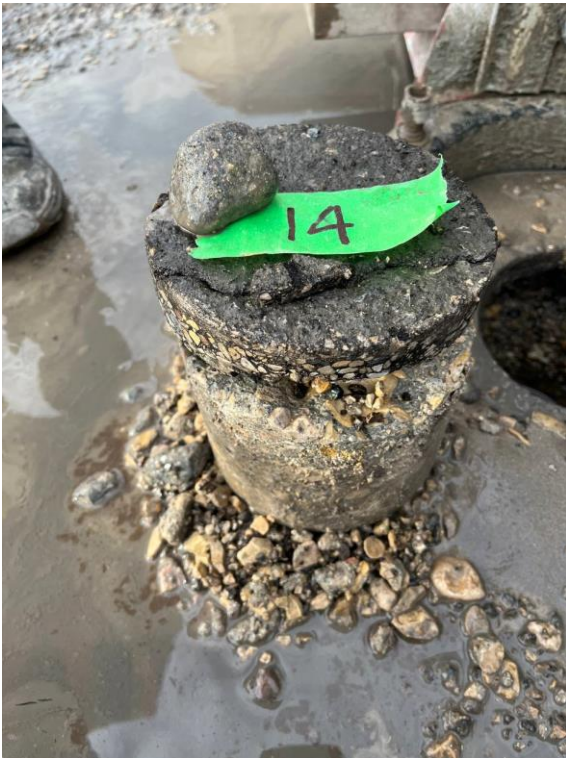
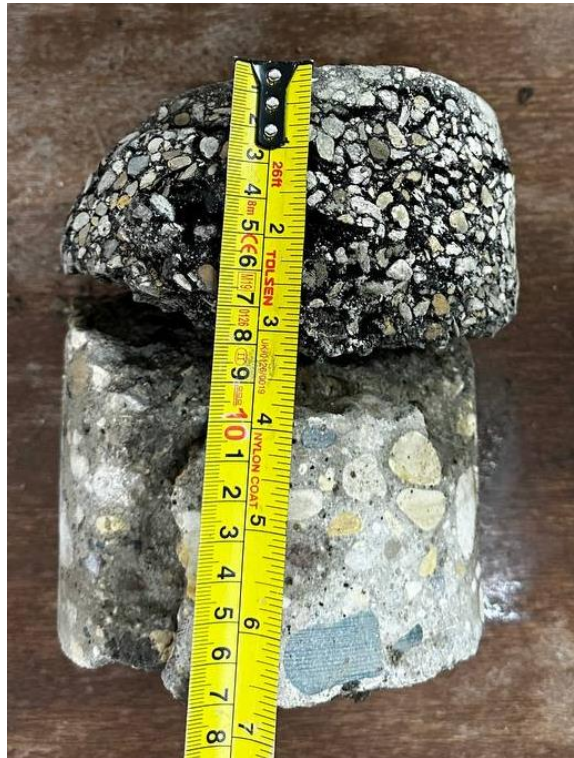
Core 14 – Sanford (NBL)

Figure 14. Core 14 showing shear deterioration of concrete and evidence of using cold mix asphalt. Void existed between pavement and base surface
