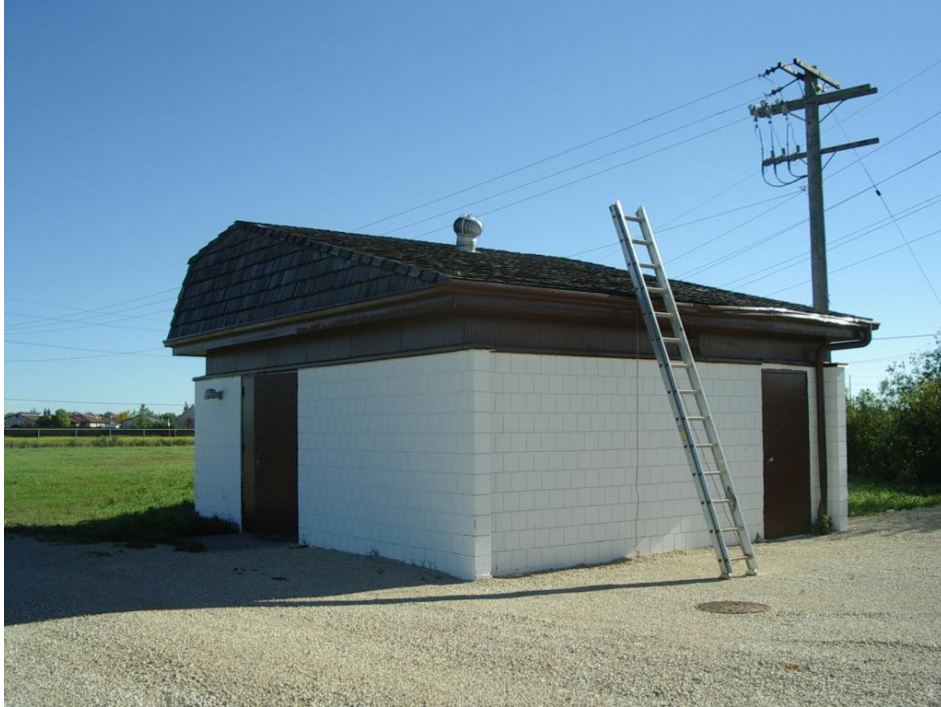
Photo 1 – Existing Building to be demolished

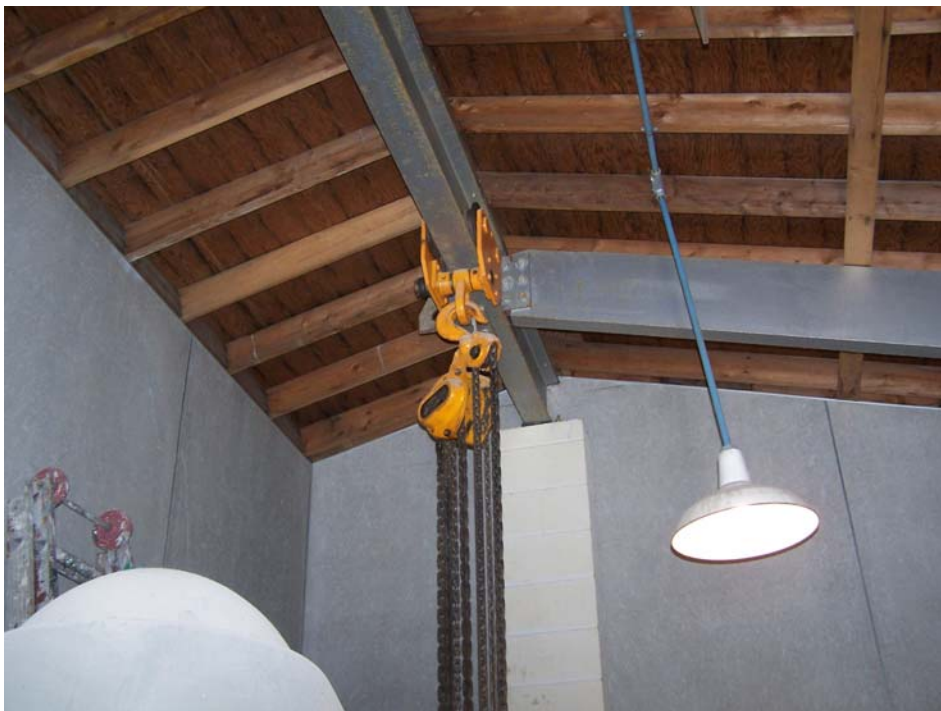
Photo 2 – Existing Asbestos wallboard to be removed (main floor).

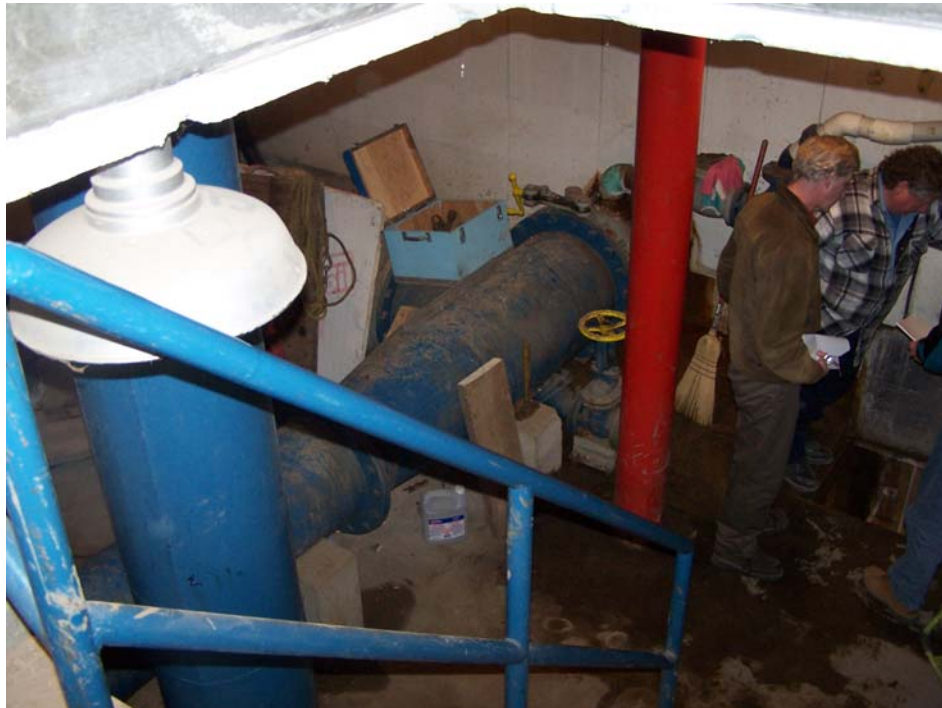
Photo 5 – Existing Piping to be removed (lower level)

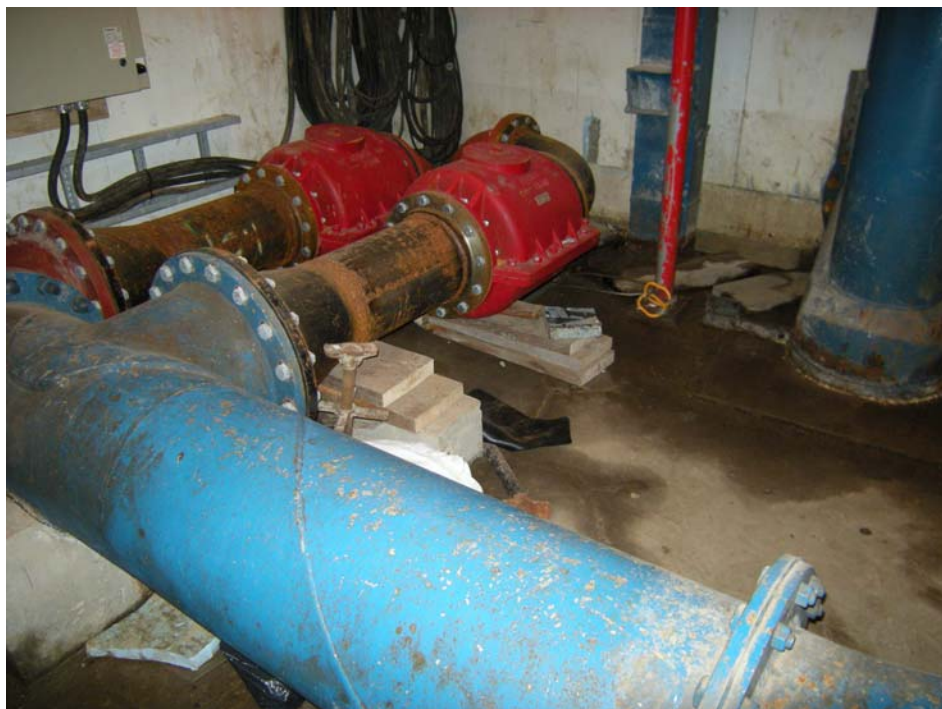
Photo 6 – Existing Piping to be removed (lower level)

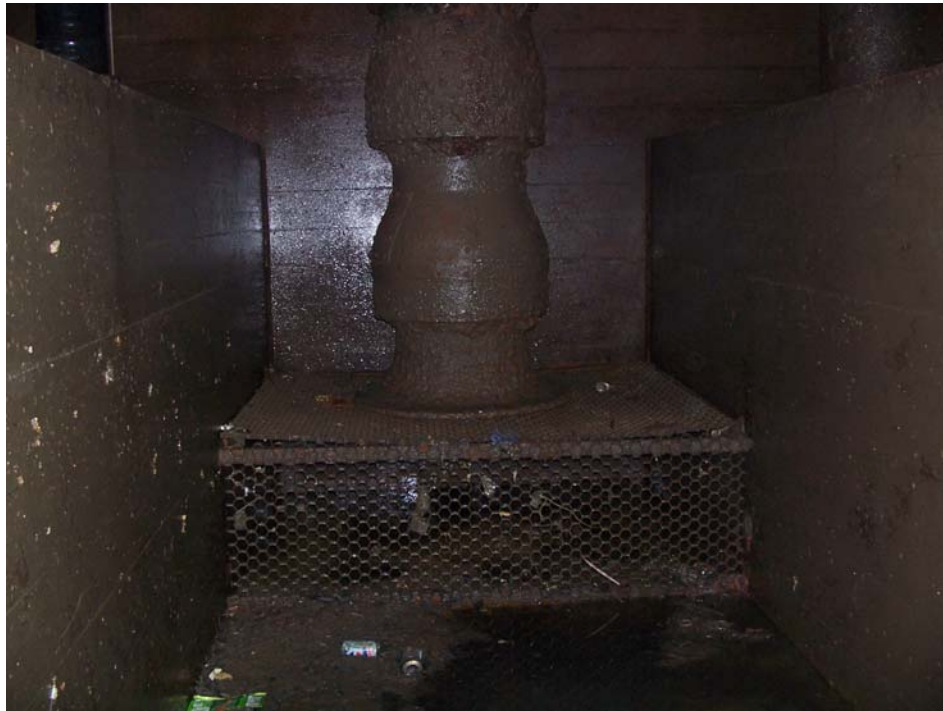
Photo 7 – Existing Pumps and Divider Walls to be Removed (Wetwell)

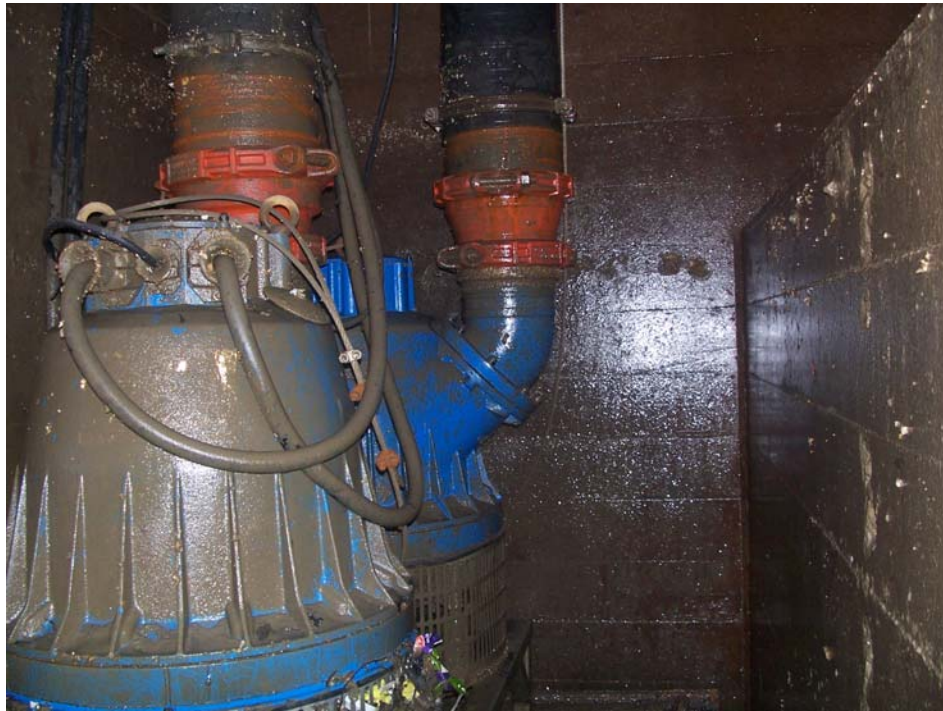
Photo 8 – Existing Submersibles to be salvaged (wet well)

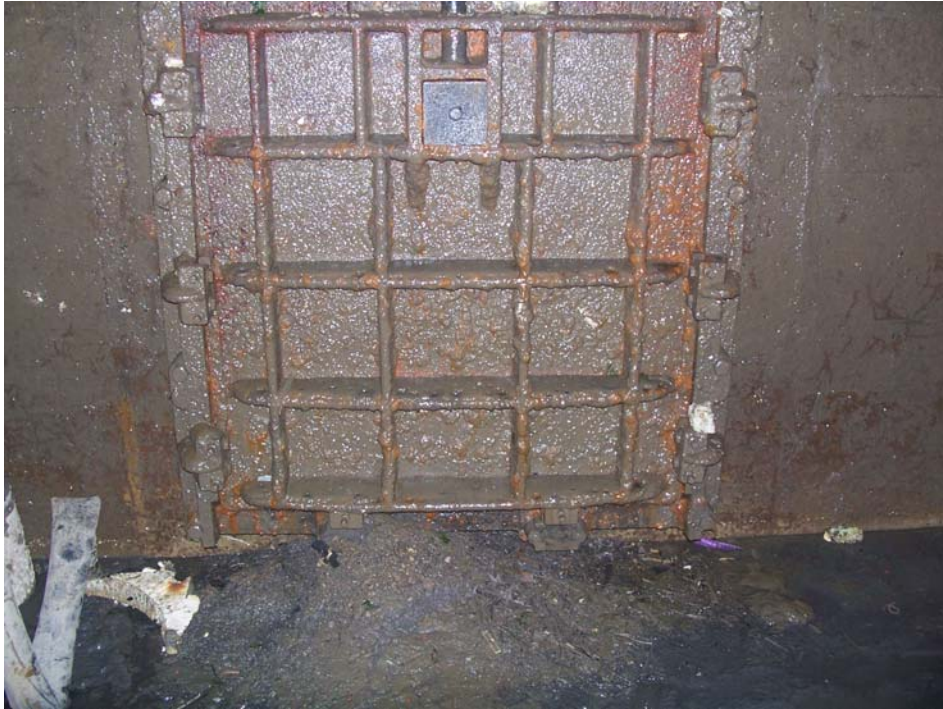
Photo 9 – Existing Slide gate to be removed

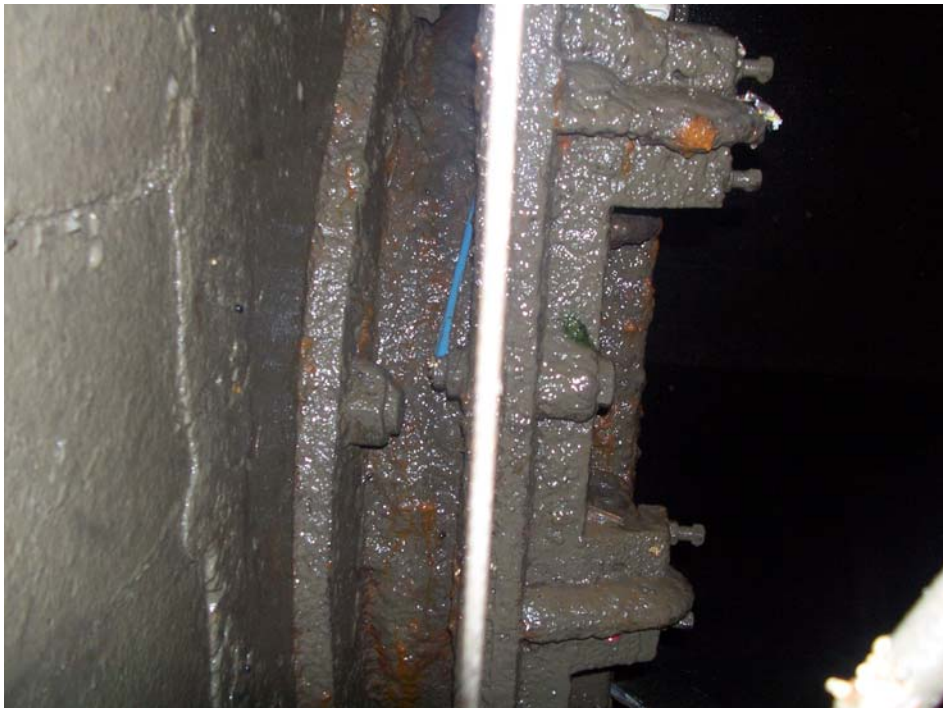
Photo 10 – Existing Slide gate to be removed

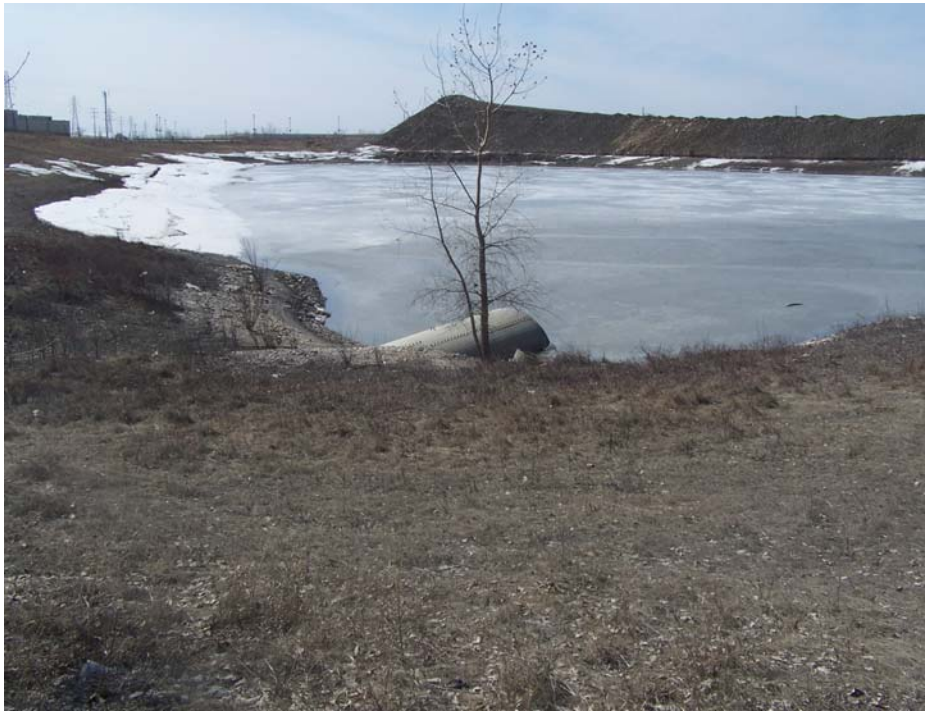
Photo 11 – Deep pond and intake pipe (April 10, 2007)

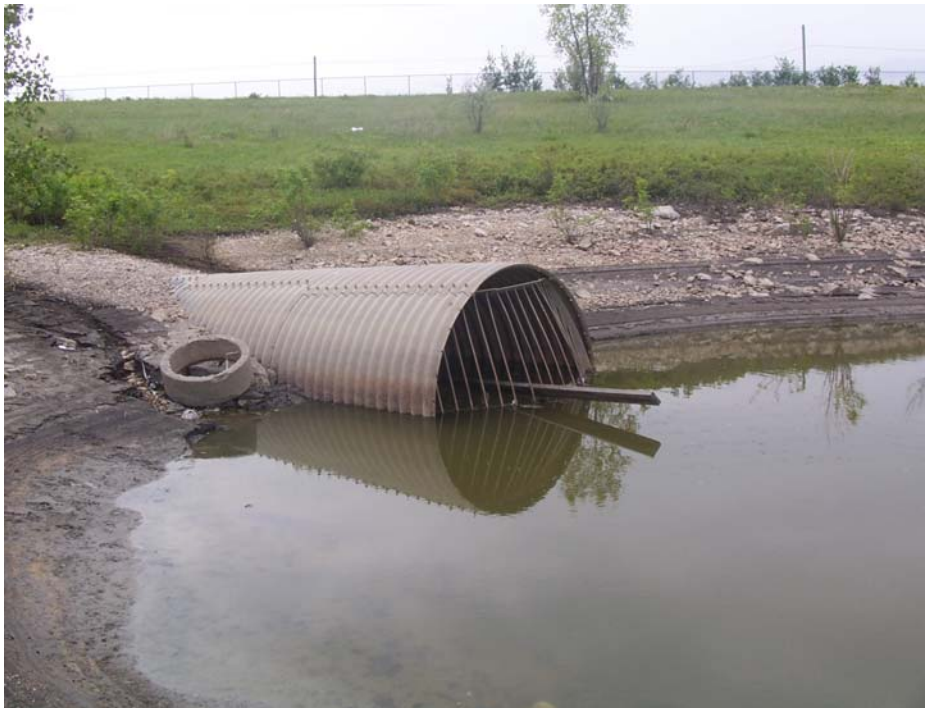
Photo 12 – Intake Pipe (April 10, 2007)

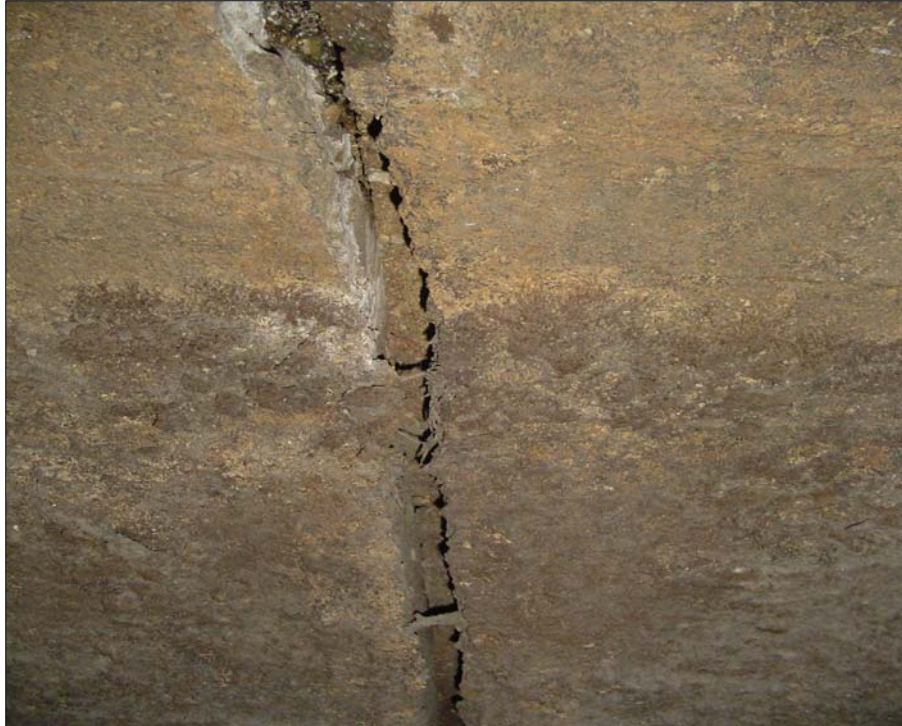
Photo 13 – Intake Pipe – Typical Wall Crack

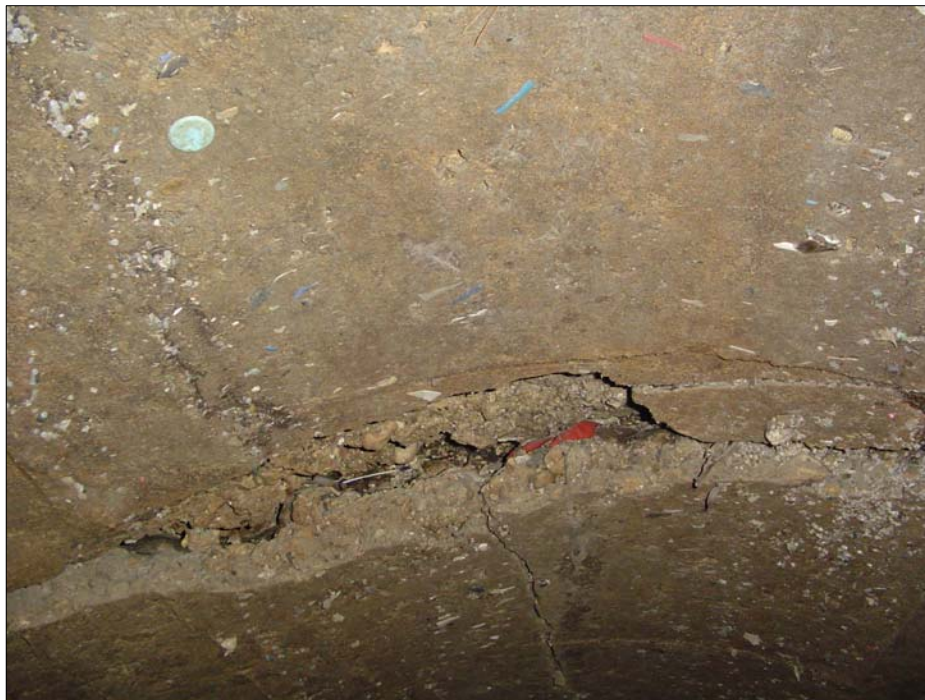
Photo 14 – Intake Pipe – Typical Ceiling Crack and Spalling.

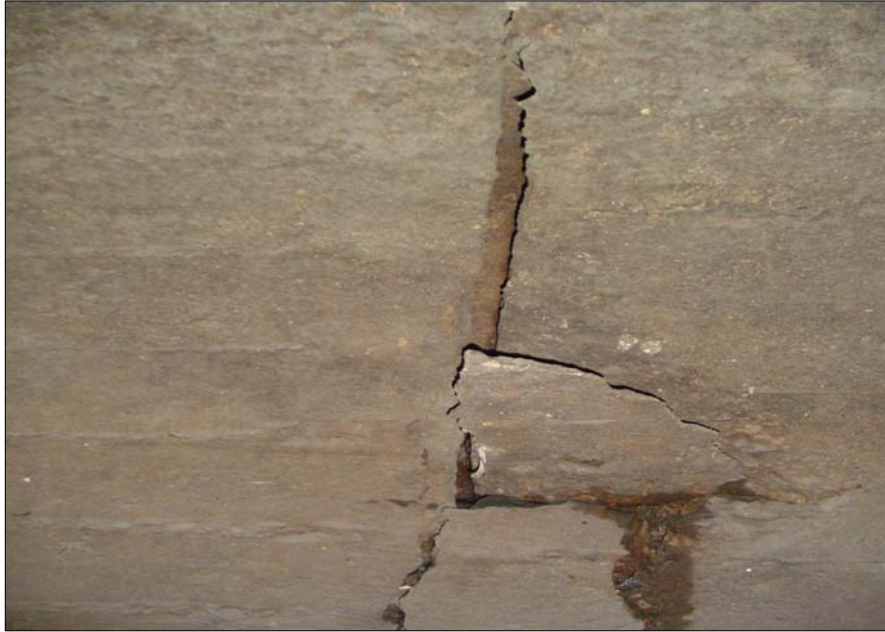
Photo 15 – Intake Pipe – Typical Wall Crack and Spalling

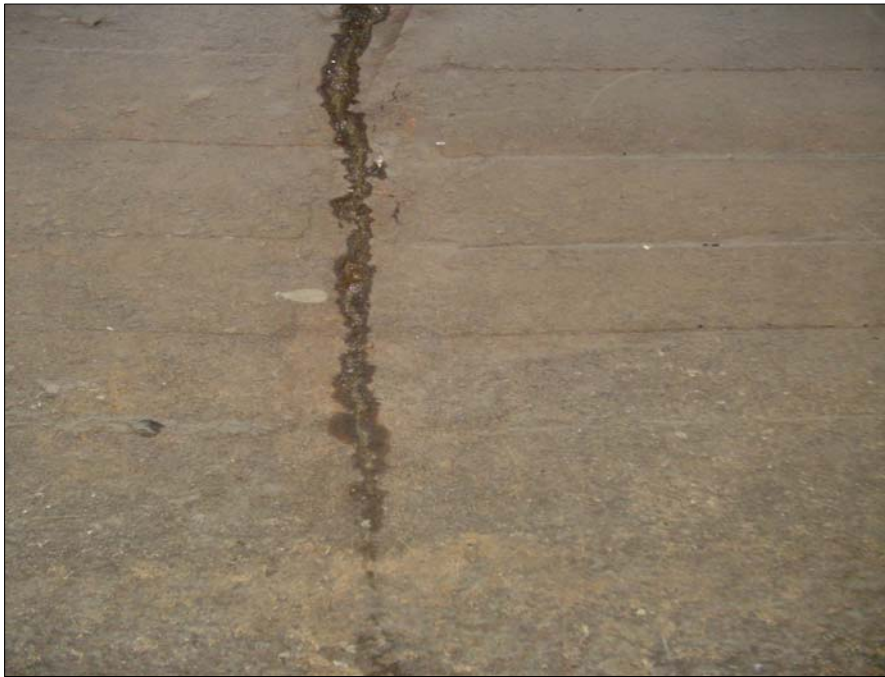
Photo 16 – Intake Pipe – Typical Wall Hairline Crack
