Electrical Cabling Material Issues

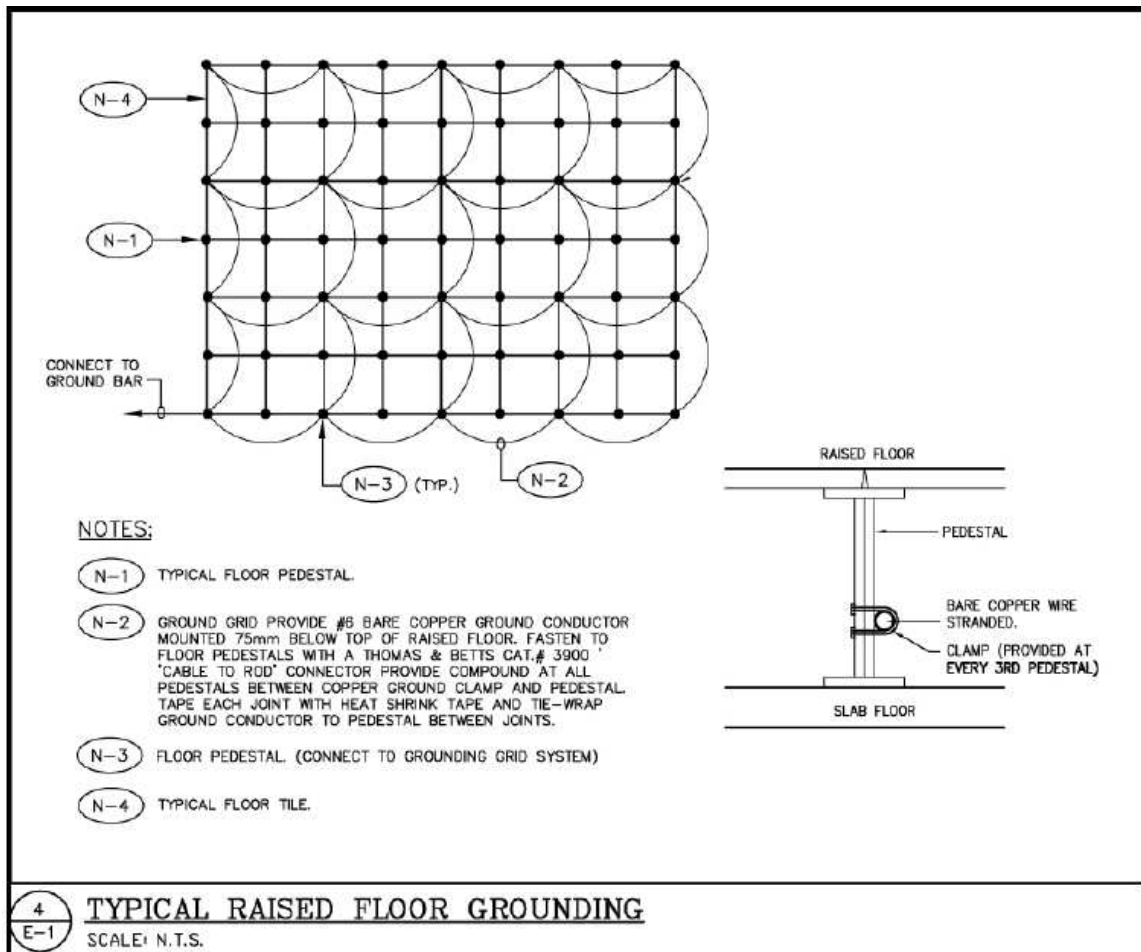
The raised access floor has not been adequately bonded to ground, as required by the Canadian Electrical Code (CEC). The code states that “every fourth pedestal” shall be bonded to ground. The purpose of this grounding system is to protect personnel from electric shock in the event the raised floor panels were to become electrically energized due to a power fault. Its secondary purpose is to allow static charges and high-frequency noise to bleed safely away from the processing equipment. The use of a bolted metal stringer under-structure for the raised floor helps to preserve the intent of this code requirement.

The requirement of “every 4th pedestal” is open to some interpretation. A typical raised floor grounding diagram is shown below for illustration purposes. This method of grounding fully satisfies the “every 4th pedestal” requirement of the CEC. Using this pattern of grounding, no single floor panel will be without a pedestal bonded to ground at one corner. Translation: Every 4th pedestal should translate into 25% of all pedestals (i.e. ¼ of all pedestals are bonded to ground).

The City should also follow IEEE-1100 grounding guidelines and ensure to bond all electrical panels, air conditioning units and equipment racks to the raised floor ground grid in both locations as well.
