# City of Winnipeg 2015: 250mm (10in) Maryland Bridge Watermain Assiniboine River Crossing

Condition Assessment Report, Standard Analysis

PICA – Pipeline Inspection & Condition Analysis Corporation  
(A Subsidiary of Russell NDT Holdings Ltd.)

PICA Project: Winnipeg 8007

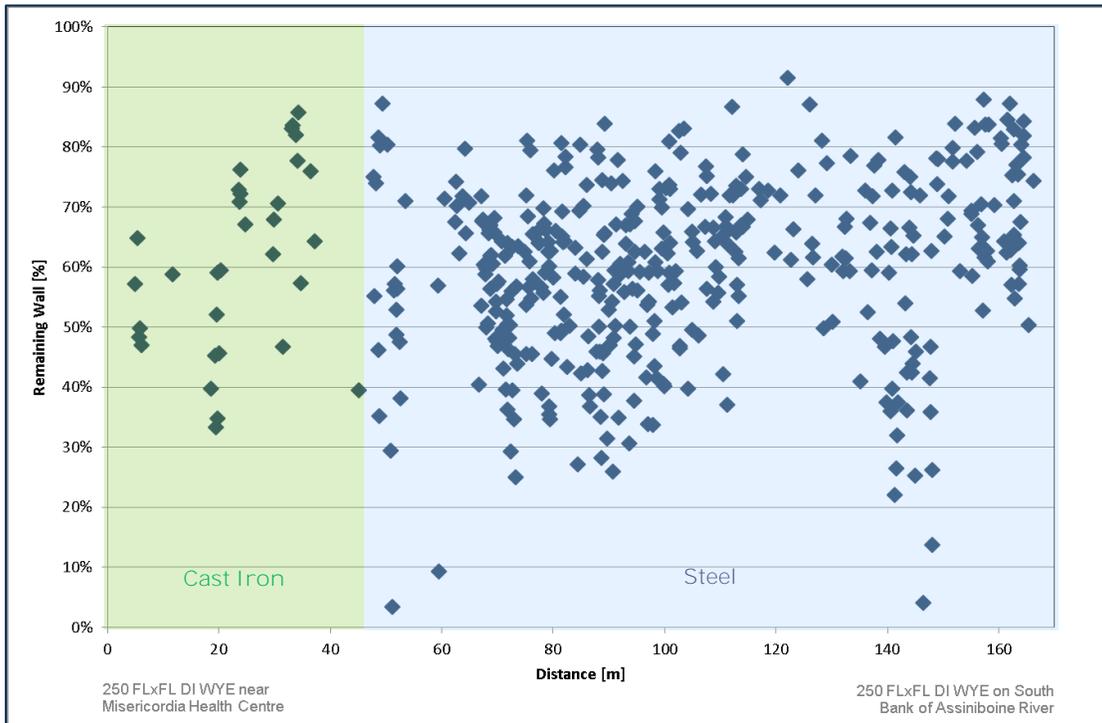
Figure 1: Distribution of wall loss with respect to remaining wall (%NWT) in pitting regions along the inspected section.

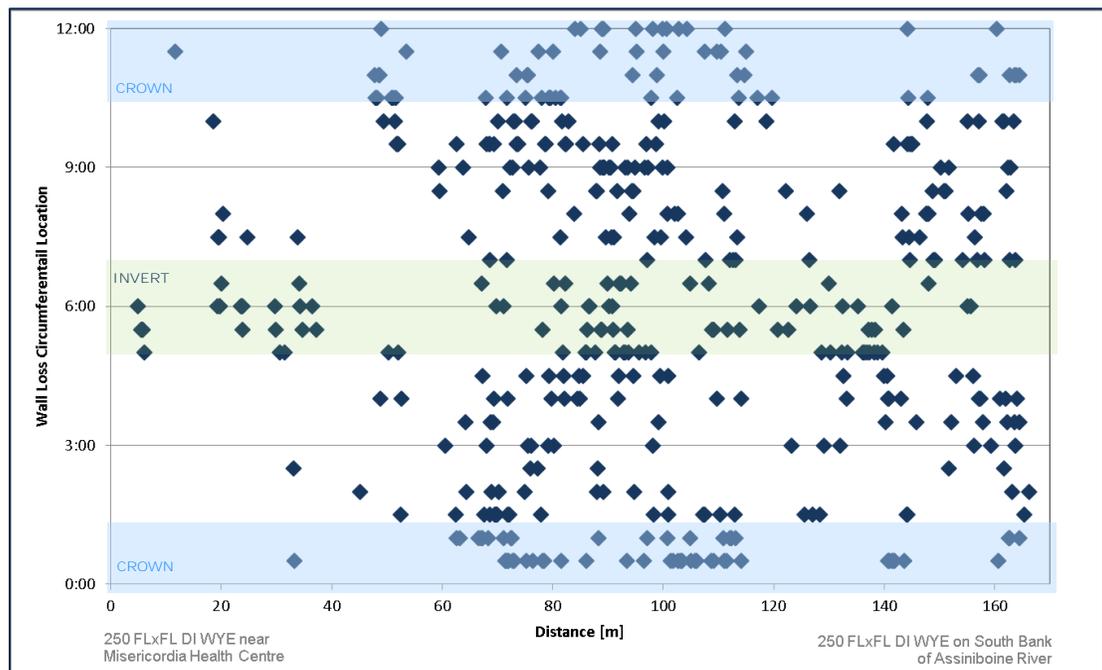
Figure 2: Circumferential distribution of pitting regions along the inspected section.

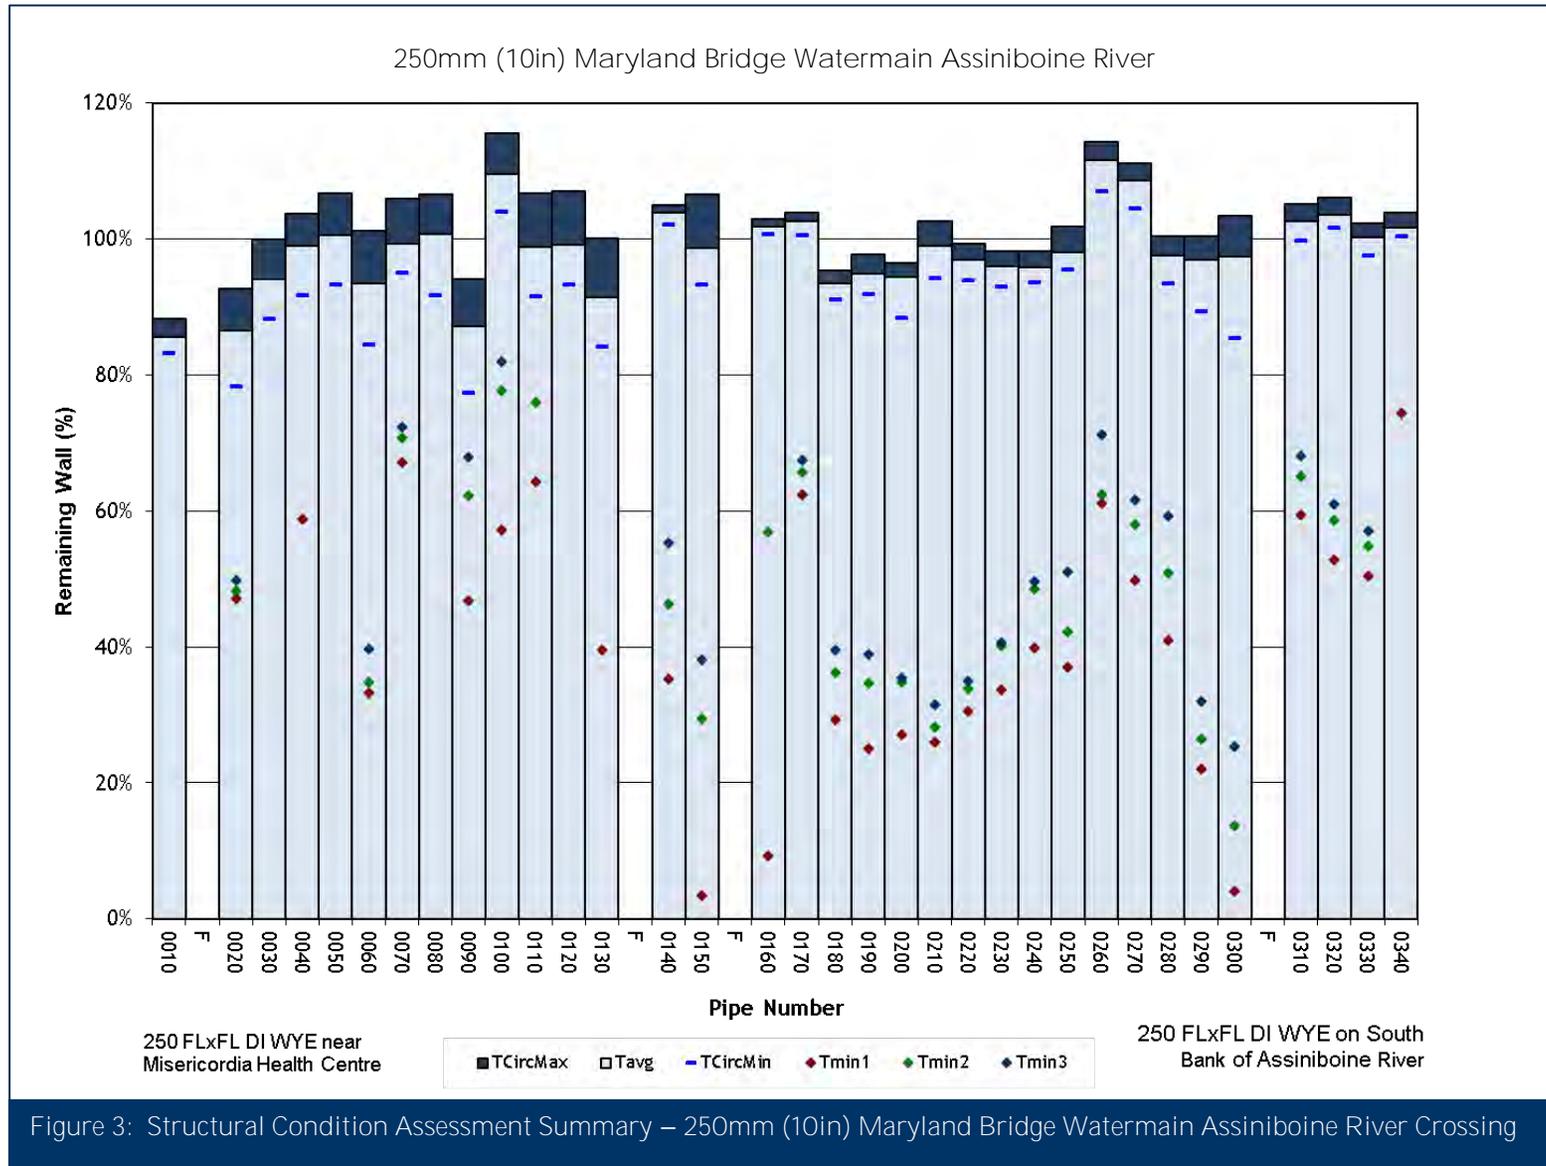
Figure 3: Structural Condition Assessment Summary – 250mm (10in) Maryland Bridge Watermain Assiniboine River Crossing

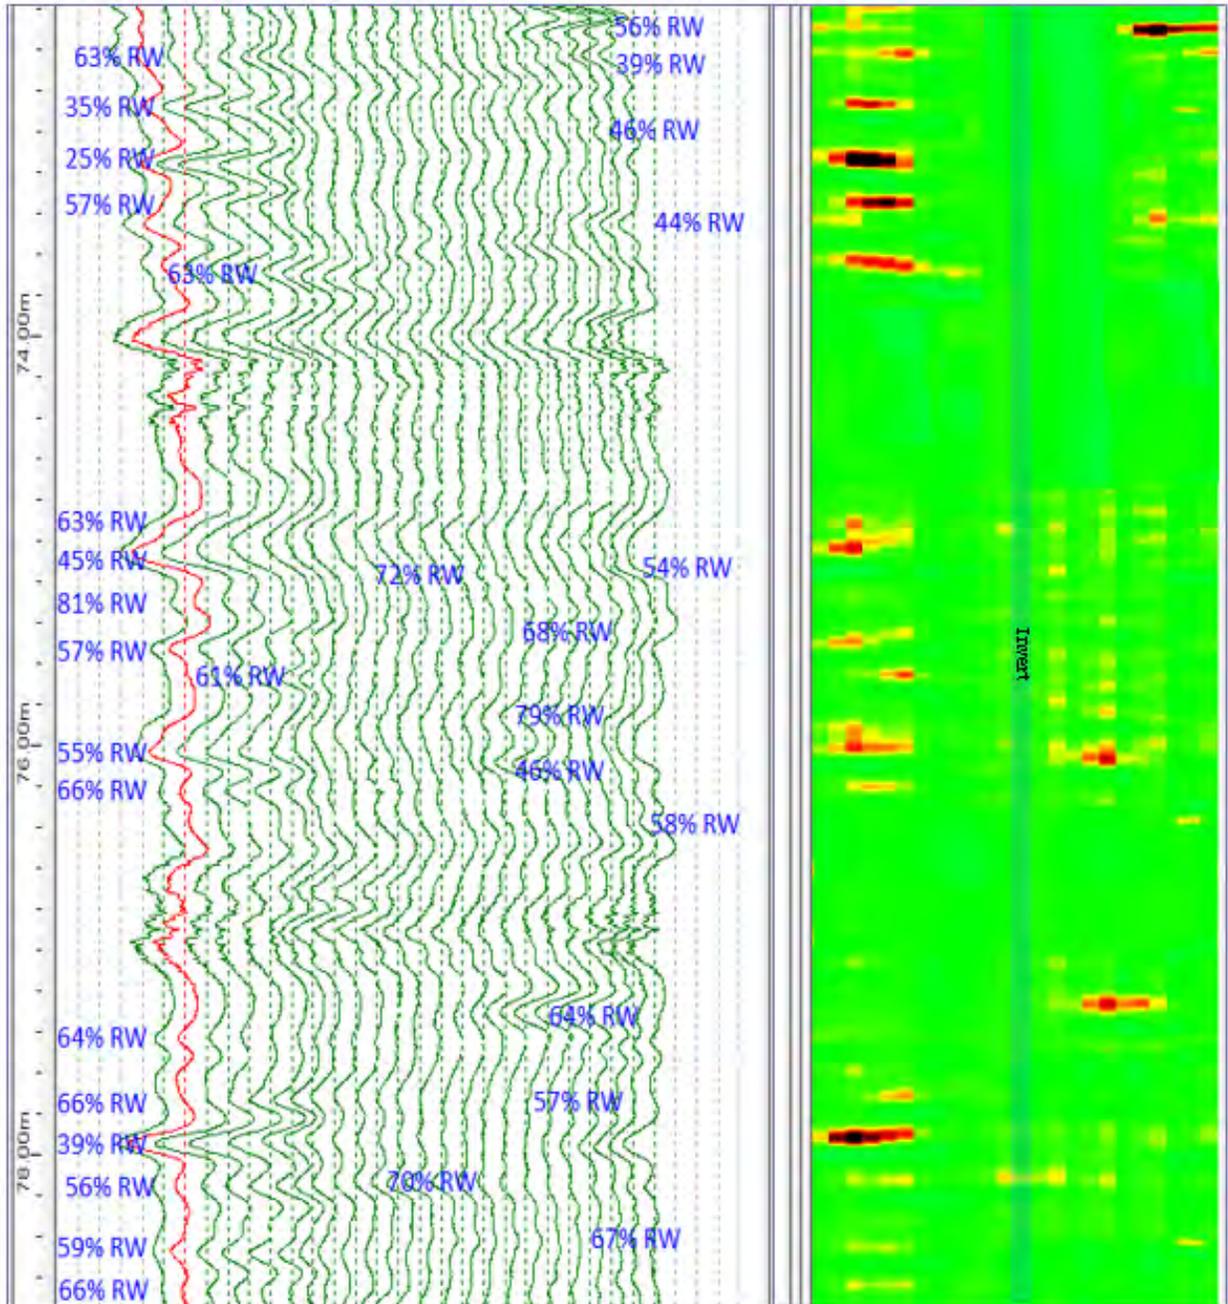
Pipe 0190: 72.44-78.81m (32 defects ranging between 25% and 81% RW)

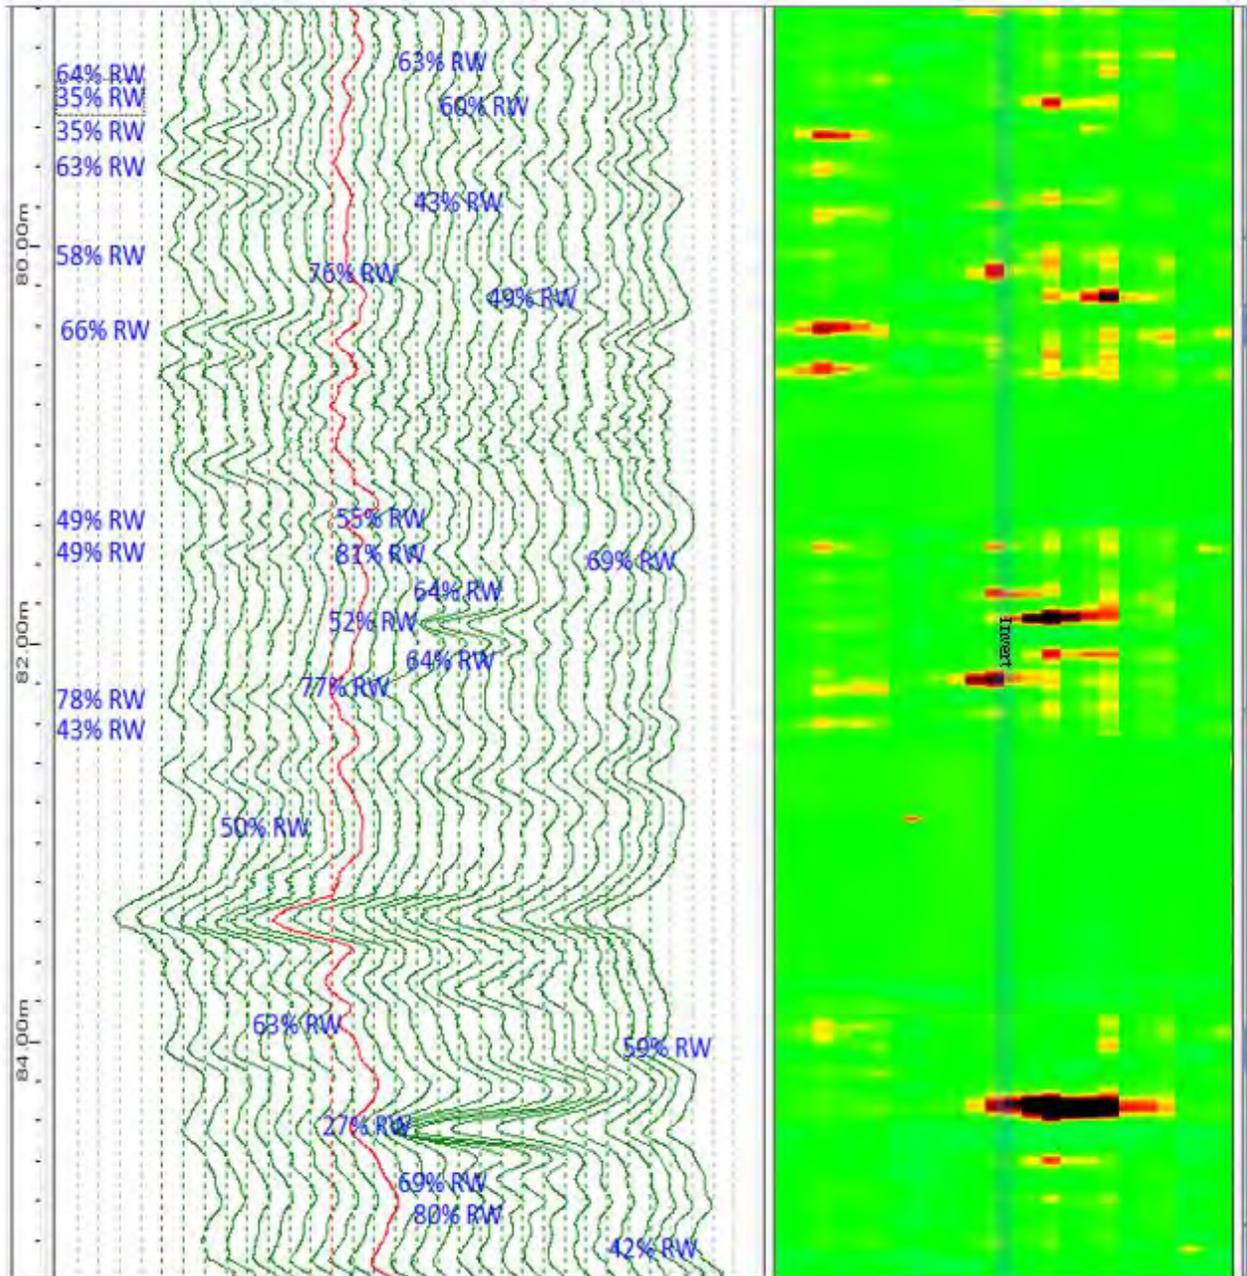
Pipe 0200: 78.81-85.14m (31 defects ranging between 27% and 81% RW)

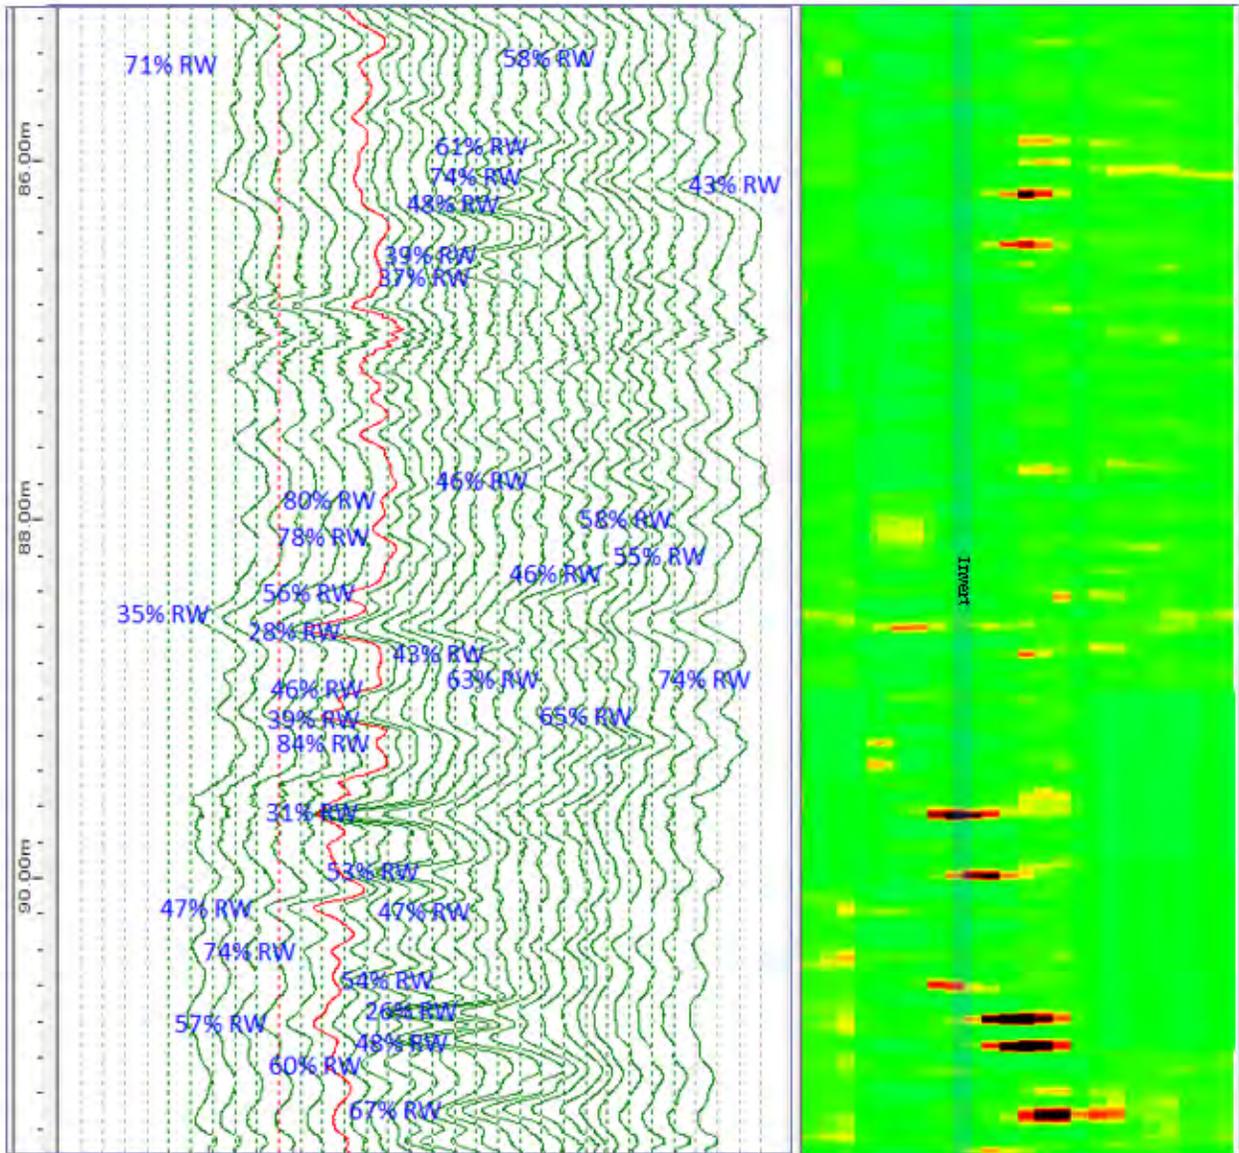
Pipe O210: 85.14-91.52m (38 defects ranging between 26% and 84% RW)

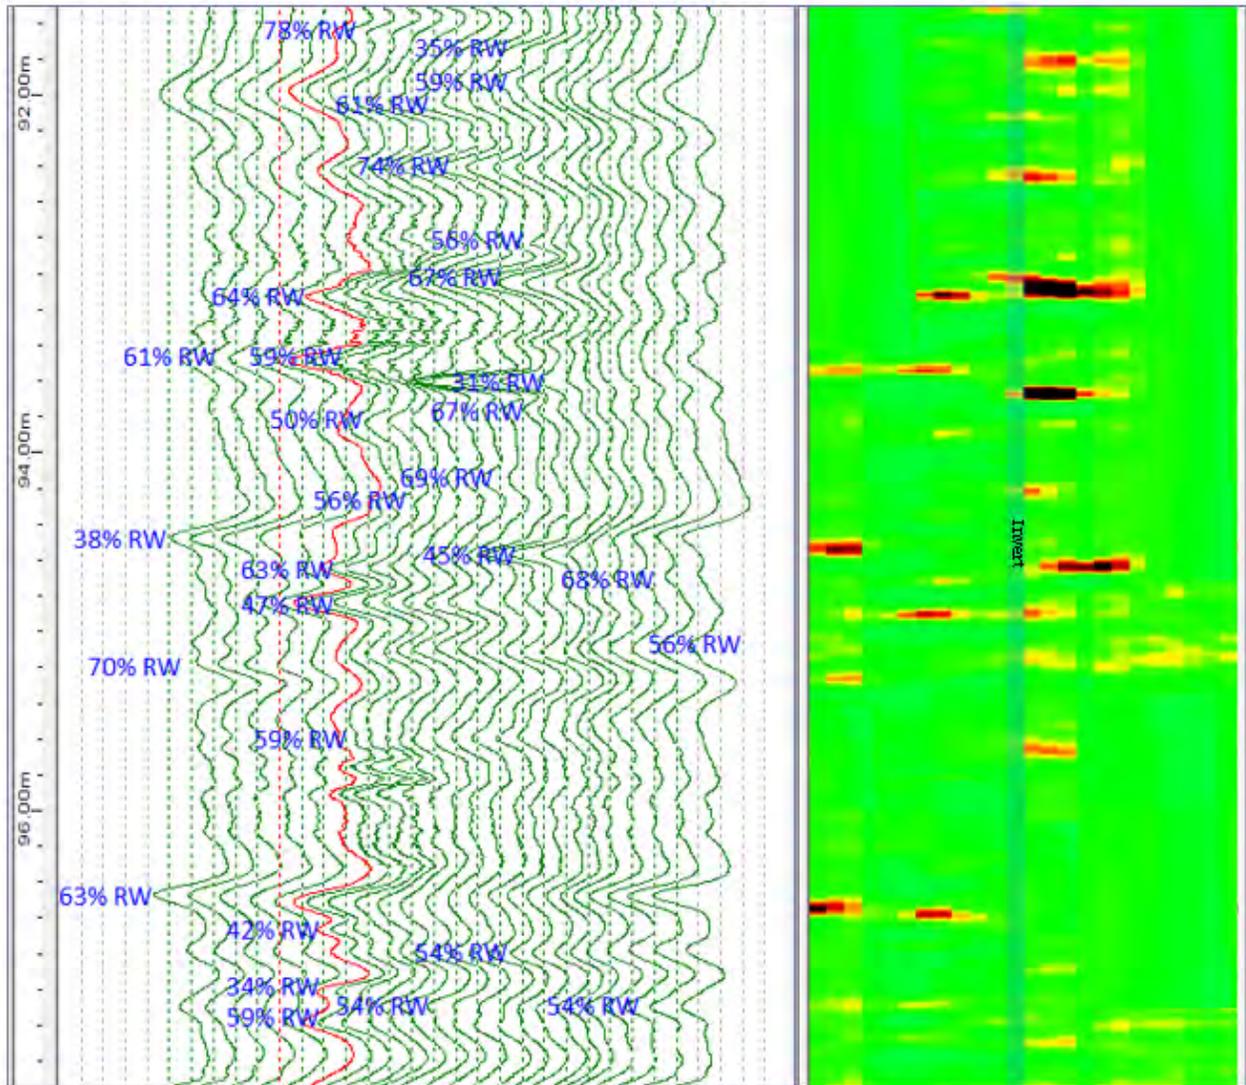
Pipe O220: 91.52-97.56m (30 defects ranging between 31% and 78% RW)
