GEOTECHNICAL REPORT

March 25, 2021

RE: City of Winnipeg Project No. 20-C-10; 2021 Portage Avenue Rehabilitation

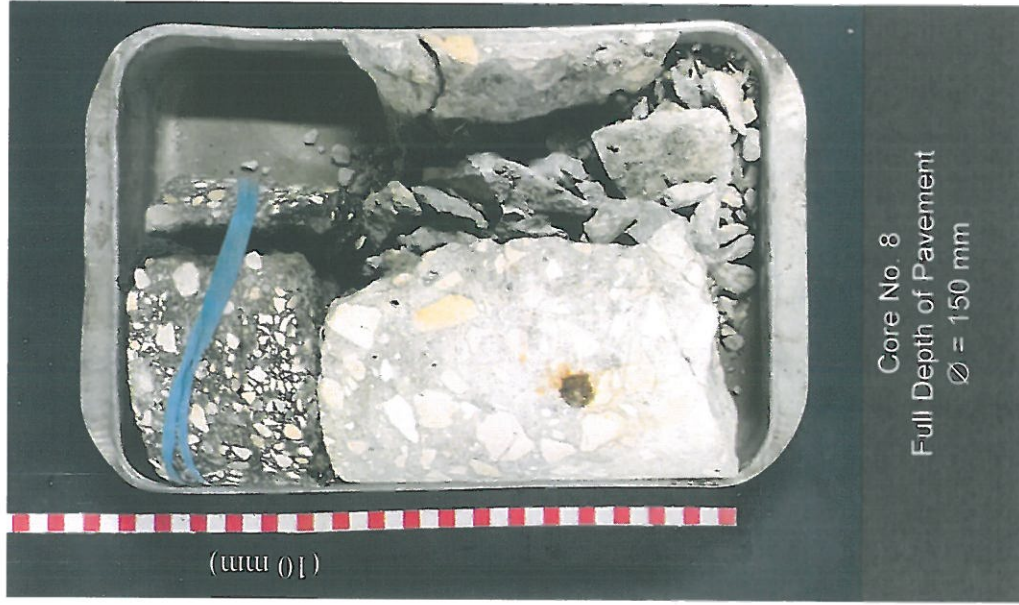
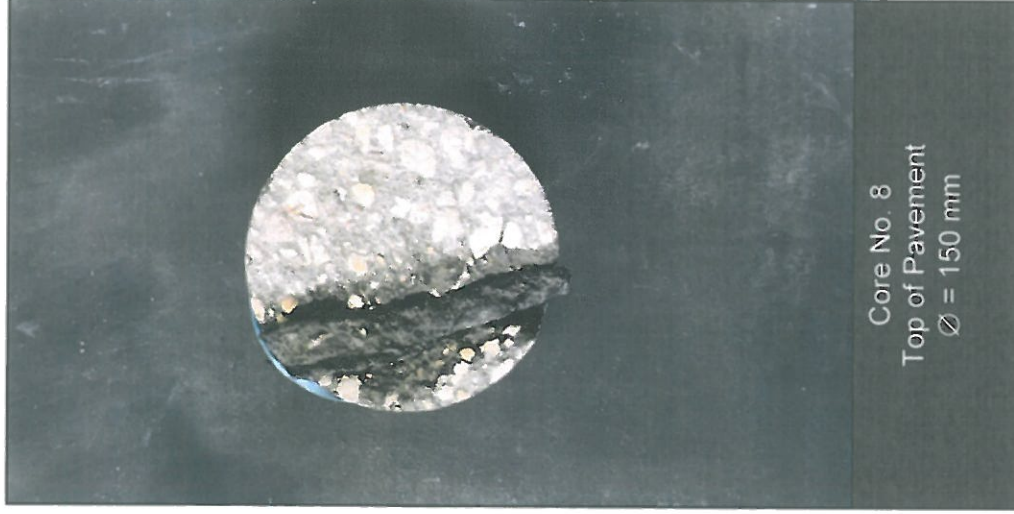
Photograph 8: Specimen from Westbound, Median Lane

Notes: Core No.'s 8, 9, 14 and 20 contained reinforcing steel bars.

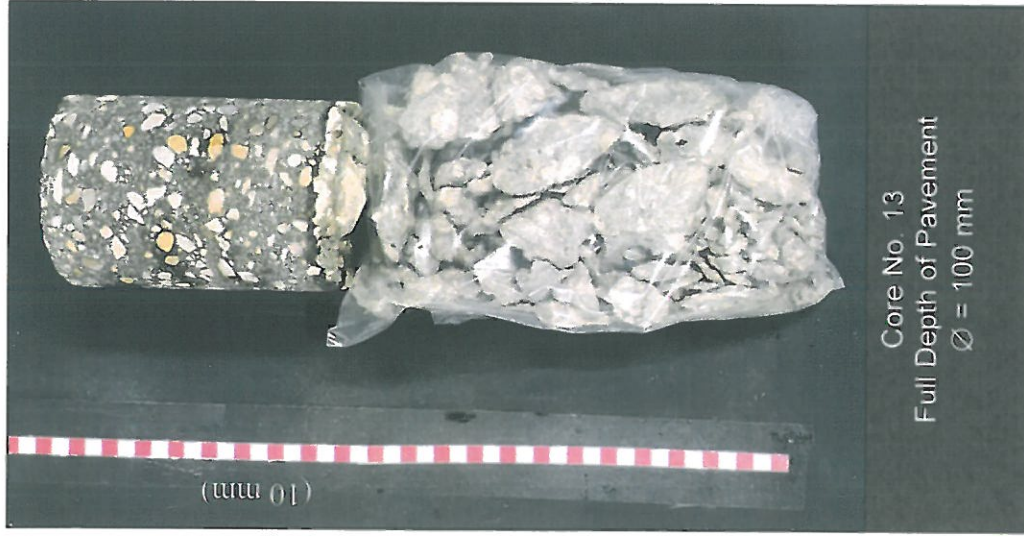
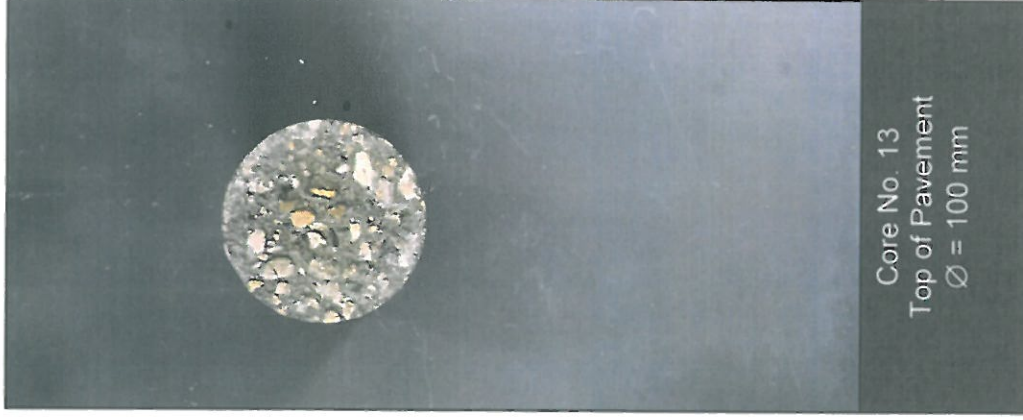
Photograph 13: Specimen from Eastbound, Median Lane

Comments: A compressive strength results was not determined from Core No. 13 location as an intact specimen was not recoverable after two attempts. Core No. 14 contained a 10M reinforcing steel bar located 100mm below top of core. The steel was removed prior to testing.
