Hazardous Building Materials Assessment of the Linden Lift and Flood Pumping Station

JUNE 28, 2021
ISSUED FOR USE
FILE: 734-2100120600-REP-V0001-00

The City of Winnipeg
Corporate Finance Department
Materials Management Division
185 King Street, Main Floor
Winnipeg, MB R3B 1J1

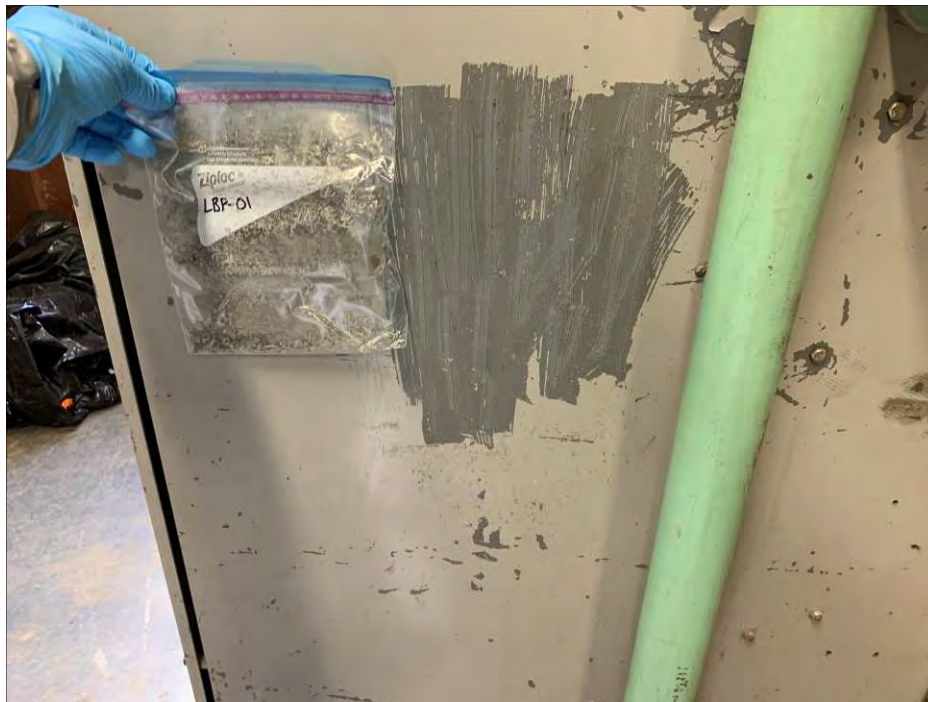
Photo 2: General view of paint chip sample LBP-01 location on electrical components on the main floor. (April 27, 2021)

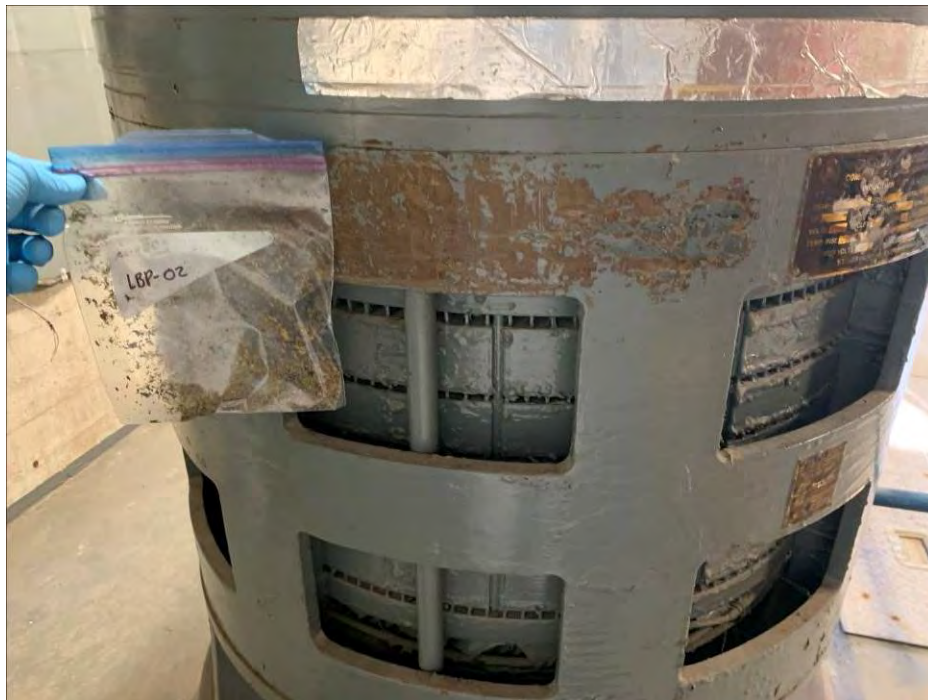
Photo 4: General view of the paint chip sample LBP-02 location on the top drive unit for centrifugal pump P-47. (April 27, 2021)

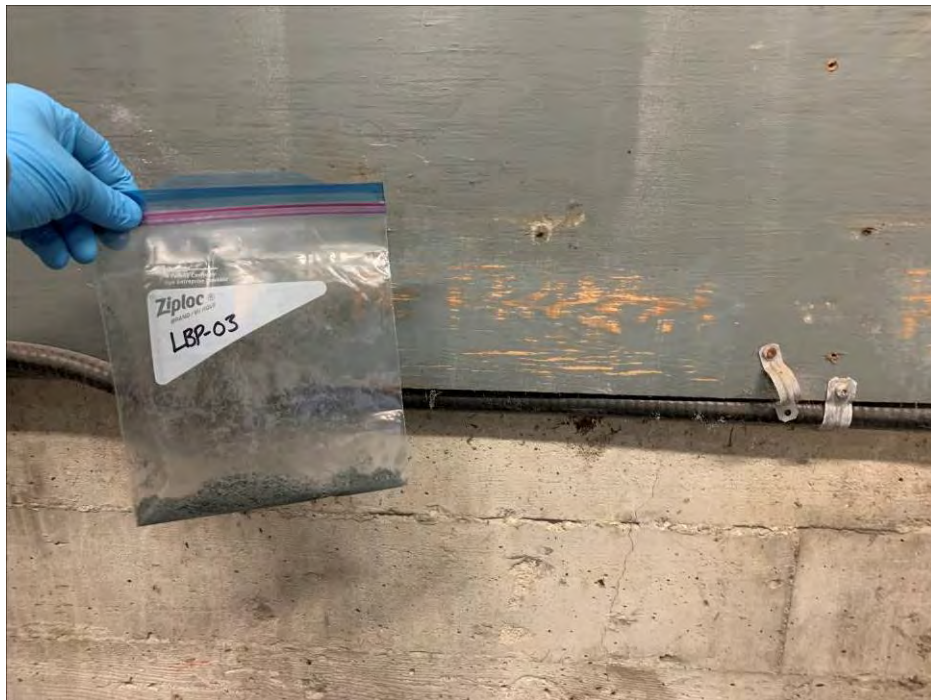
Photo 6: General view of paint chip sample LBP-03 location on the plywood backing board for the electrical panel on the main floor. (April 27, 2021)

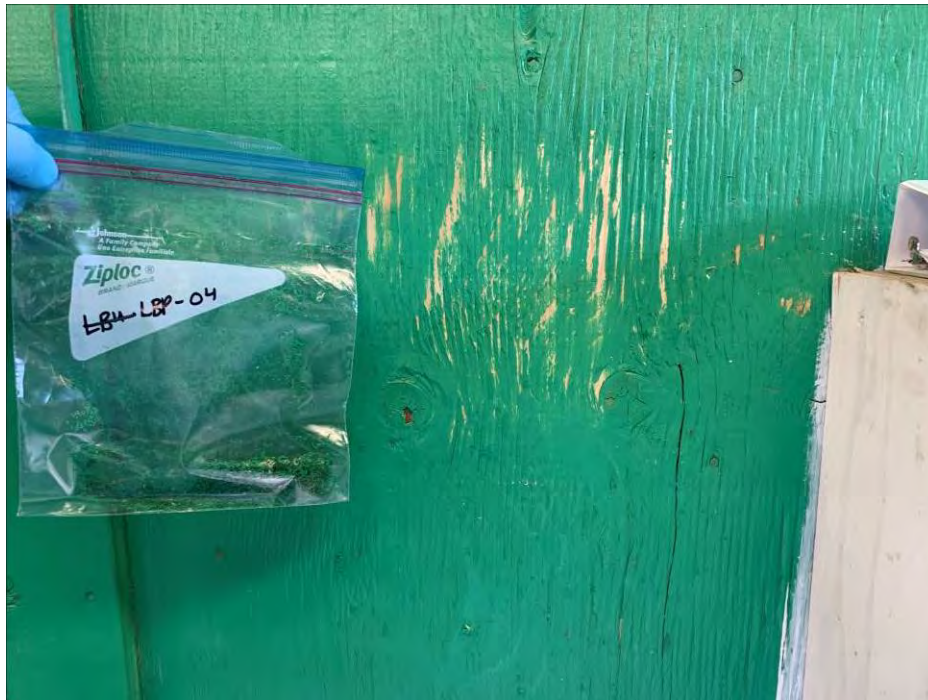
Photo 8: General view of the paint chip sample LBP-04 location on the vestibule on the northeast side of the main floor. (April 27, 2021)

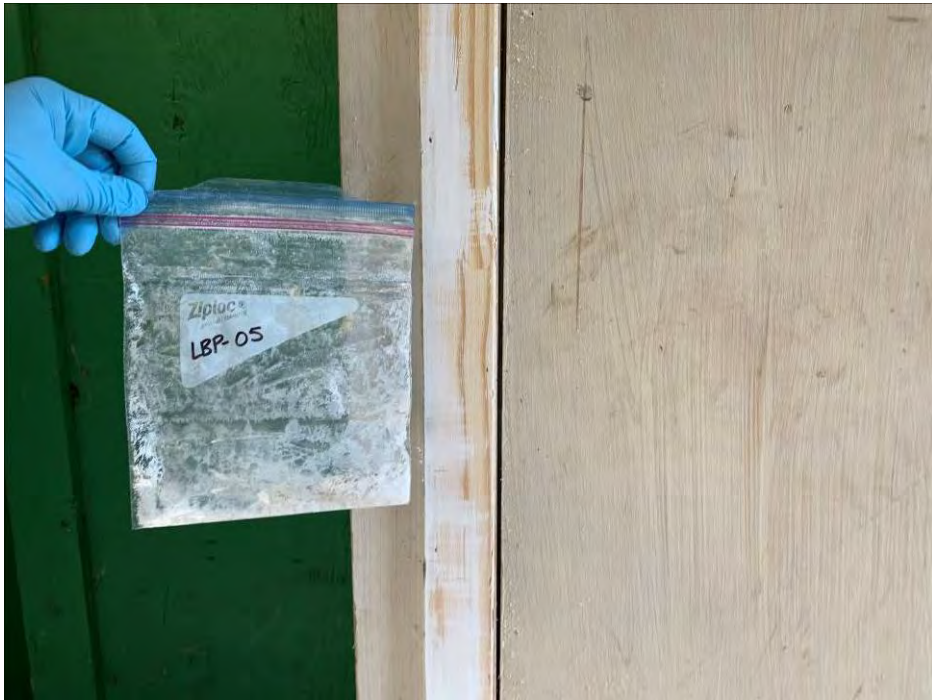
Photo 9: General view of the paint chip sample LBP-05 location on the cupboard on the northeast side of the main floor. (April 27, 2021)

Table 1 Paint Chip Sample Laboratory Analytical Results Hazardous Building Materials Assessment City of Winnipeg Linden Lift and Flood Pumping Station, Winnipeg, Manitoba					
Sample ID	Date Sampled	Material Description	General Condition	Paint Chip Samples	
				Lead (mg/kg)	Mercury (mg/kg)
LBP-01	27-Apr-21	Grey paint - on electrical components on main floor	Fair - some flaking (Photo 2)	4130	4.13
LBP-02	27-Apr-21	Grey over brown paint - top drive for pump P-47 on main floor	Fair - some paint flaking due to corrosion at joints. (Photo 4)	1710	0.231
LBP-03	27-Apr-21	Grey paint - on plywood backing for electrical panels on the main floor	Good (Photo 6)	5220	2.29
LBP-04	27-Apr-21	Green paint - on plywood vestibule for stairwell on the main floor	Good (Photo 8)	18.9	0.623
LBP-05	27-Apr-21	White paint - on plywood for cabinet attached to green plywood vestibule on the main floor	Good (Photo 9)	7.7	<0.050

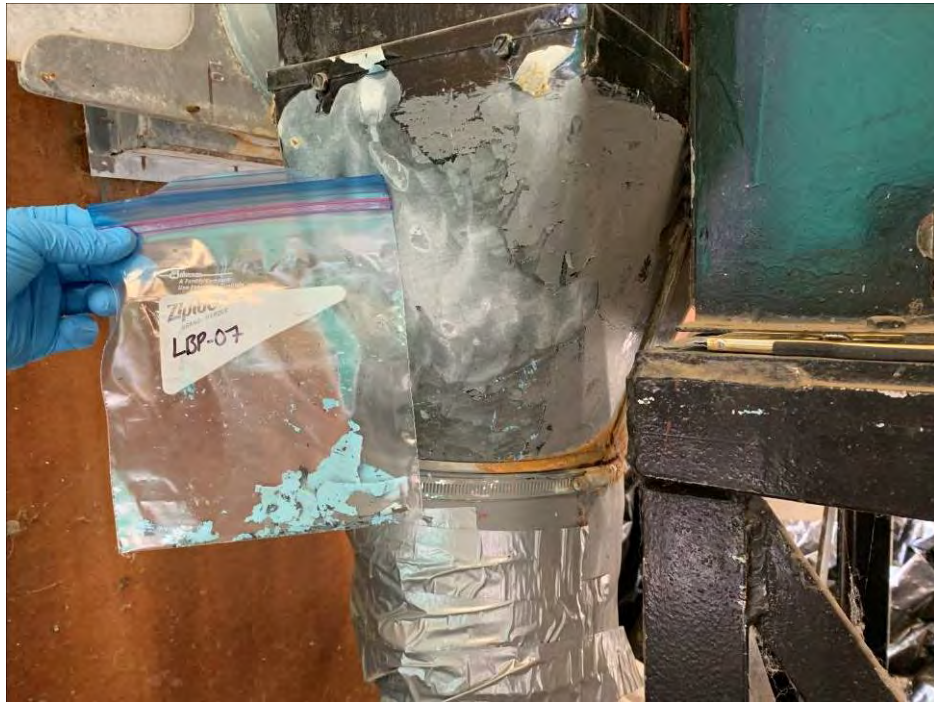
Photo 11: General view of the paint chip sample LBP-07 location on the piping for the blower near the northeast corner of the main floor. (April 27, 2021)

LBP-07	27-Apr-21	Grey over blue paint - on blower pipe near entrance door on main floor	Poor - flaking and chipping (Photo 11)	260	6.61
LBP-08	27-Apr-21	Black paint - on blower stand near entrance on the main floor	Poor - flaking and chipping (Photo 13)	337	3.05
LBP-09	27-Apr-21	Green paint - on conduit pipe connecting electrical components on the main floor	Good (Photo 15)	2150	763
LBP-10	27-Apr-21	Blue paint - railing on the main floor	Fair - some chipping and worn (Photo 17)	944	5.18
LBP-11	27-Apr-21	Brown paint - door frame around entrance near on the main floor	Fair - some chipping (Photo 19)	10.5	0.142
LBP-12	27-Apr-21	Grey paint - concrete floor of the main floor	Fair - worn (Photo 21)	11.9	0.187
LBP-14	27-Apr-21	Silver over orange paint - on pump P-46 in the dry well	Poor - extensive chipping and flaking (Photo 23)	112000	4.90
LBP-15	27-Apr-21	Blue paint - on piping in the motor room	Fair - some chipping and physical damage (Photo 25)	1530	4.55

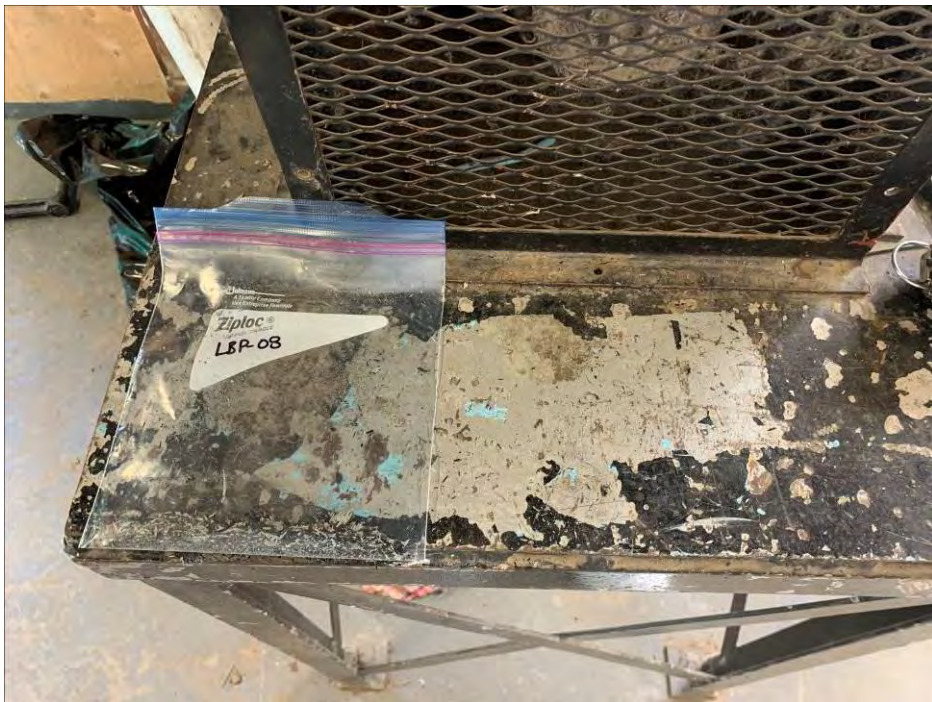
Photo 13: General view of paint chip sample location LBP-08 on the stand for the blower near the northeast corner of the main floor. (April 27, 2021)

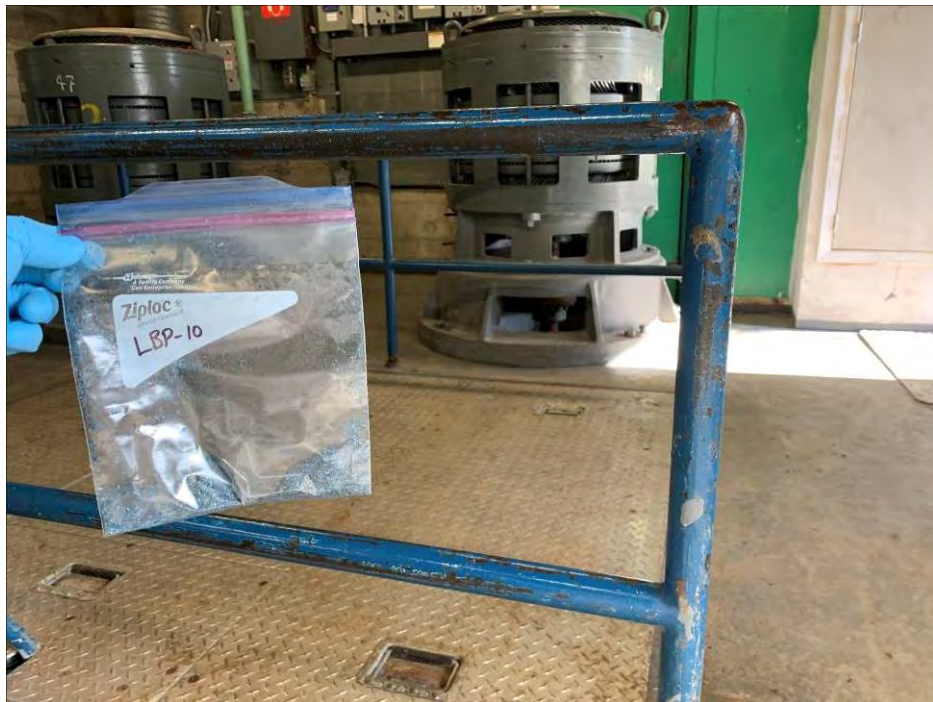
Photo 17: General view of paint chip sample LBP-10 location on the guard rail near the center of the main floor. (April 27, 2021)

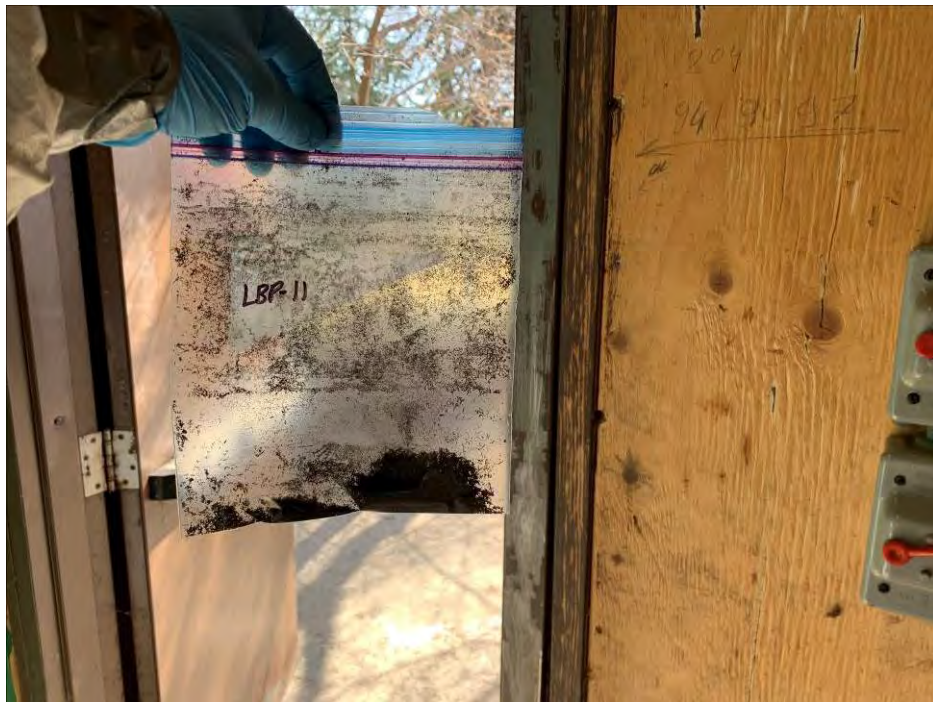
Photo 19: General view of paint chip sample LBP-11 location on the door frame at the northeast corner of the main floor. (April 27, 2021)

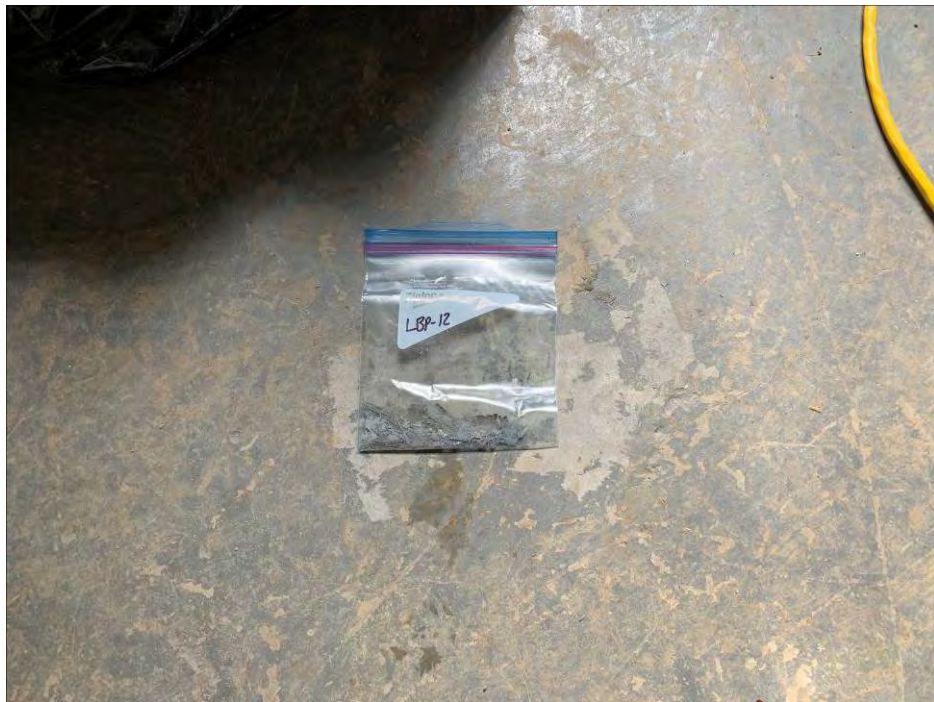
Photo 21: General view of the paint chip sample LBP-12 location on the main floor. (March 15, 2018)

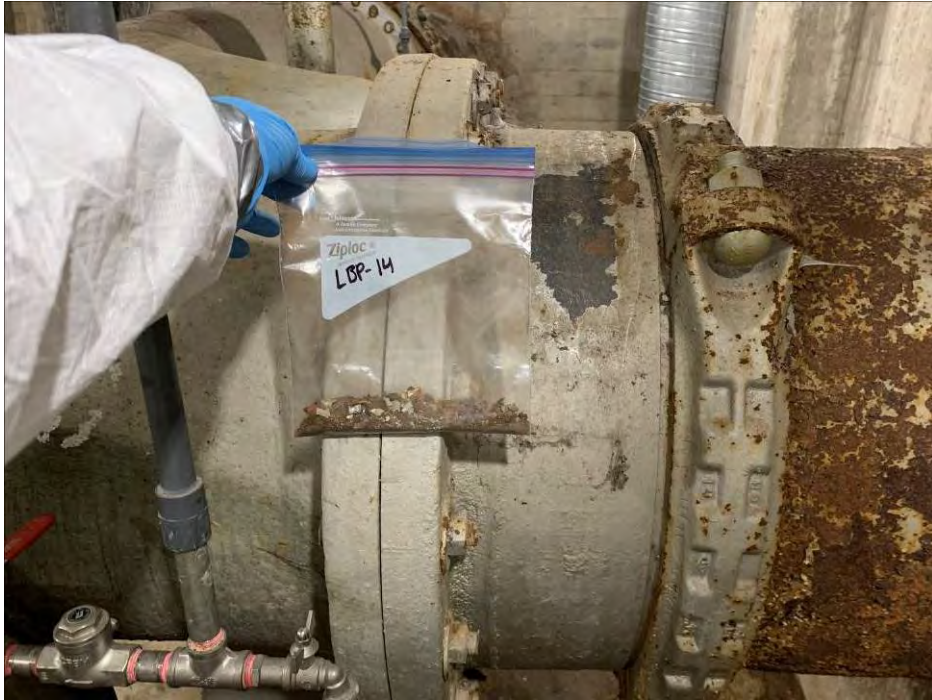
Photo 23: General view of the paint chip sample LBP-14 location on centrifugal pump P-46 in the dry well. (April 27, 2021)

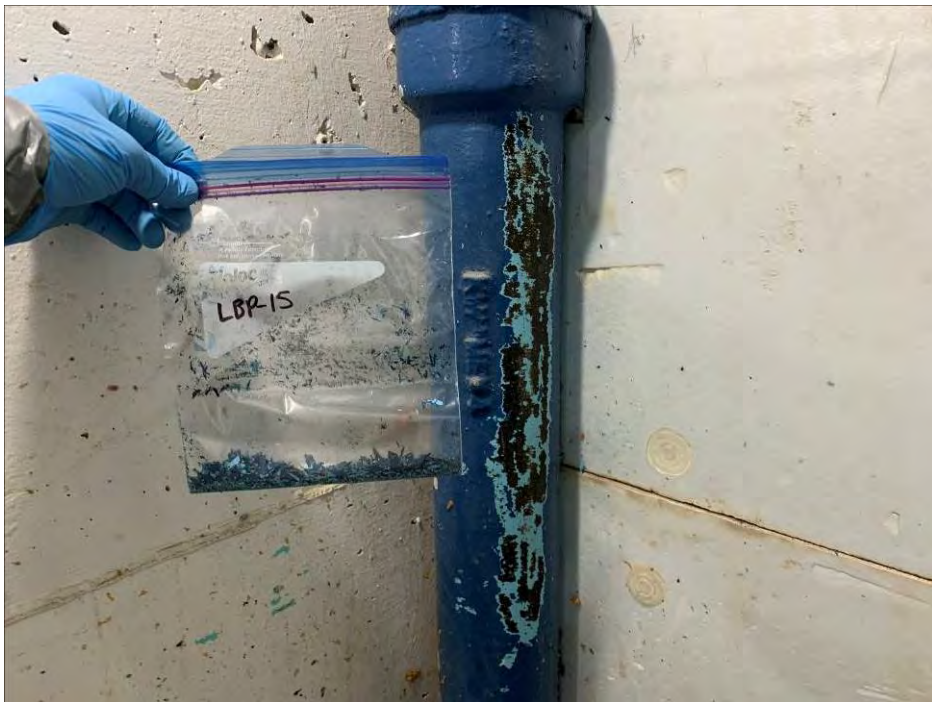
Photo 25: General view of the paint chip sample LBP-15 location on the piping in the motor room. (April 27, 2021)

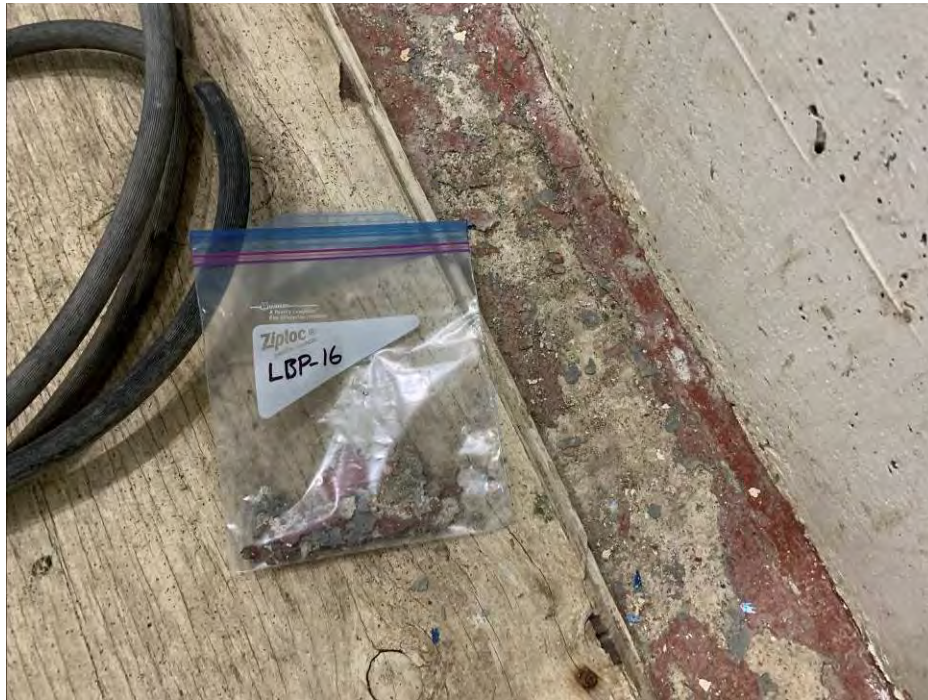
Photo 27: General view of the paint chip sample LBP-16 location on the floor in the motor room. (April 27, 2021)

LBP-16	27-Apr-21	Red over grey paint - on flooring in the motor room	Poor - extensive chipping, flaking, and physical damage (Photo 27)	2693	4.45
LBP-17	27-Apr-21	White over blue paint - on the walls of the pump chamber	Poor - extensive chipping and flaking (Photo 29)	30.3	1.12
LBP-18	27-Apr-21	Blue over red over teal paint - on pumps in the pump chamber	Poor - extensive chipping, flaking, and physical damage (Photo 31)	931	1.52
LBP-19	27-Apr-21	Silver paint - on stairs throughout the station	Fair - some flaking and physical damage (Photo 33)	380	5.89
Referenced Environmental Quality Guideline				90 ^a	10 ^a
Notes: Analytical exceedances shown in bold text. ^a Government of Canada, 2010; 2016. <i>Canada Consumer Products Safety Act, Consumer Products Containing Lead (Contact with Mouth) Regulations SOR/2010-273; Surface Coating Materials Regulations SOR/2016-193.</i>

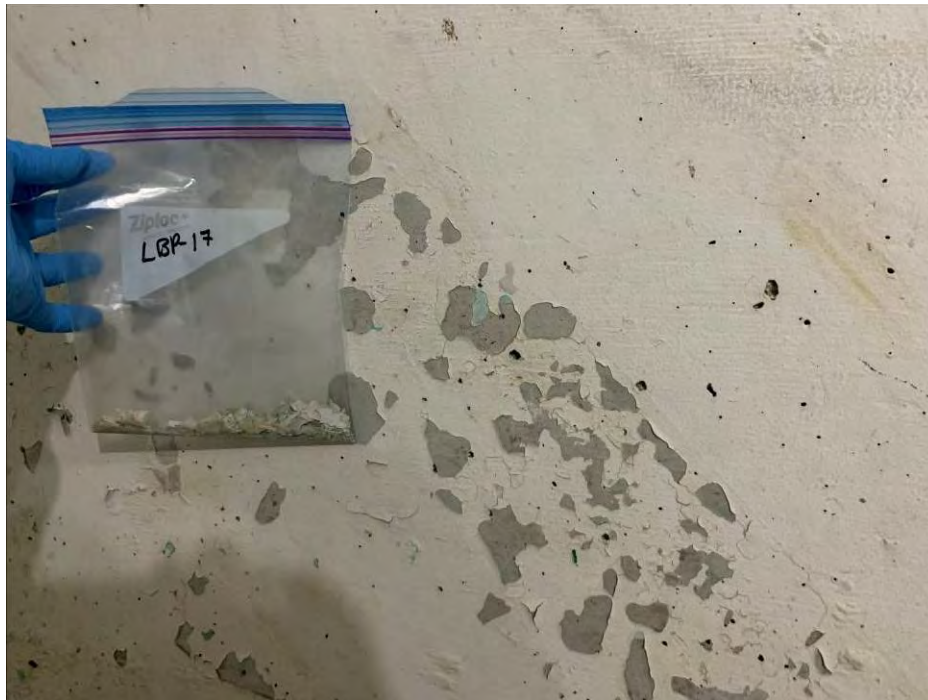
Photo 29: General view of the paint chip sample LBP-17 location on the wall of the pump chamber. (April 27, 2021)

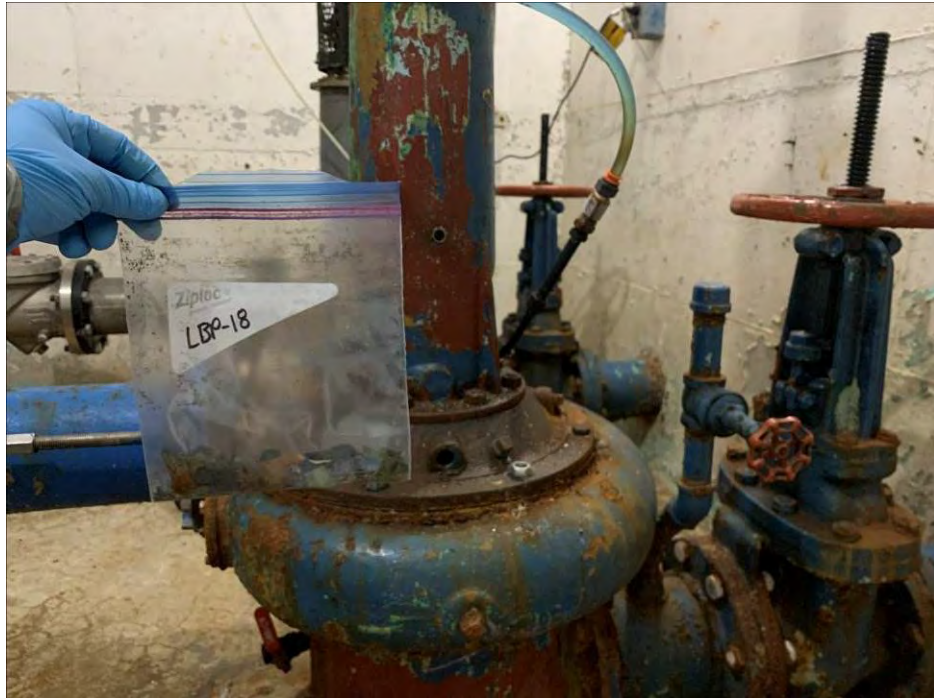
Photo 31: General view of the paint chip sample location LBP-18 location on a pump in the pump chamber. (April 27, 2021)

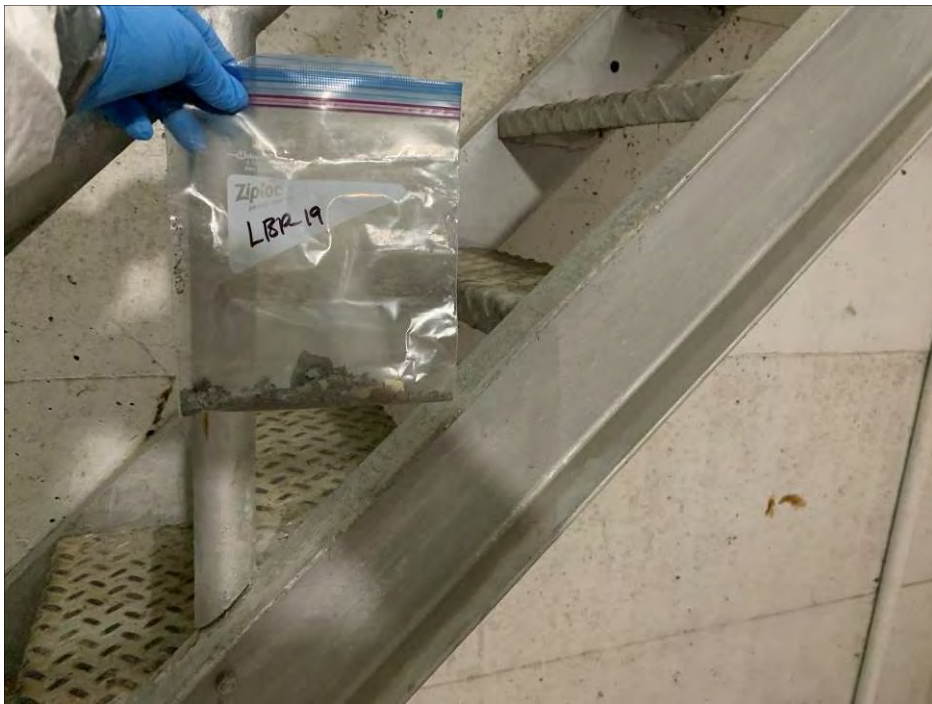
Photo 33: General view of the paint chip sample LBP-19 location on the access stairs in the motor room. (April 27, 2021)
