4. City Facility Assessments

4.1 Introduction

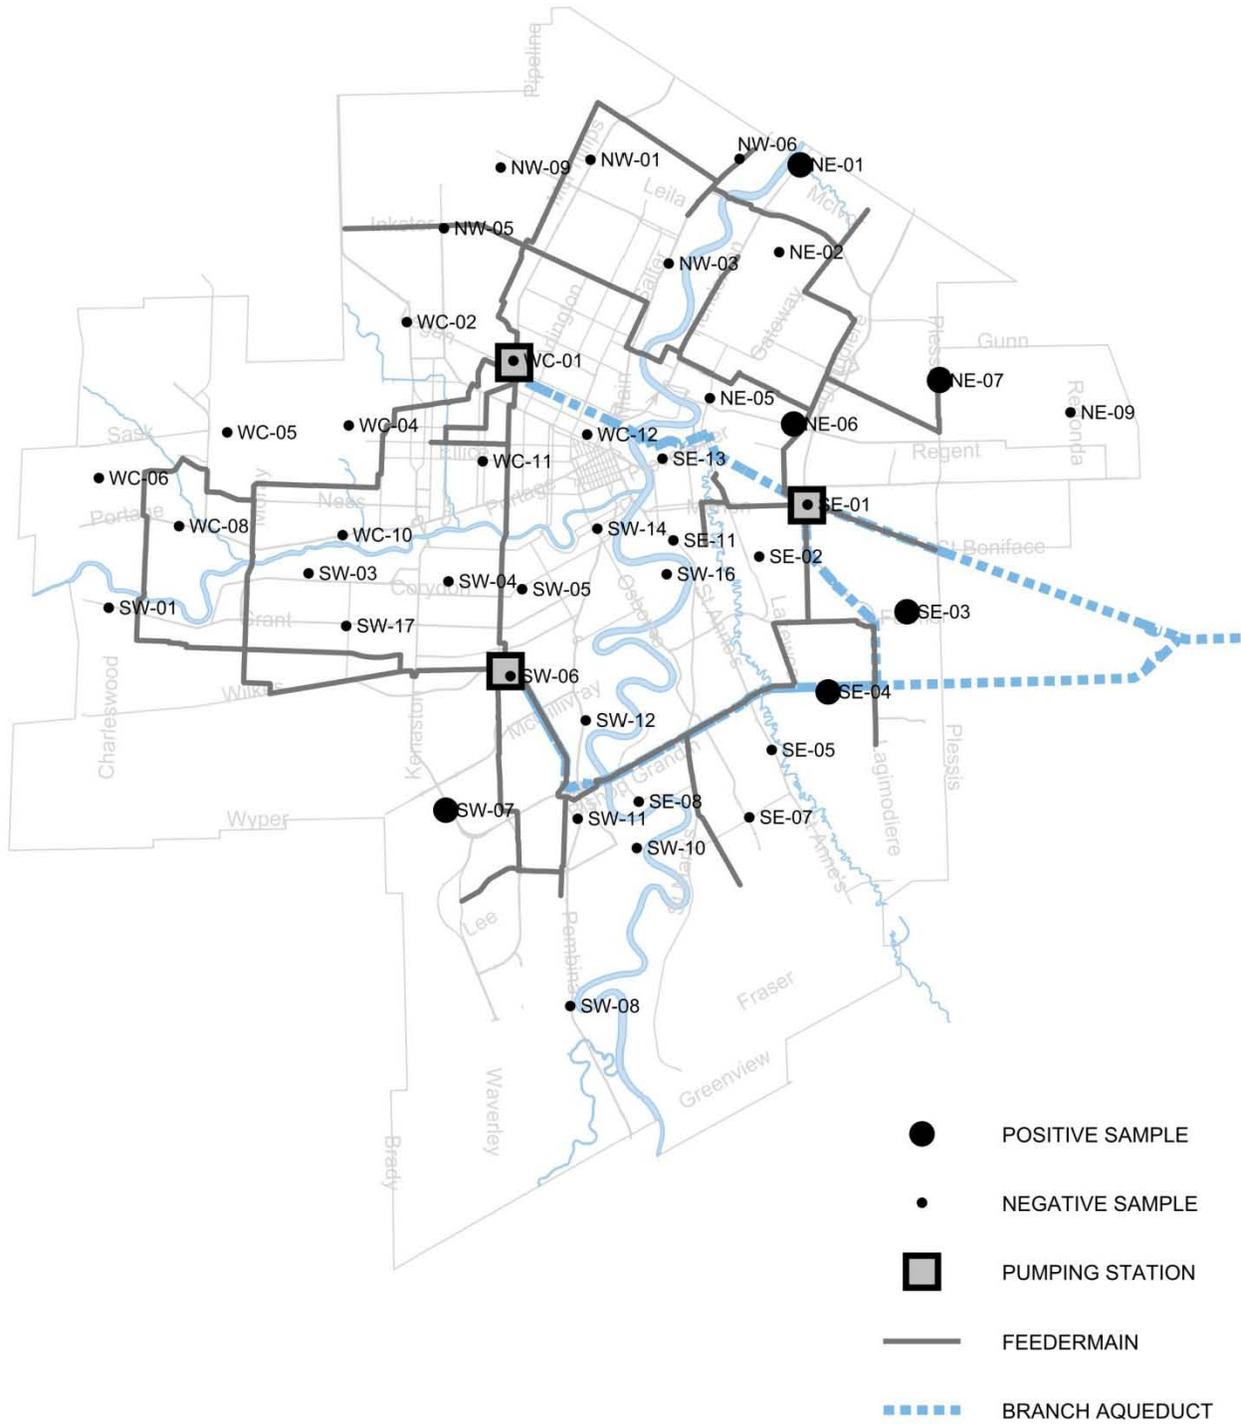
Figure 7: Compliance Sample Locations, Jan 26, 2015

Sampling locations testing positive for TC/EC in the City (**Figure 7**) were evaluated by AECOM and City staff. Of note was the correlation between the positive samples attributed to a single sample collector (**Figure 8**). Some of the existing water sampling locations appear to be at risk of contamination due to the following circumstances:

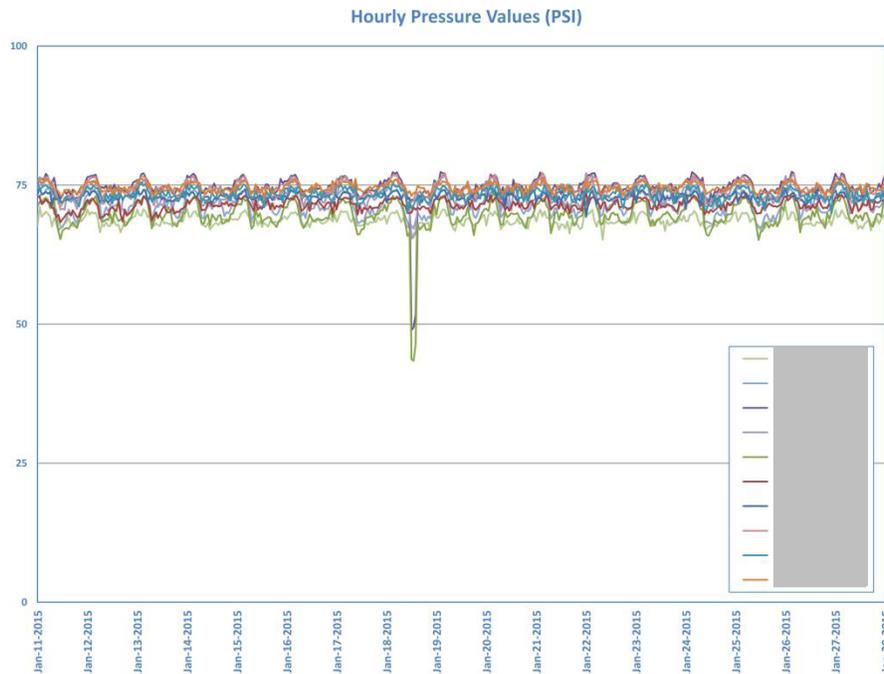
Figure 14: SCADA Hourly Pressure Values

The City continuously monitors pressure readings throughout the distribution system and at each pumping station, as noted in **Figure 14**, **Figure 15** and **Figure 16**. Pressure-monitoring points are calibrated annually at a minimum. If issues arise between calibrations (e.g. loss of signal, erroneous readings, plugged impulse lines), the City will perform maintenance as required.

Overall, available pressure readings were found to be within acceptable ranges. No unusual pressure readings/losses were noted immediately before or after the January 26, 2015 contamination event.

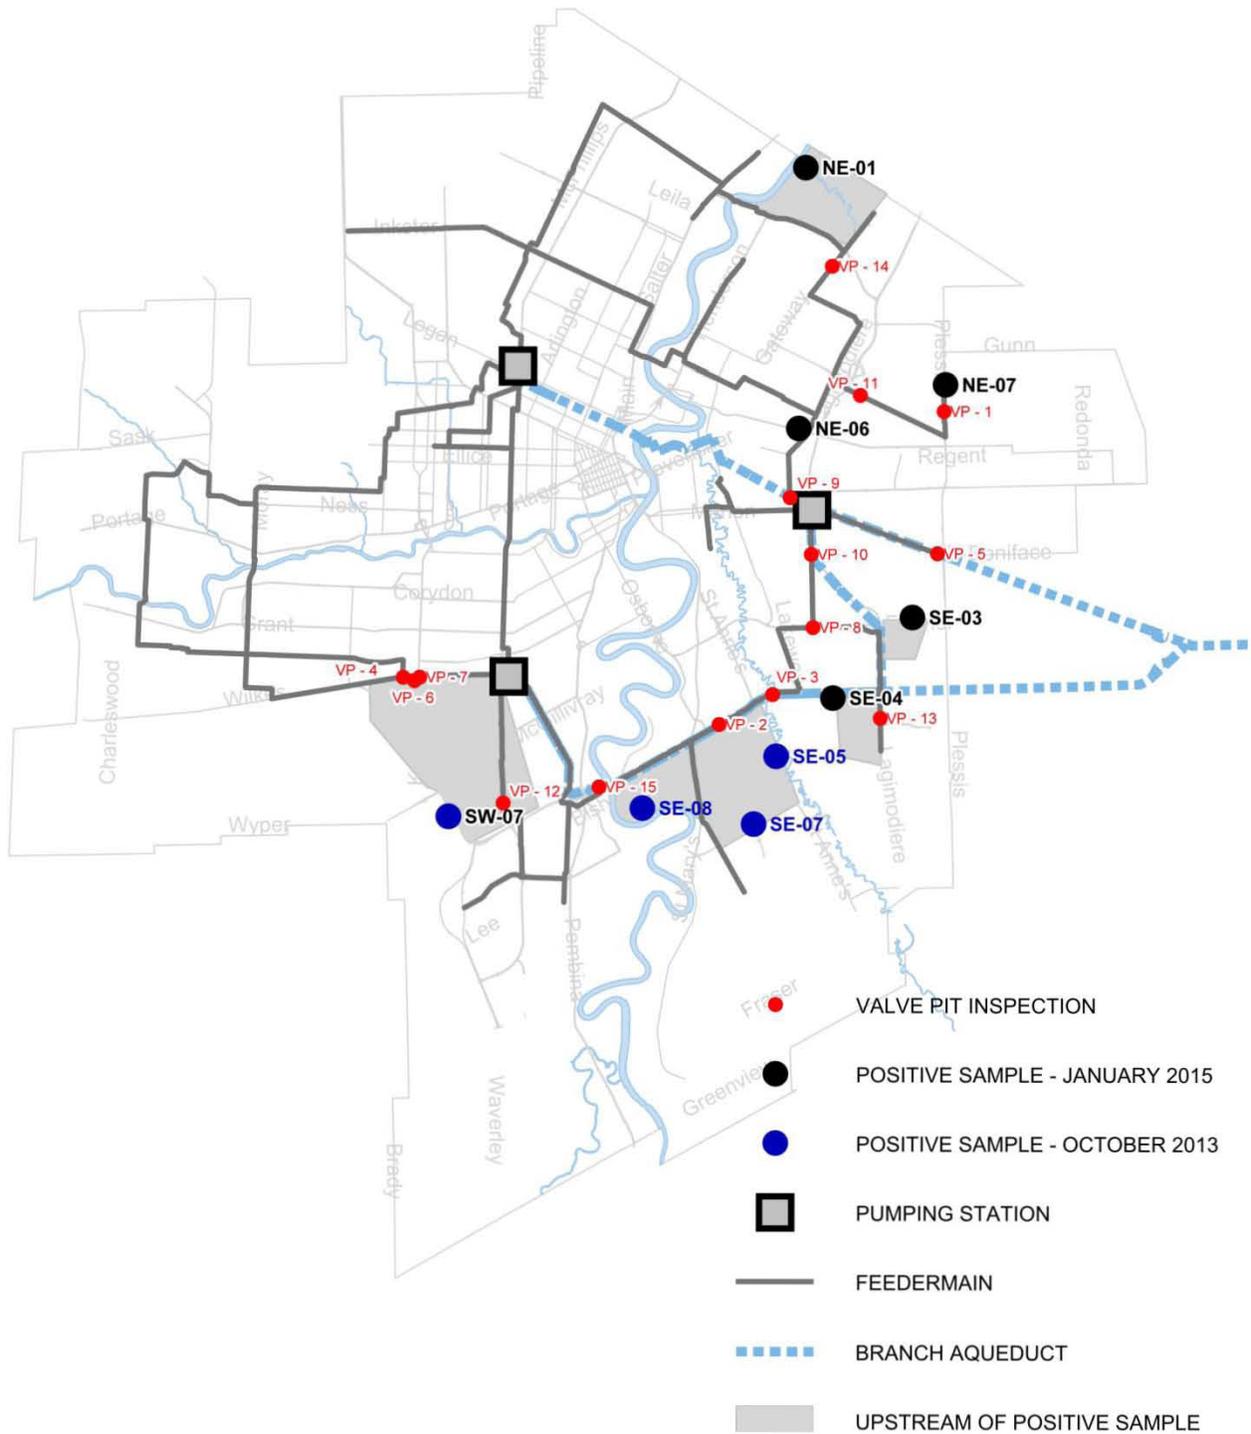
Figure 17: Valve Pit Inspections

City staff set out on the first week of March, 2015 to investigate the 15 air chambers and valve pits that were identified as previously having had water in them. The results of these investigations are summarized in **Table 4**.

If a complete loss of pressure occurred in the distribution system, there is potential that water in the valve chamber could be drawn into the feedermain if the automatic air relief valve was submerged. Of the 15 air chambers and valve pits inspected, 10 of them had water. Two of the 10 had water above the air relief valve. The first location where the air relief valve was submerged, VP-05, was on a feedermain flowing east of the MacLean Pumping Station and is not hydraulically connected to any of the sample sites that tested positive for TC on either January 26, 2015 or October 7, 2013. The second location, VP-11, is on a feedermain that feeds sample point NE-07, which tested positive on January 26, 2015. This location, however, is not hydraulically connected to any of the remaining five sample sites which tested positive on January 26, 2015. In addition, both air relief valves that were submerged were manual air relief valves, not automatic. The risk of backsiphoning is associated with automatic air relief valves. Considering this, and the fact that no pressure loss in the system was observed on either event, it is very unlikely that submerged air release valves contributed to the January 26, 2015, May 26, 2014 or the October 7, 2013 positive sample results.

The air chambers/valve pits were likely not the cause of the positive coliform events. Despite this, many of the valve pits were filled with water from the environment – efforts should be made to reduce the chance of having automatic air relief valves from being submerged. Regular inspection and maintenance of such pits are part of the City's current SOPs.

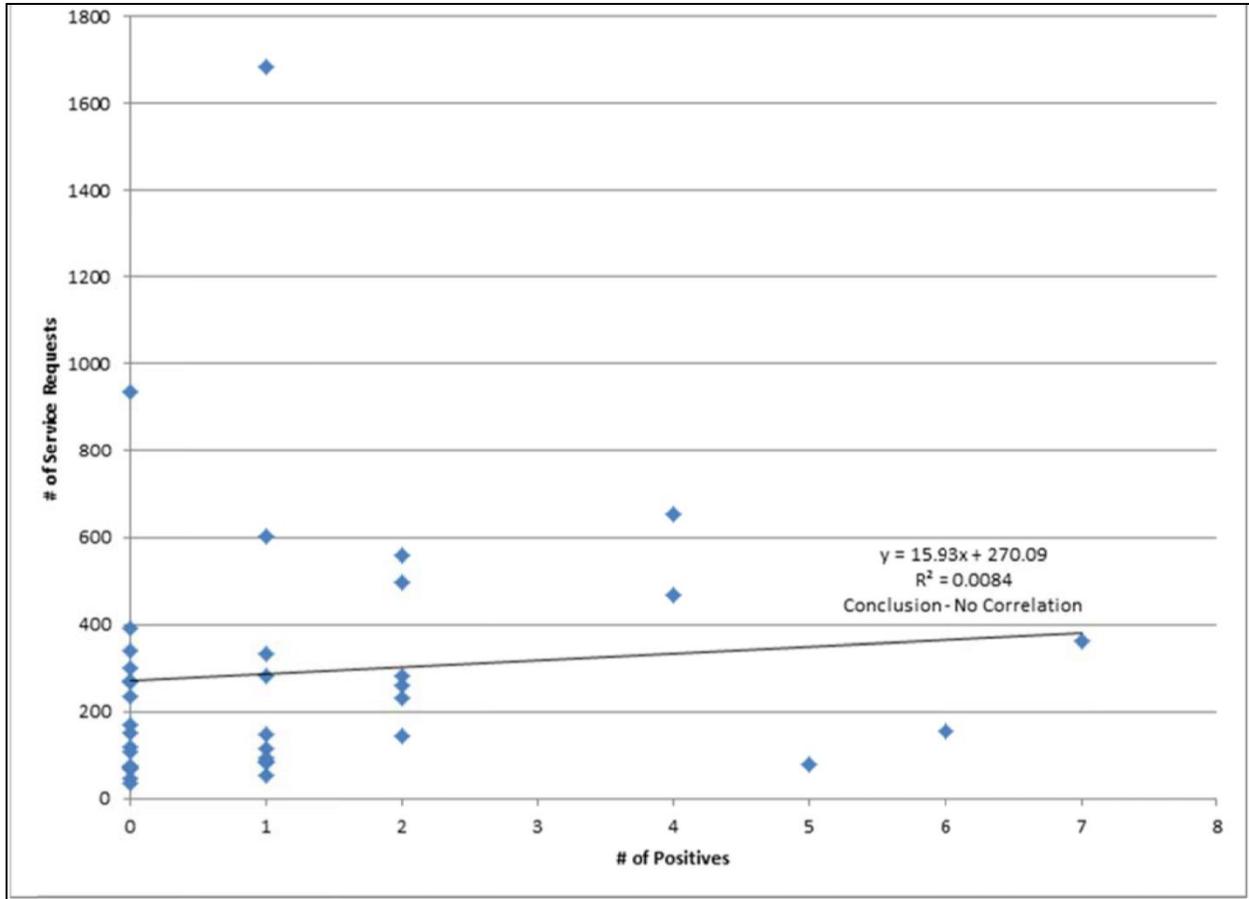
Figure 18: Monthly Service Requests vs Monthly Occurrence of Positive Bacteriological Samples

Over the past few years, there have been many occurrences of discoloured water in the distribution system. The City has separately completed a thorough investigation of discoloured water occurrences and causes which found no evidence of health concerns with observed discoloured water events. Monthly SRs for the past three years were plotted against monthly occurrences of positive bacteriological samples to see if there was a correlation. As seen in **Figure 18**, no relation between SRs and positive samples could be drawn.

No link could be found between historical discoloured water complaints and historical positive bacteriological samples.
