APPENDIX C

ADDITIONAL SITE PHOTOS OF OUTFALL SITES REQUIRING PRIVATE PROPERTY AUTHORIZATION

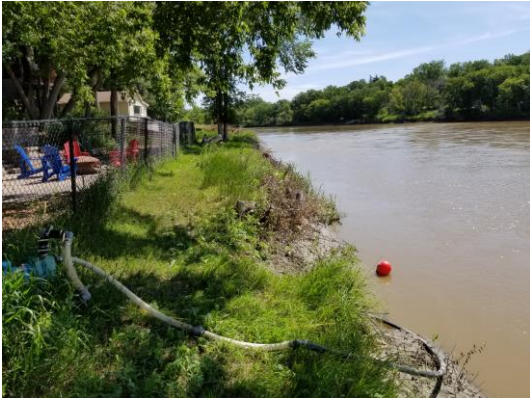
Photo 1: 2782 Assiniboine Avenue – Looking east along shoreline

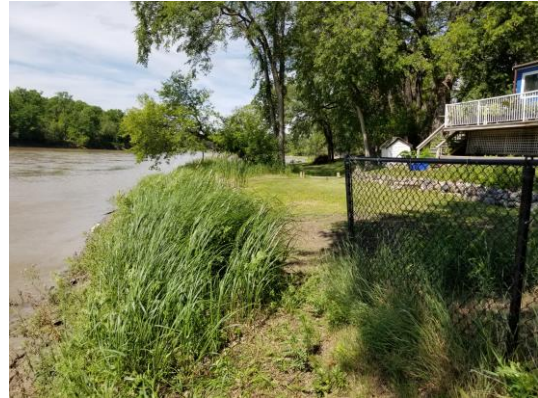
Photo 2: 2782 Assiniboine Avenue – Looking west along shoreline/backyard of 2782 Assiniboine Ave.

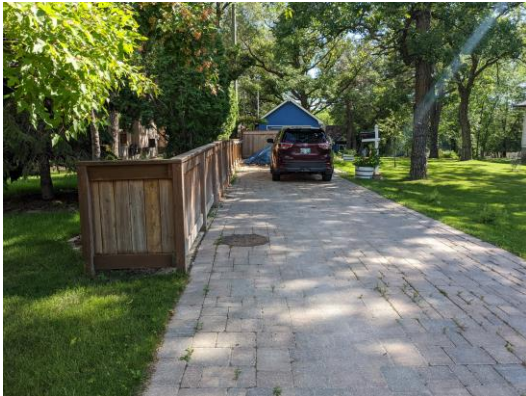
Photo 3: 2782 Assiniboine Avenue – Looking south at upstream manhole within driveway

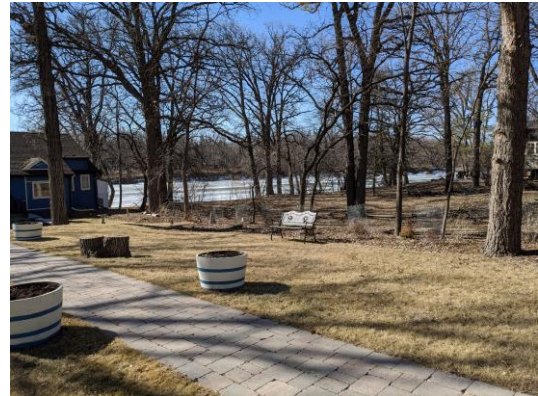
Photo 4: 2782 Assiniboine Avenue – Looking southwest within front yard of 2782 Assiniboine Ave.

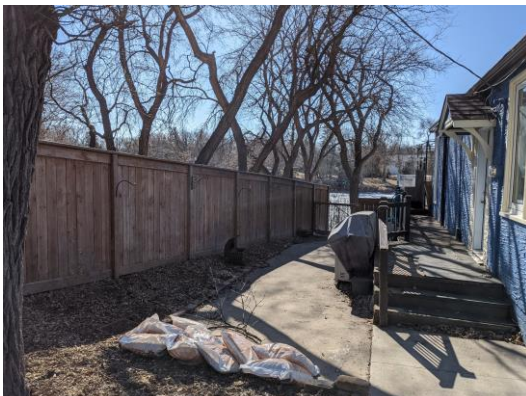
Photo 5: 2782 Assiniboine Avenue – Looking south at intermediate manhole location (manhole is along fenceline)

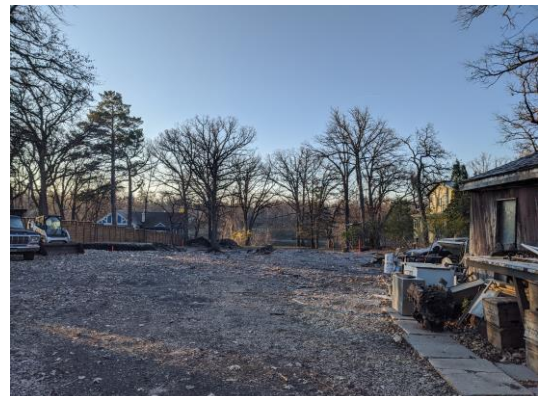
Photo 6: Looking south from front of 2788 Assiniboine Ave. (along proposed access route)

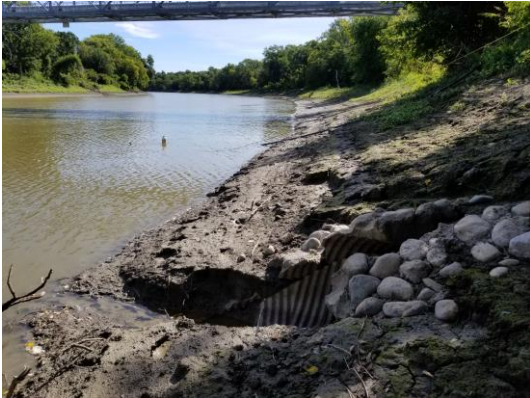
Photo 1: Wellington Crescent – Looking east along shoreline

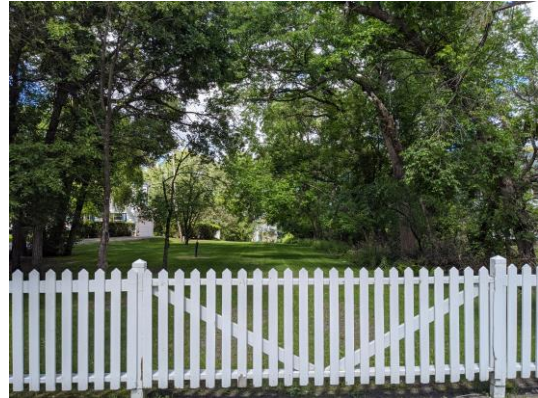
Photo 2: Wellington Crescent – Looking north along existing feedermain alignment (City owned ROW along 925 Wellington Cr.)

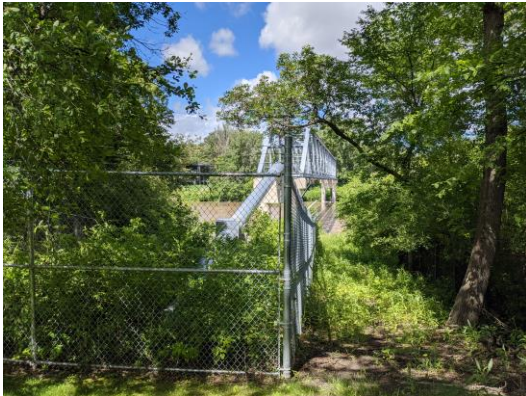
Photo 3: Wellington Crescent – Looking north at existing feedermain overhead crossing

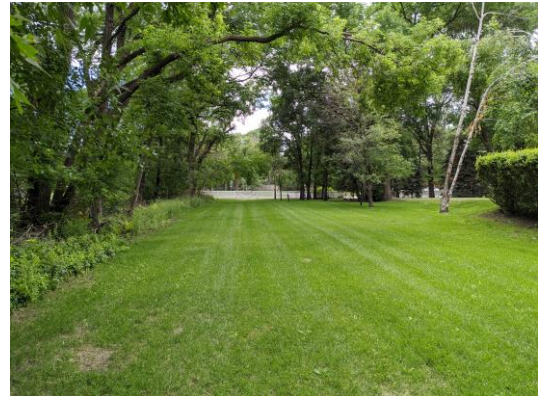
Photo 4: Wellington Crescent – Looking south along existing feedermain alignment (City owned ROW along 925 Wellington Cr.)

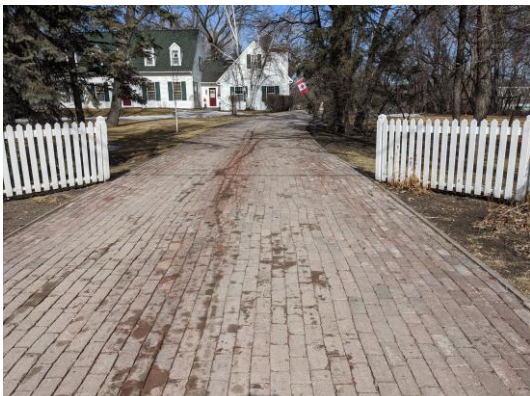
Photo 5: Wellington Crescent – Looking north along 925 Wellington Cr. driveway

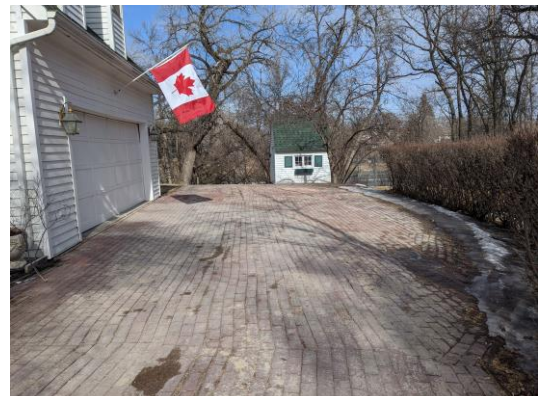
Photo 6: Wellington Crescent – Looking north along 925 Wellington Cr. driveway

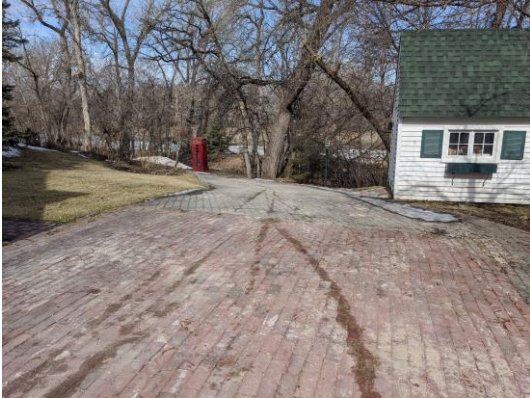
Photo 7: Wellington Crescent – Looking northwest at back of 925 Wellington Cr. property

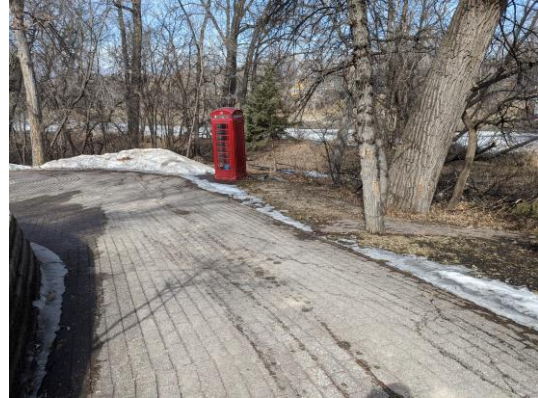
Photo 8: Wellington Crescent – Looking northwest at back of 925 Wellington Cr. property

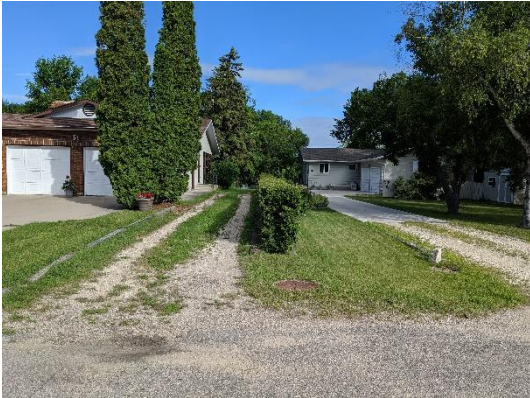
Photo 1: 50 Eastwood Drive – Looking northwest along pipe alignment

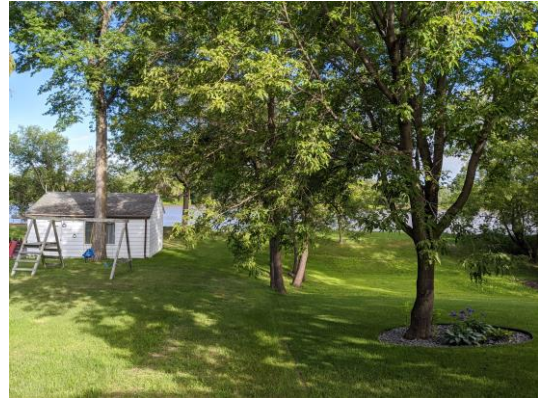
Photo 2: 50 Eastwood Drive – Looking northwest along pipe alignment between 34 Eastwood Dr. and 50 Eastwood Dr.

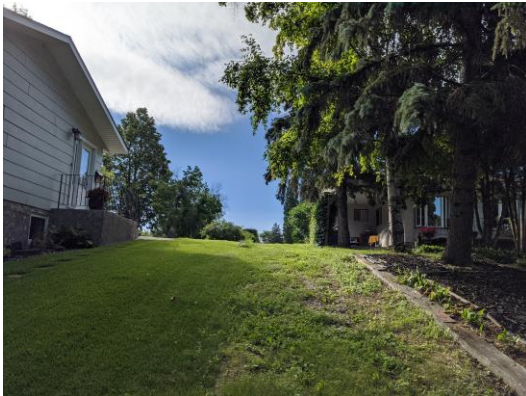
Photo 3: 50 Eastwood Drive – Looking southeast along pipe alignment between 34 Eastwood Dr. and 50 Eastwood Dr.

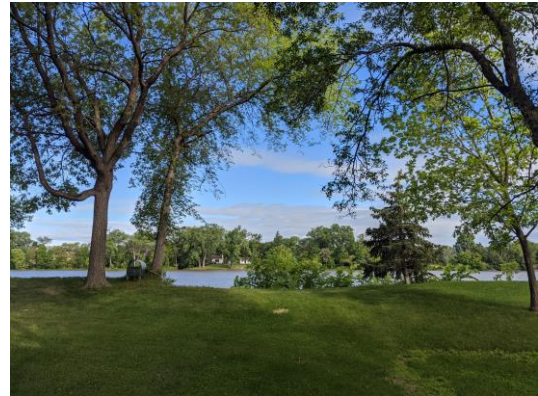
Photo 4: 50 Eastwood Drive – Looking northwest along pipe alignment near existing flood dike

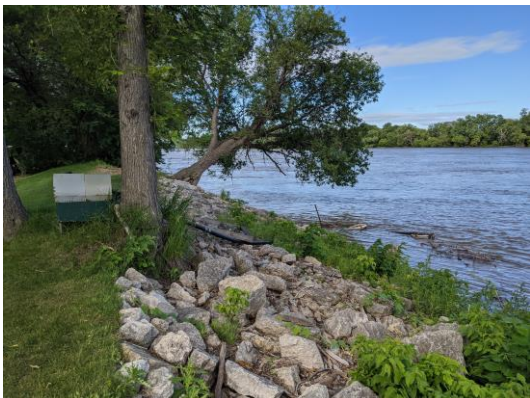
Photo 5: 50 Eastwood Drive – Looking west along top of bank

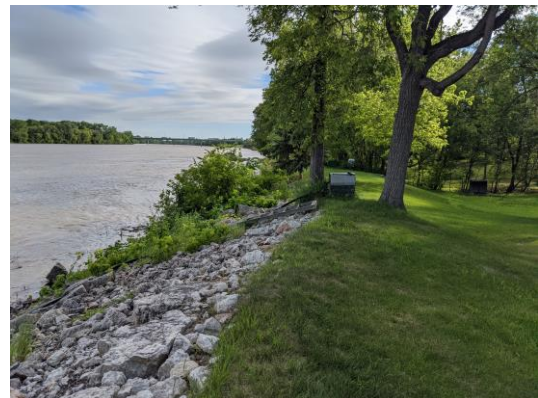
Photo 6: Looking northeast along top of bank

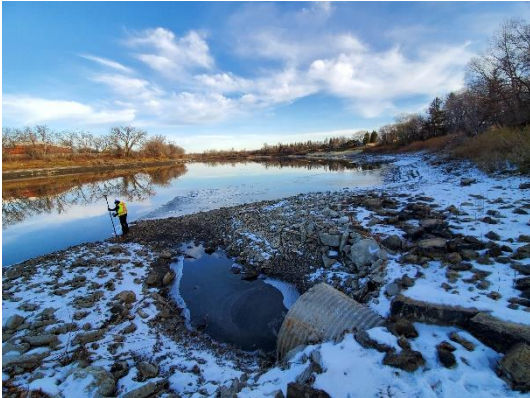
Photo 1: 300 Dunkirk Drive – Looking north at pipe outlet/shoreline

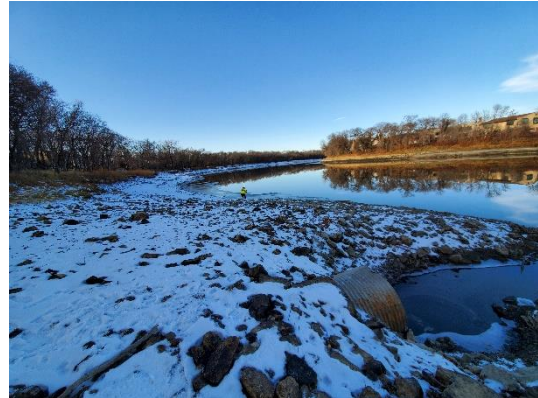
Photo 2: 300 Dunkirk Drive – Looking southwest at pipe outlet/shoreline

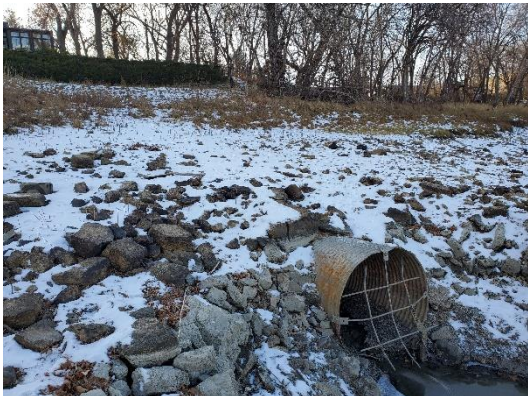
Photo 3: 300 Dunkirk Drive – Looking south at pipe outlet

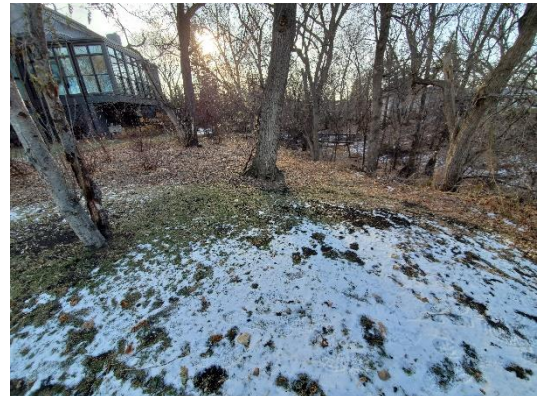
Photo 4: 300 Dunkirk Drive – Looking southeast from 300 Dunkirk Drive backyard

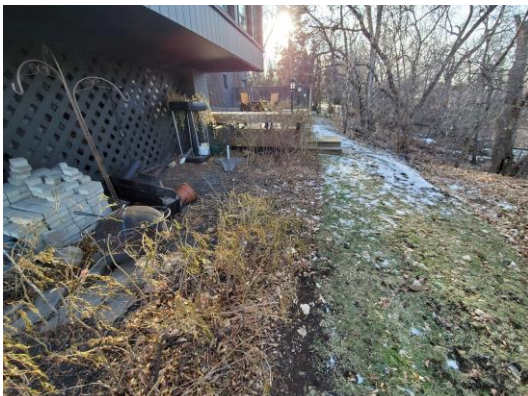
Photo 5: 300 Dunkirk Drive – Looking southeast along pipe alignment

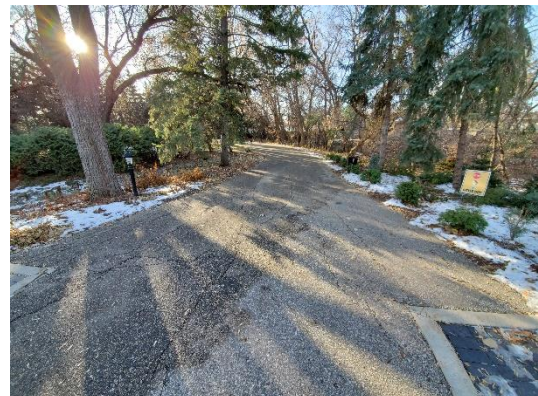
Photo 6: 300 Dunkirk Drive - Looking east along driveway access

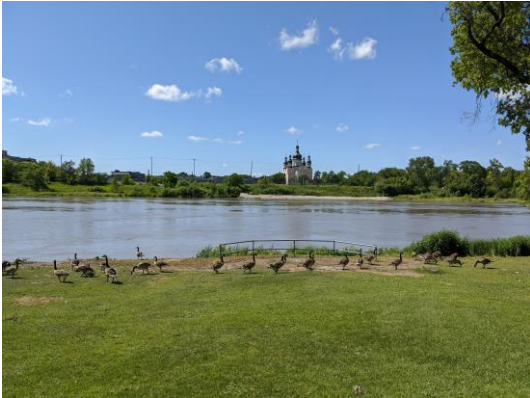
Photo 1: 1 Hart Avenue – Looking west from mid-bank

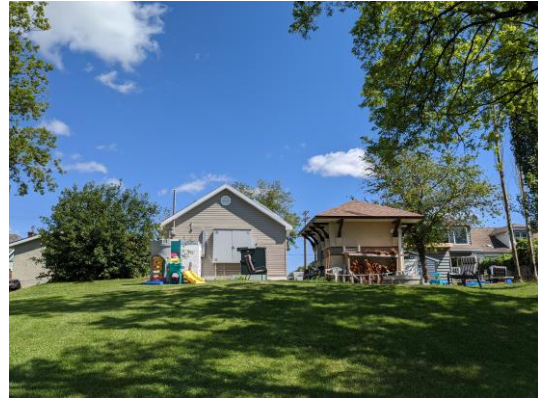
Photo 2: 1 Hart Avenue – Looking east towards pumping station

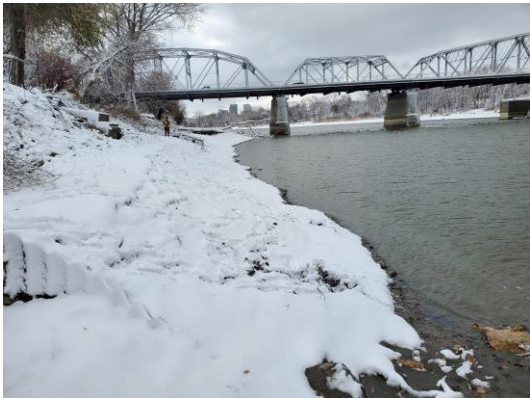
Photo 3: 1 Hart Avenue – Looking south along shoreline

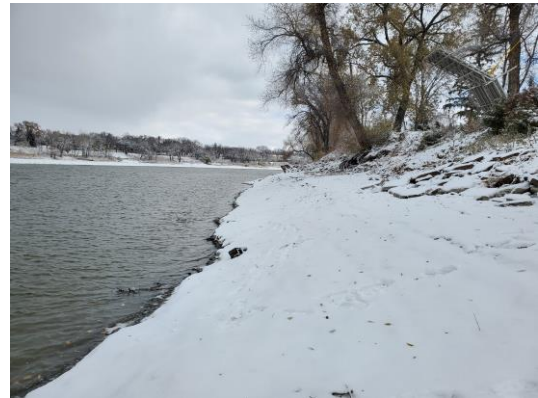
Photo 4: 1 Hart Avenue – Looking north along shoreline

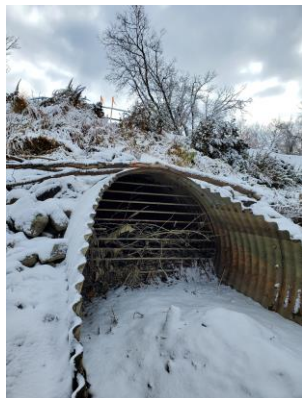
Photo 5: 1 Hart Avenue – Looking south at pipe outlet

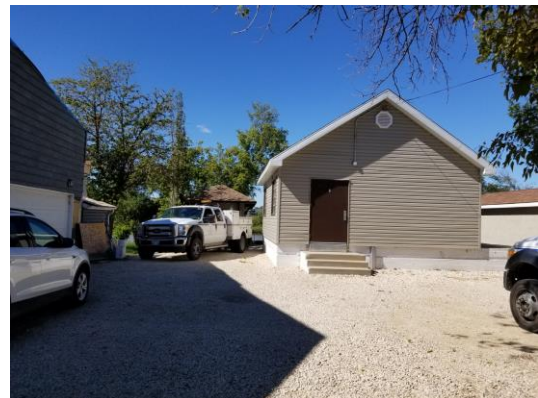
Photo 6: 1 Hart Avenue – Looking west towards pumping station from Glenwood Crescent

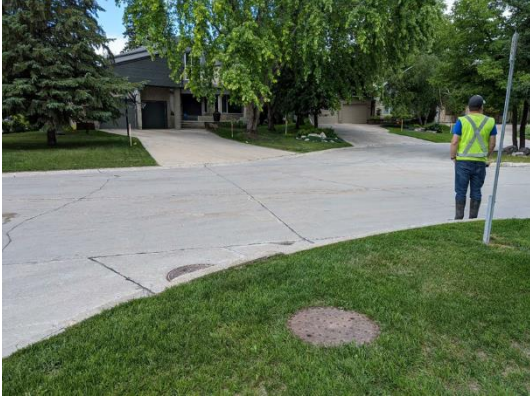
Photo 1: 3087 Vialoux Drive – Looking north along pipe alignment towards 3087 Vialoux Dr.

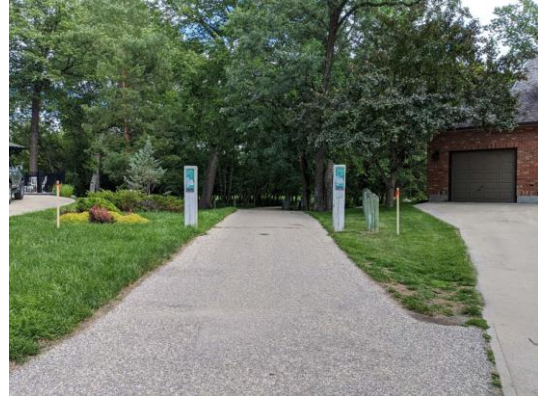
Photo 2: 3087 Vialoux Drive – Looking east to entrance of existing asphalt path from Vialoux Dr.

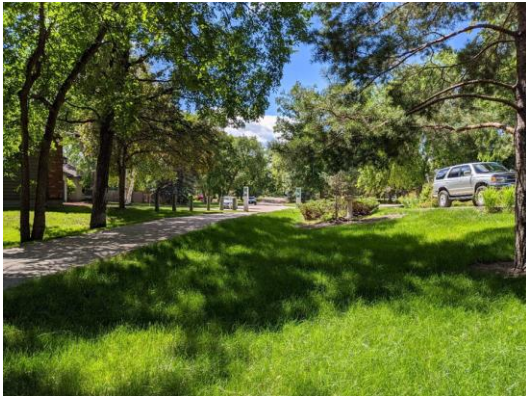
Photo 3: 3087 Vialoux Drive – Looking west from asphalt path back towards Vialoux Dr.

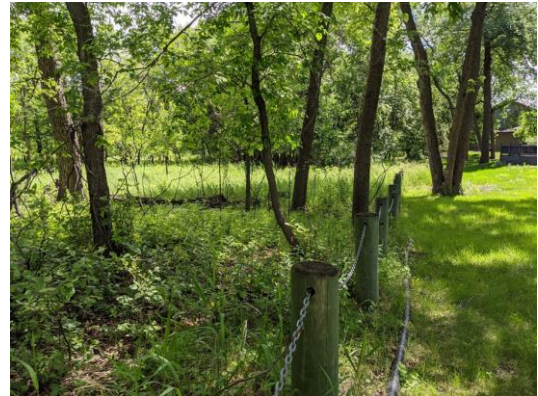
Photo 4: 3087 Vialoux Drive – Looking south from mid-bank area along property line between existing park space and 3079 Vialoux Dr.

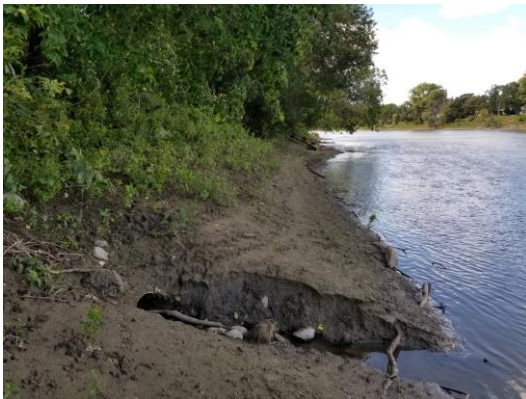
Photo 5: 3087 Vialoux Drive – Looking west along shoreline

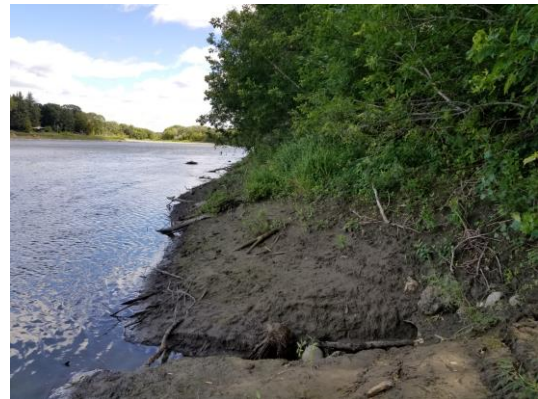
Photo 6: 3087 Vialoux Drive – Looking east along shoreline

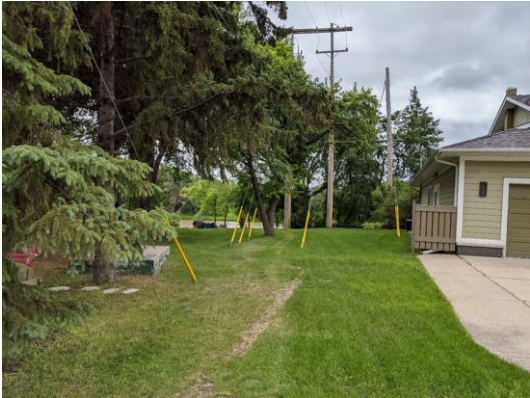
Photo 1: 2464 Assiniboine Crescent – Looking south from Assiniboine Crescent

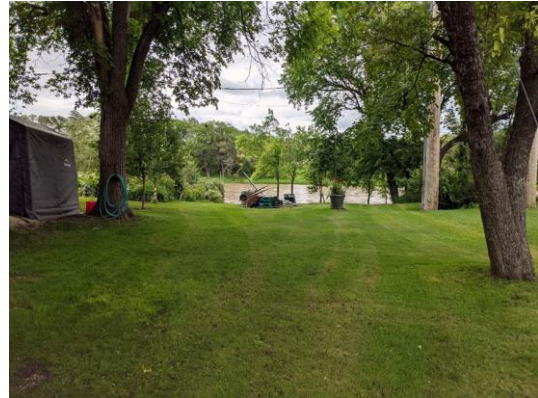
Photo 2: 2464 Assiniboine Crescent – Looking south from mid-bank along pipe alignment

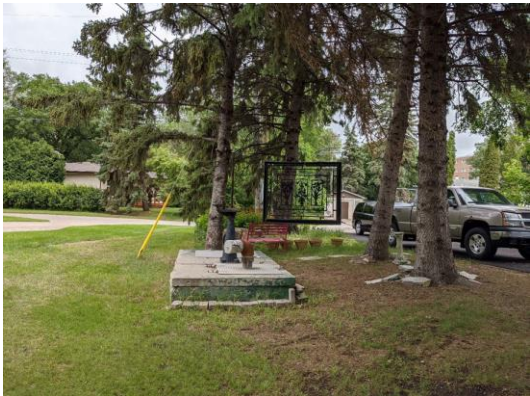
Photo 3: 2464 Assiniboine Crescent – Looking north at existing chamber

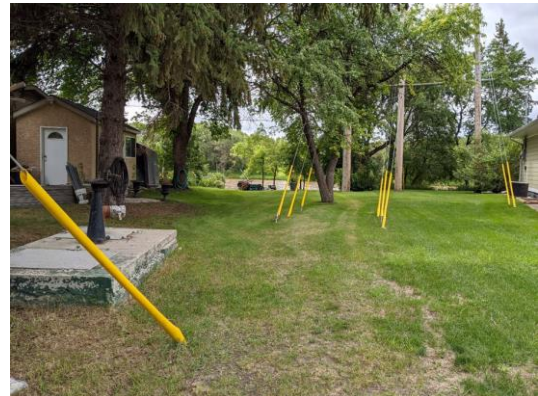
Photo 4: 2464 Assiniboine Crescent – Looking south from existing chamber
