PROJECT  
 OPTIMIST PARK  
 EAST SOCCER FIELD AND  
 ASSOCIATED FACILITIES  
 1600 SUMMIT ROAD  
 WINNIPEG

DRAWING TITLE  
 SITE SURVEY  
 EXISTING CONDITIONS  
 SHEET NO.

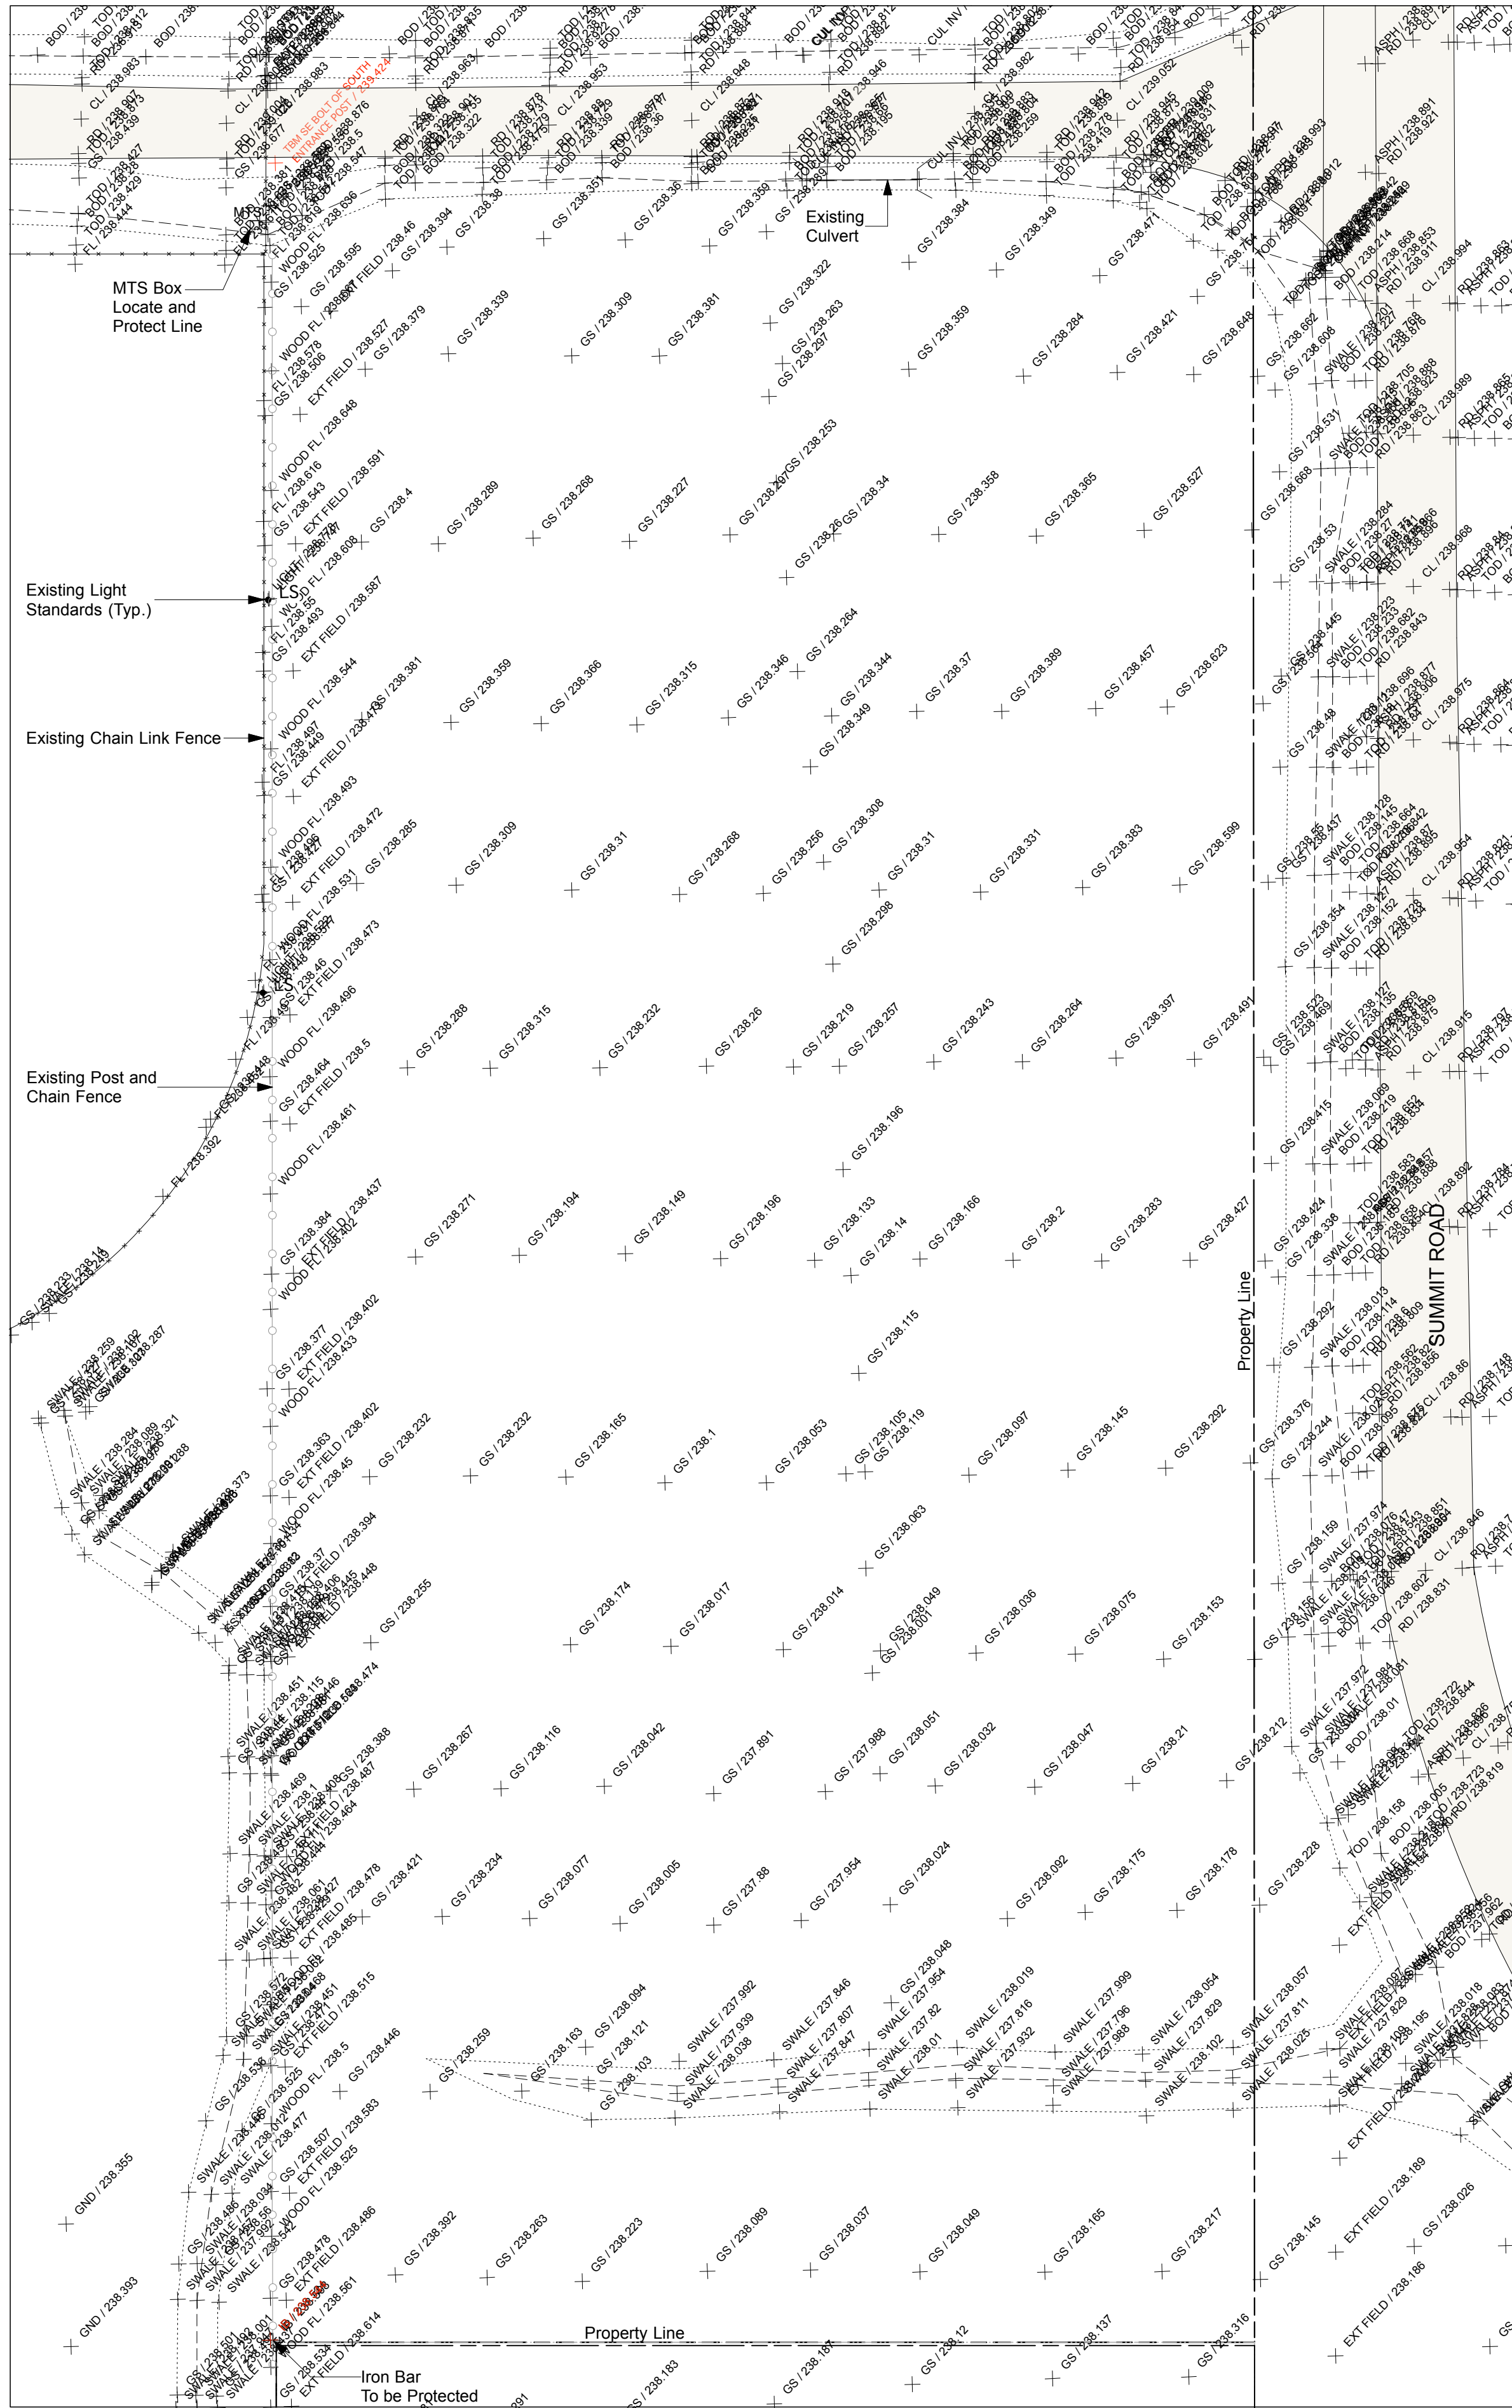
2 SITE SURVEY  
L-1 Scale: 1:500

Survey by WSP; completed October 21, 2017  
 239.1 - Existing Geodetic Grades in Metric  
 - Existing Drainage Pattern  
 Bench Mark - TBM SE Bolt of South Entrance Post, 239.424

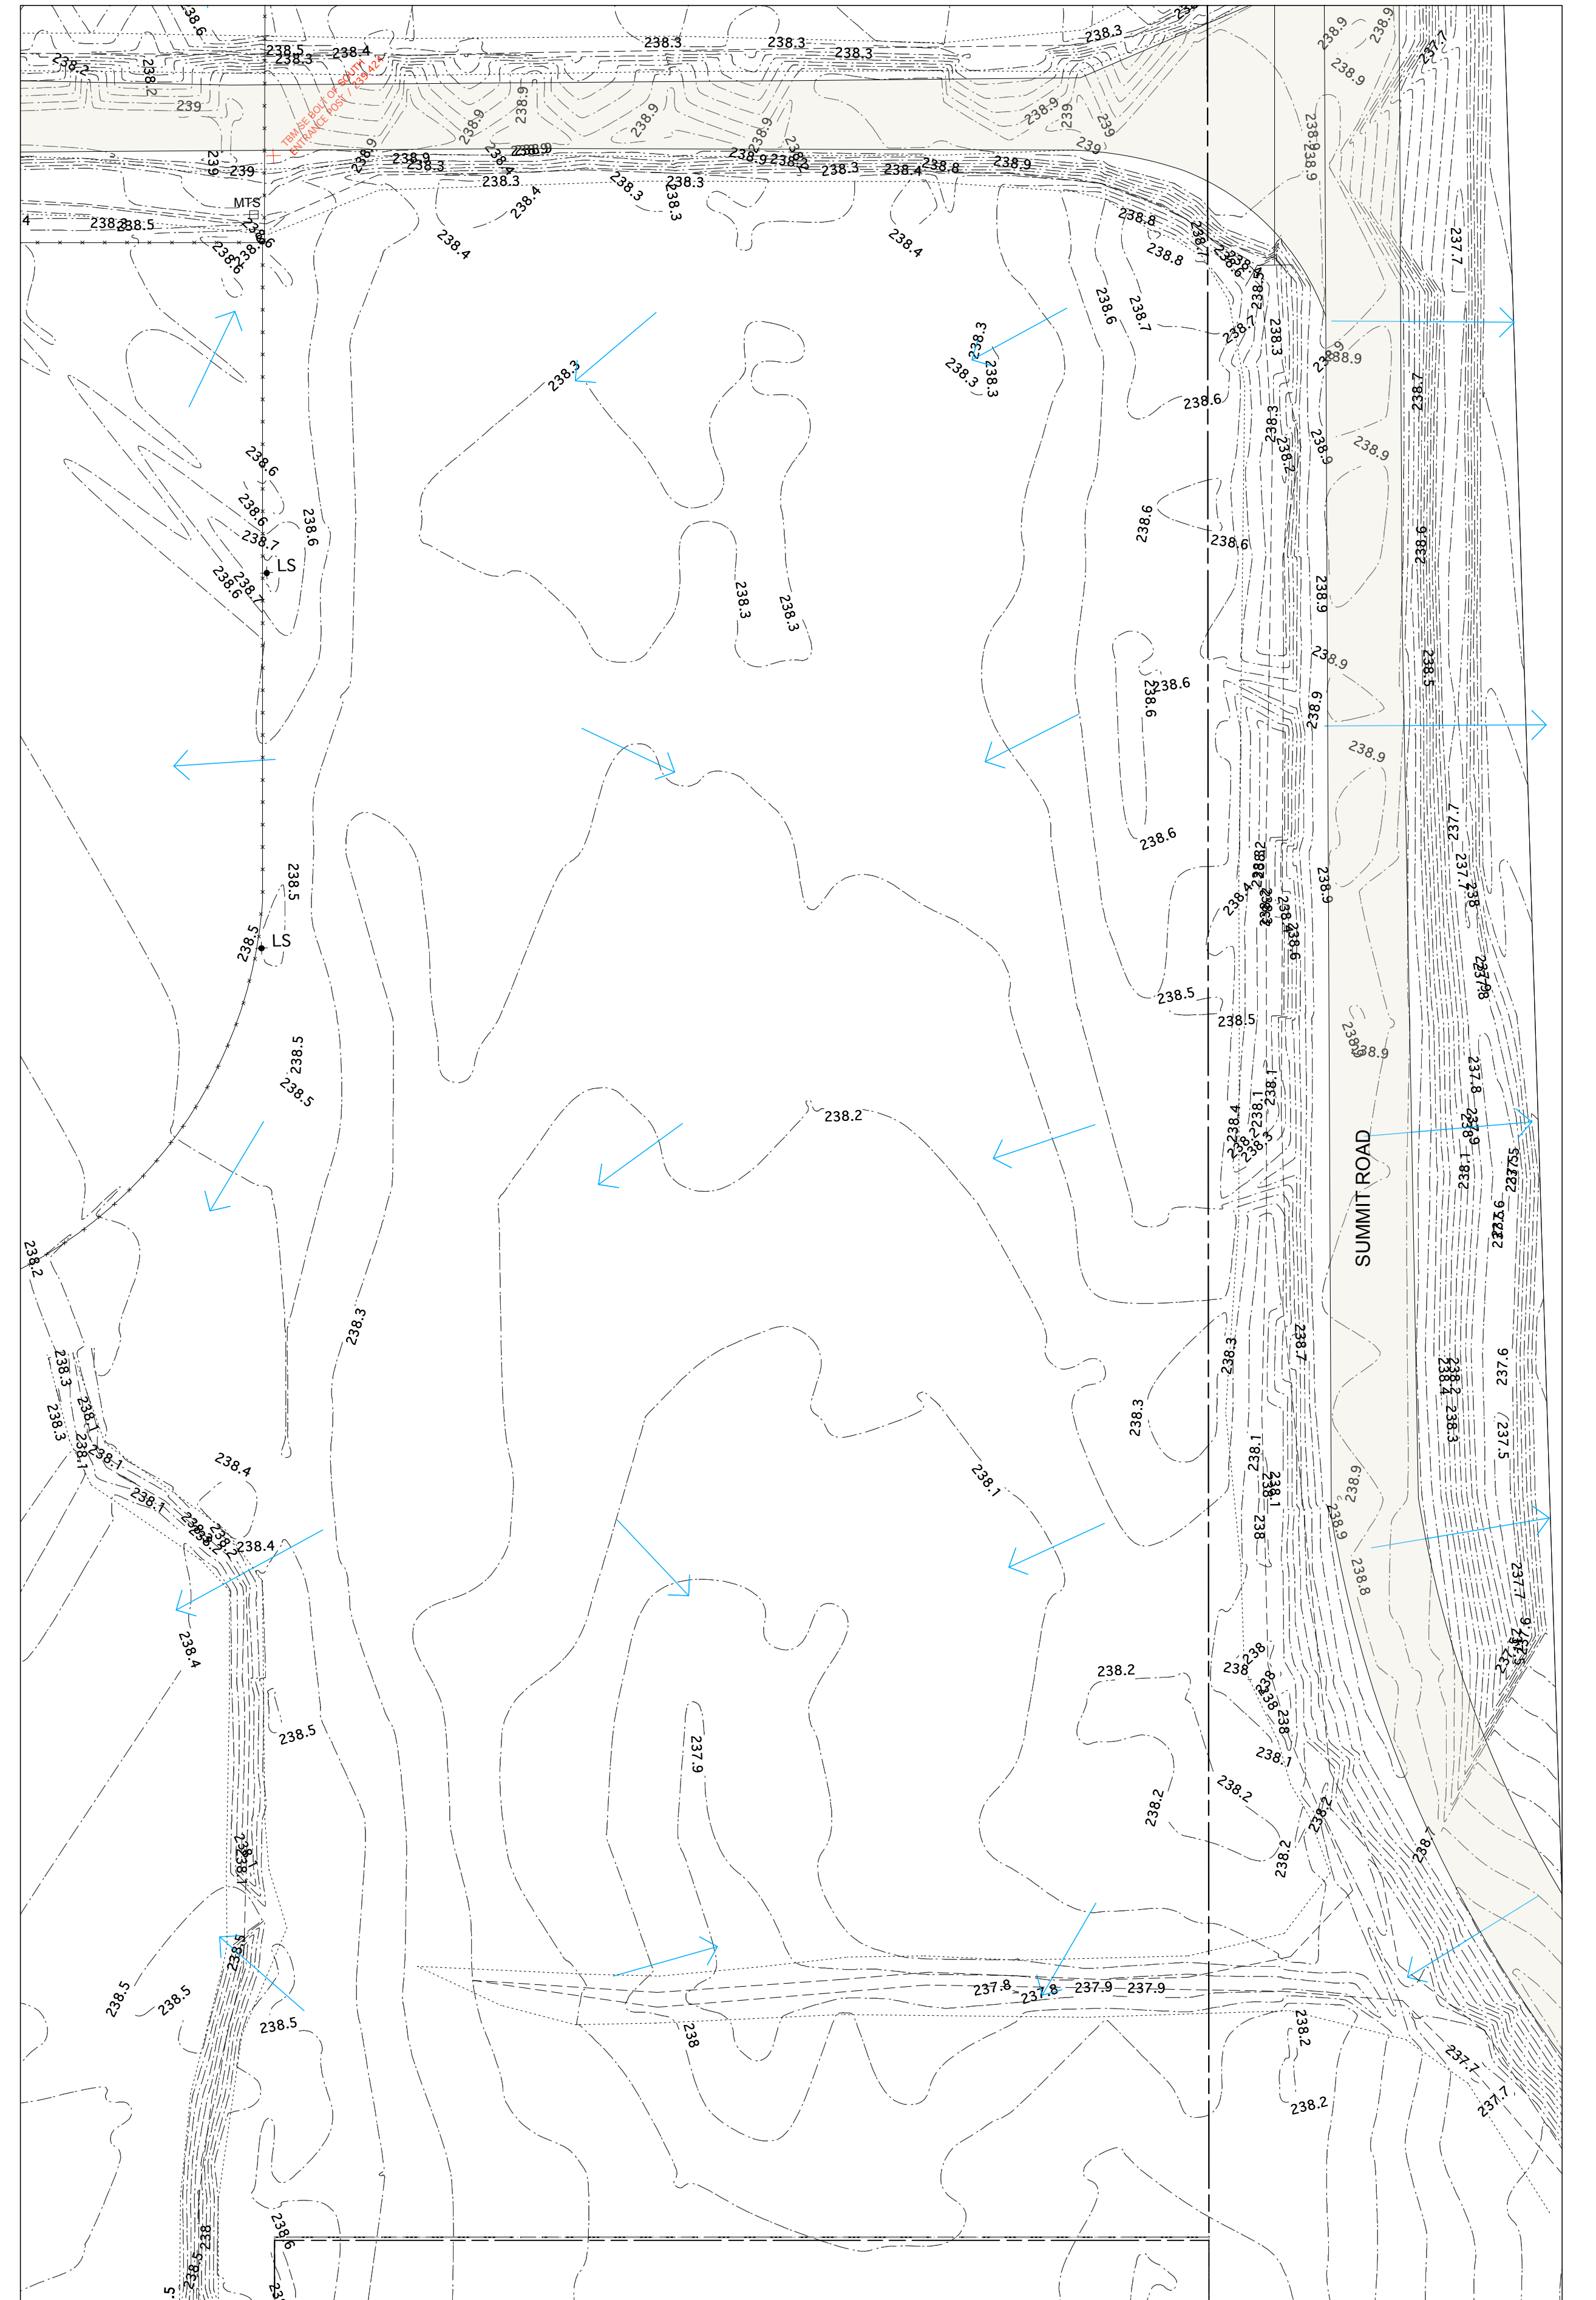
3 EXISTING DRAINAGE CONDITIONS  
L-1 Scale: 1:500

----- Top of Swale  
 - - - - - Bottom of Swale
