# **Geotechnical Investigation**

**City of Winnipeg Street Investigation**

**Winnipeg, Manitoba**

**WX19092**

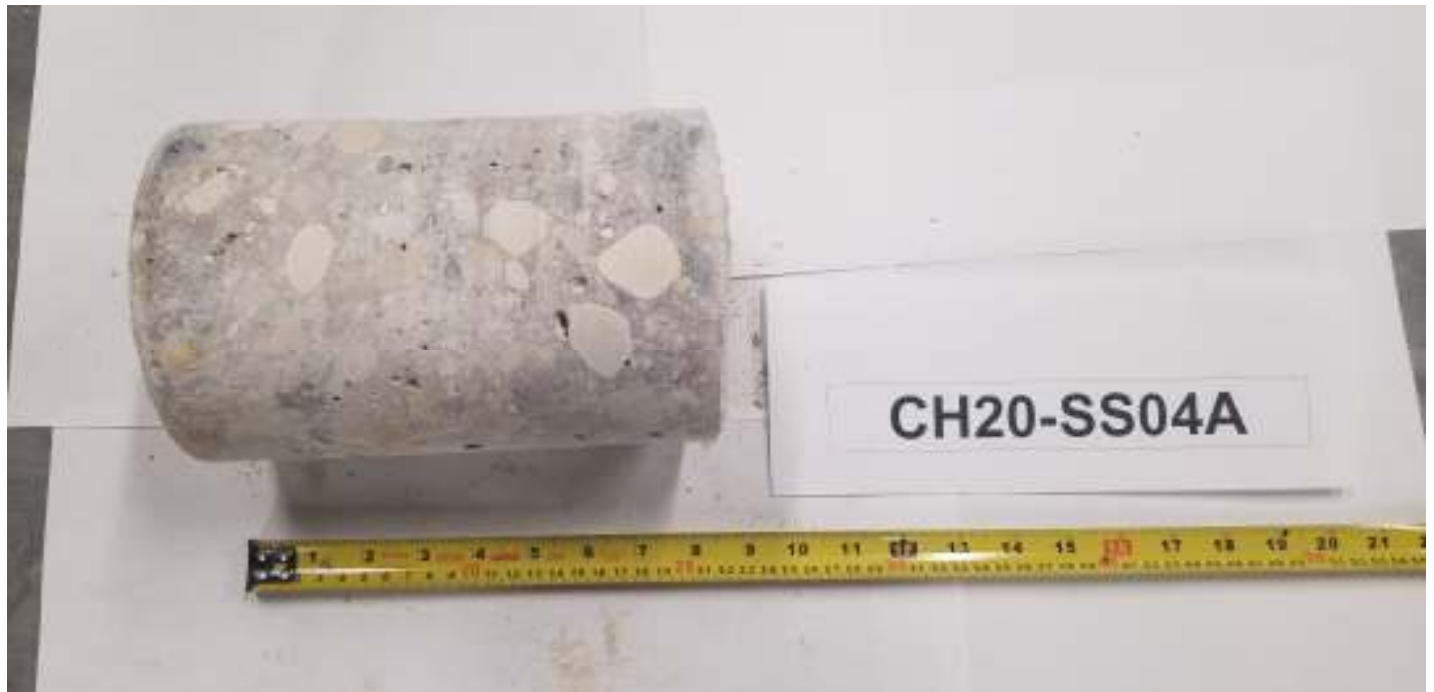
**Granular Structure Below Pavement:** Gravel fill – poorly graded, medium grained, damp to moist, compact (inferred), light brown

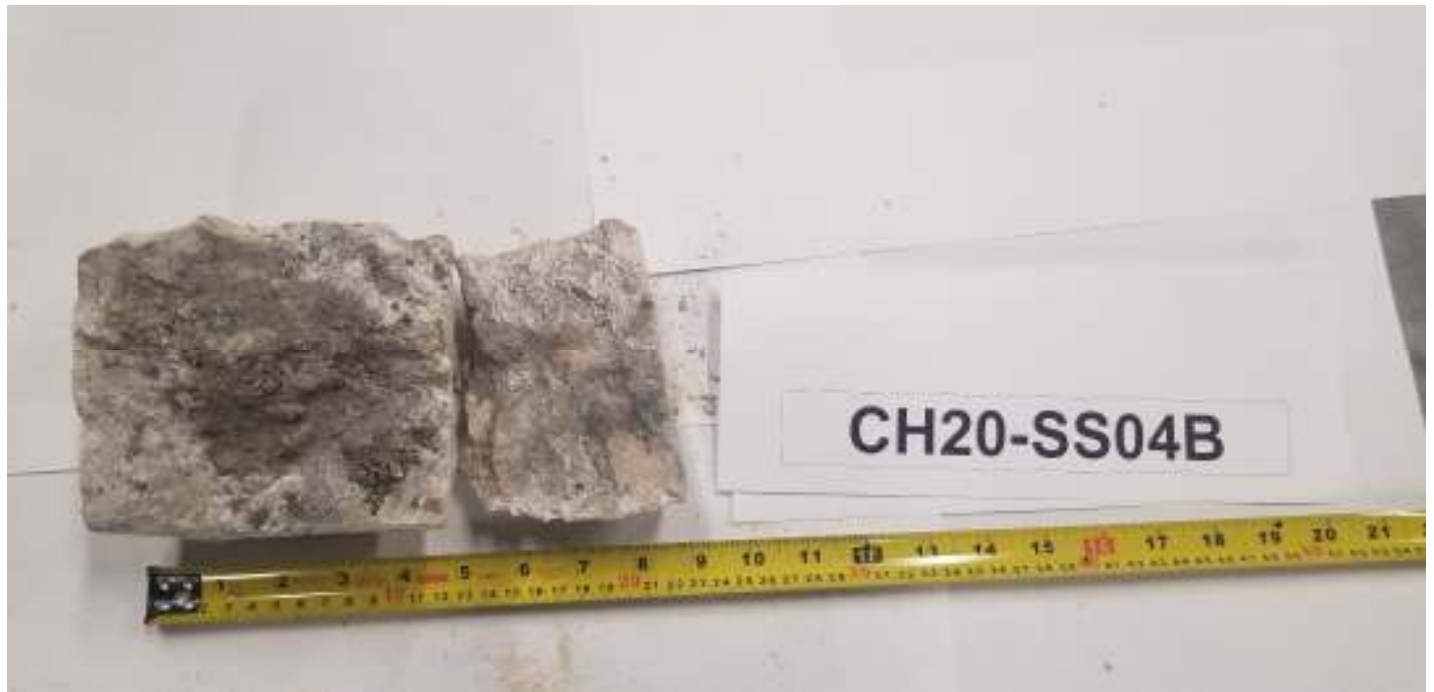
**Granular Structure Below Pavement:** Gravel fill – poorly graded, medium grained, damp to moist, compact (inferred), light brown

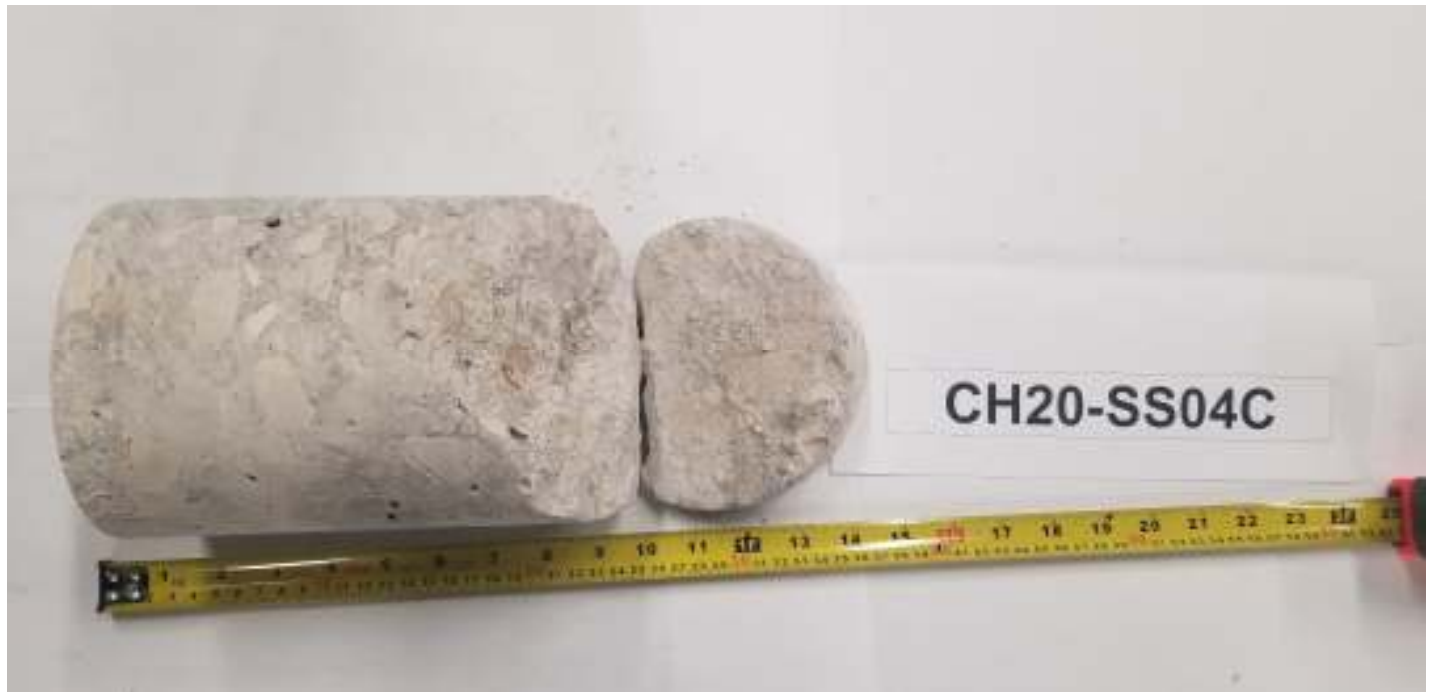
**Granular Structure Below Pavement:** Gravel fill – poorly graded, medium grained, damp to moist, compact (inferred), light brown

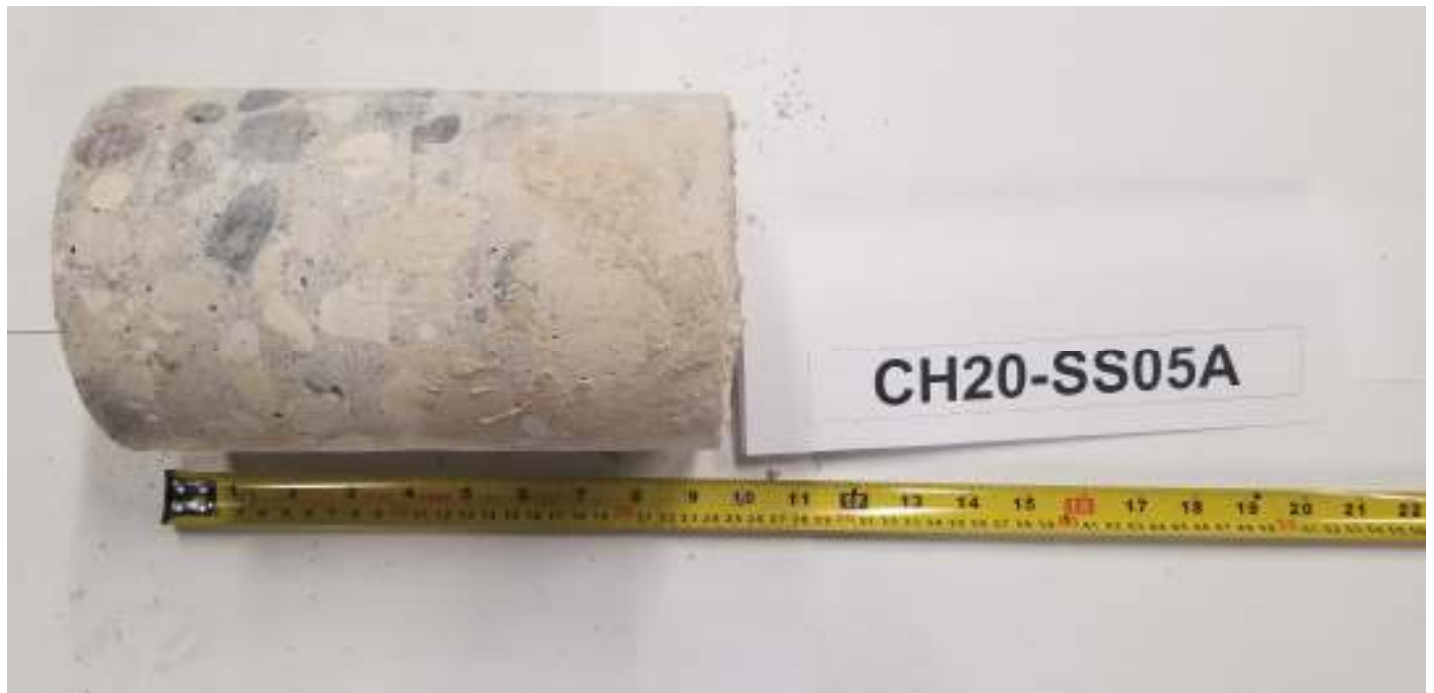
**Granular Structure Below Pavement:** Gravel fill – sandy, poorly graded, fine grained, damp to moist, compact (inferred), light brown

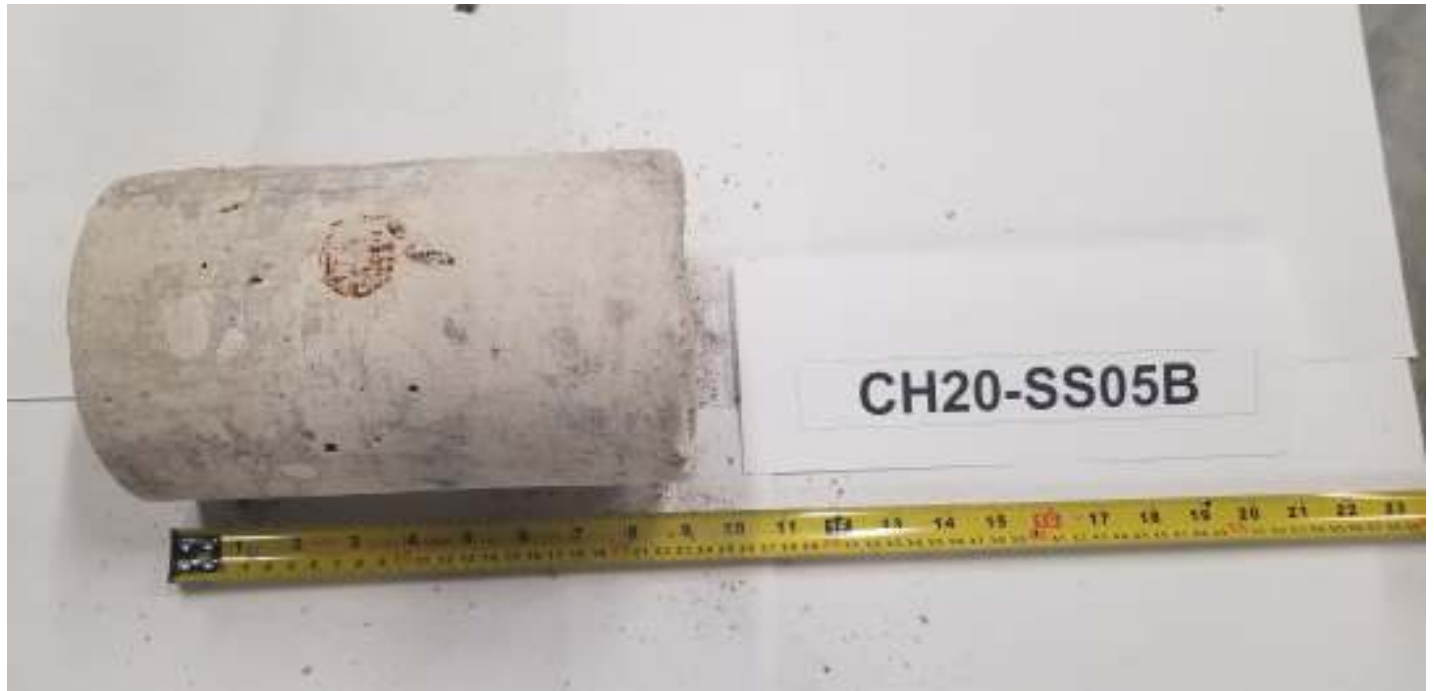
**Granular Structure Below Pavement:** Gravel fill – sandy, poorly graded, fine grained, damp to moist, compact (inferred), light brown

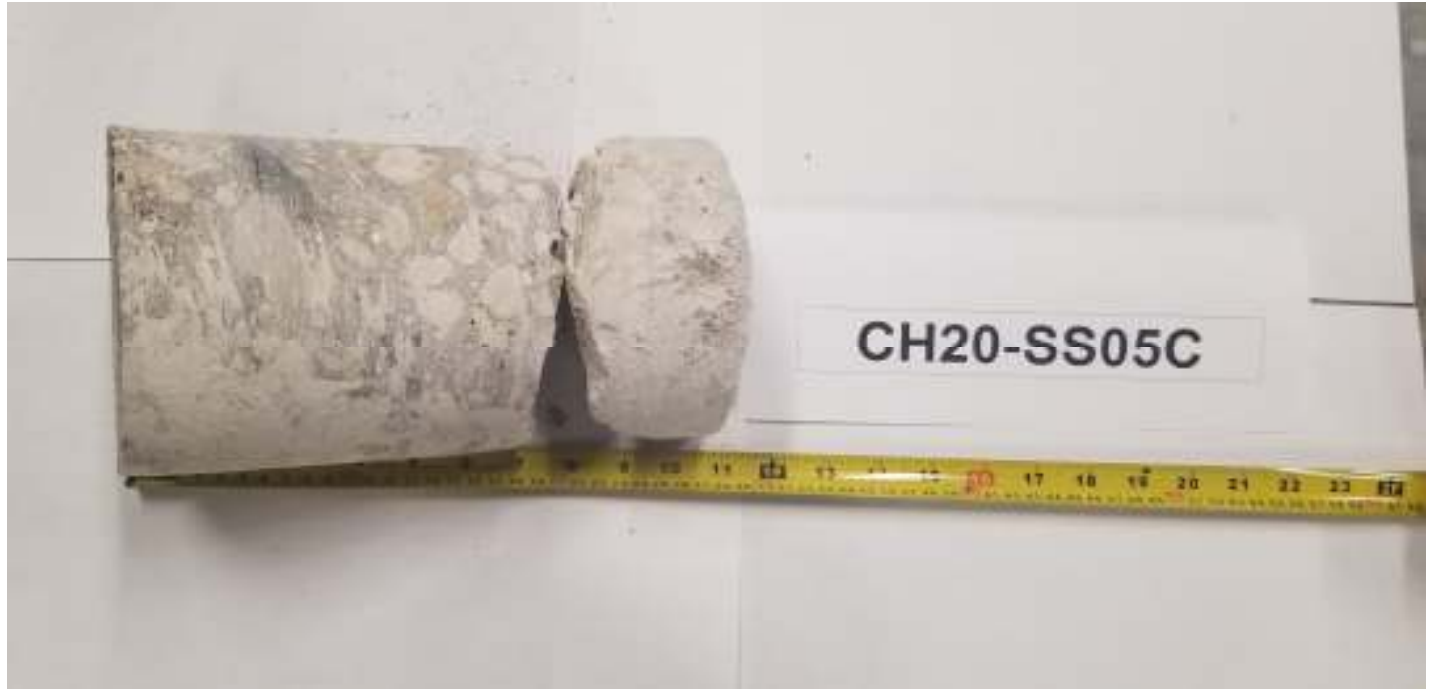
**Granular Structure Below Pavement:** Gravel fill – sandy, poorly graded, fine grained, damp to moist, compact (inferred), light brown

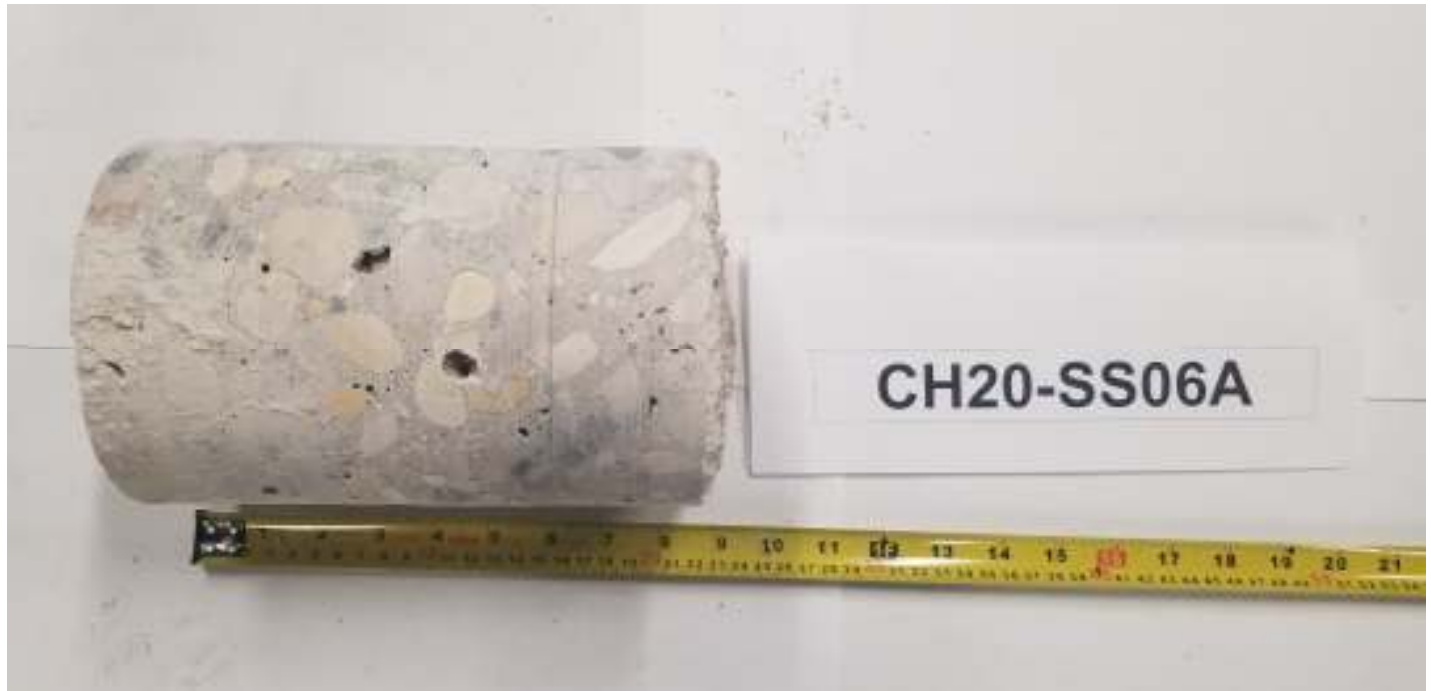
**Granular Structure Below Pavement:** Gravel fill – sandy, poorly graded, fine grained, damp to moist, compact (inferred), light brown

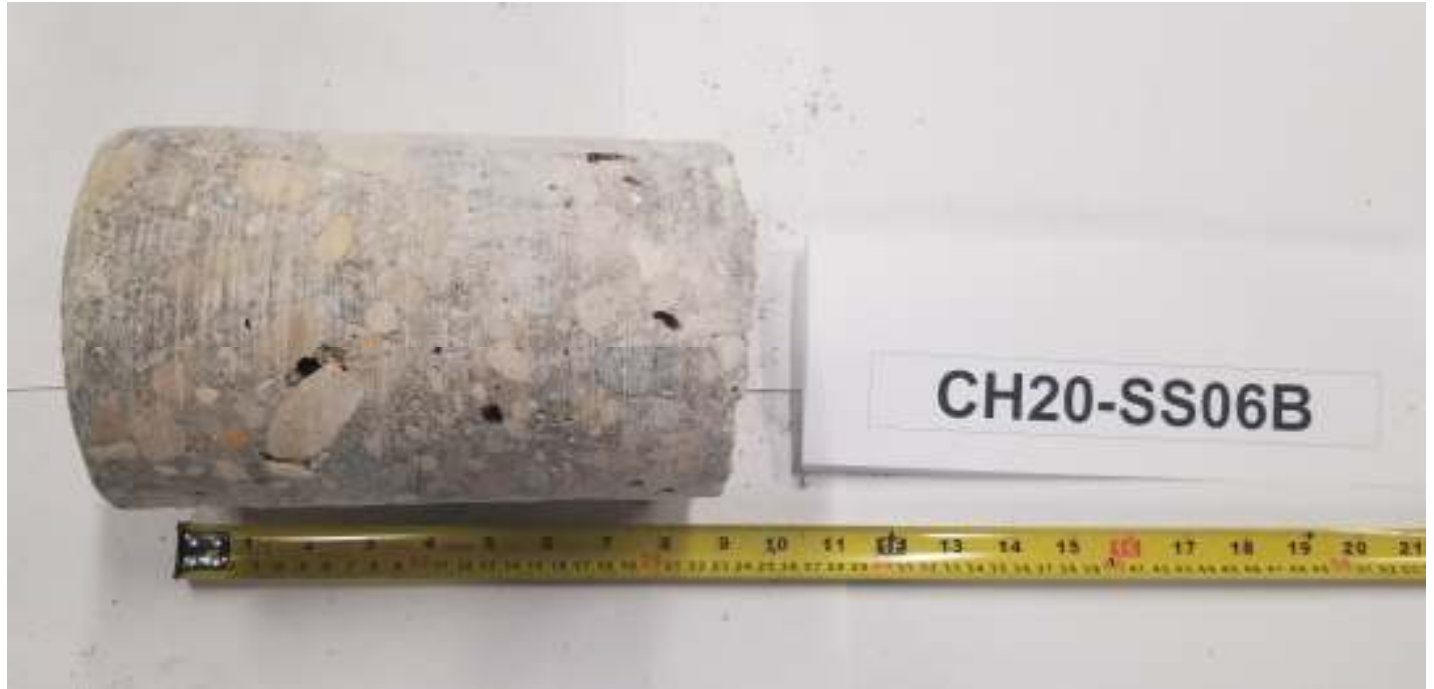
**Granular Structure Below Pavement:** Gravel fill – sandy, poorly graded, fine grained, damp to moist, compact (inferred), light brown

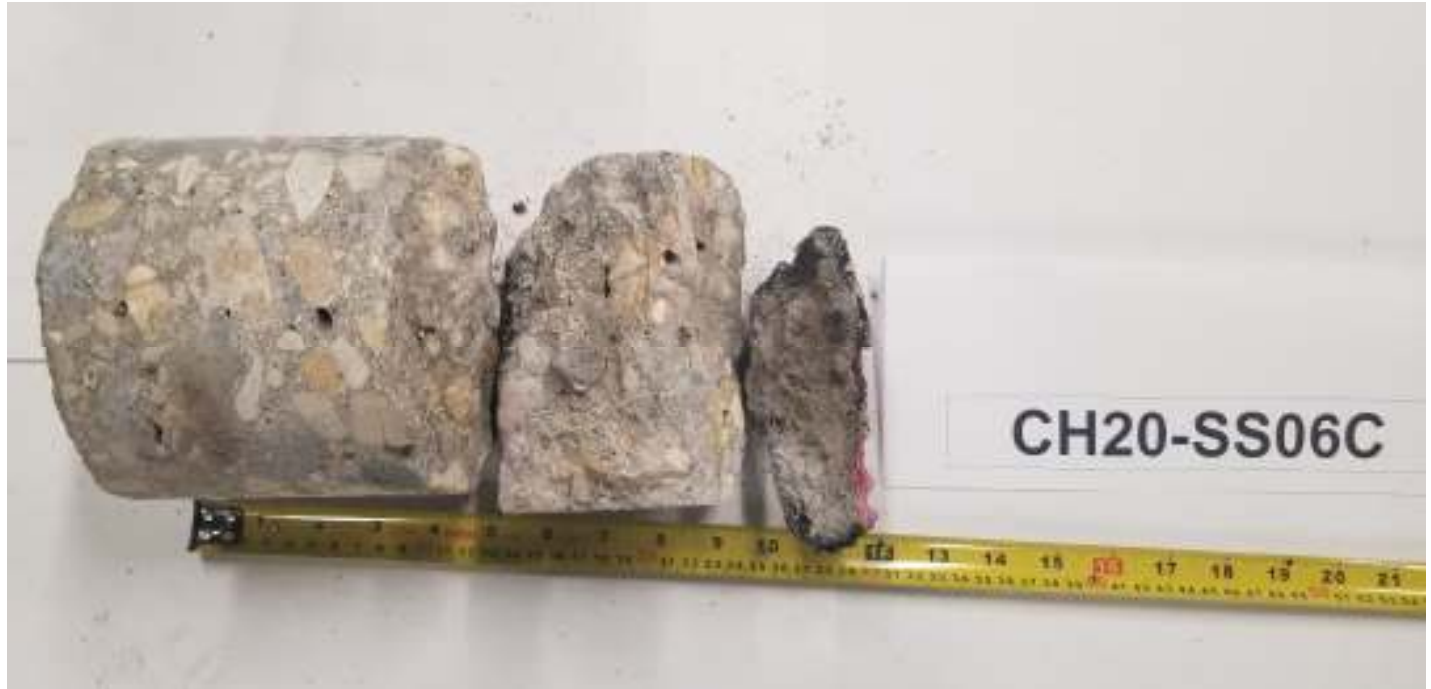
**Granular Structure Below Pavement:** Gravel fill – sandy, poorly graded, fine grained, damp to moist, compact (inferred), light brown

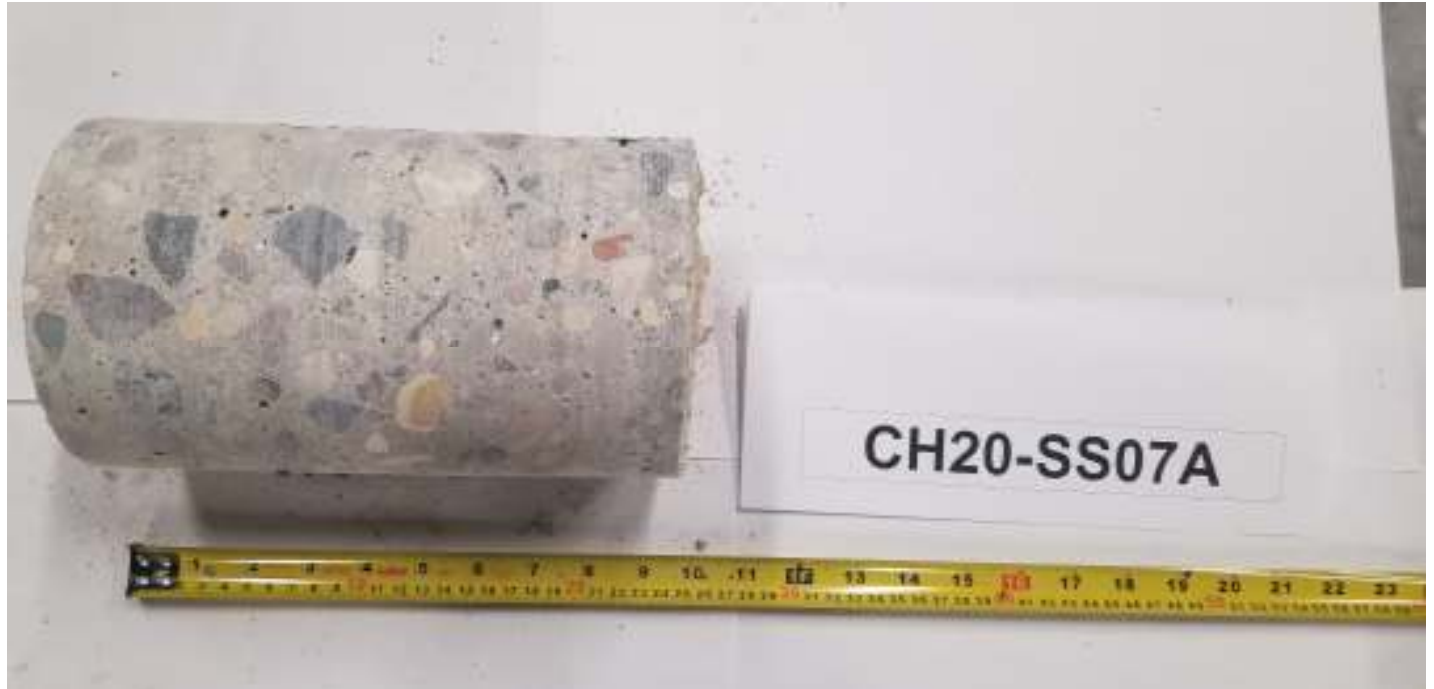
**Granular Structure Below Pavement:** Gravel fill – sandy, poorly graded, fine grained, damp to moist, compact (inferred), light brown

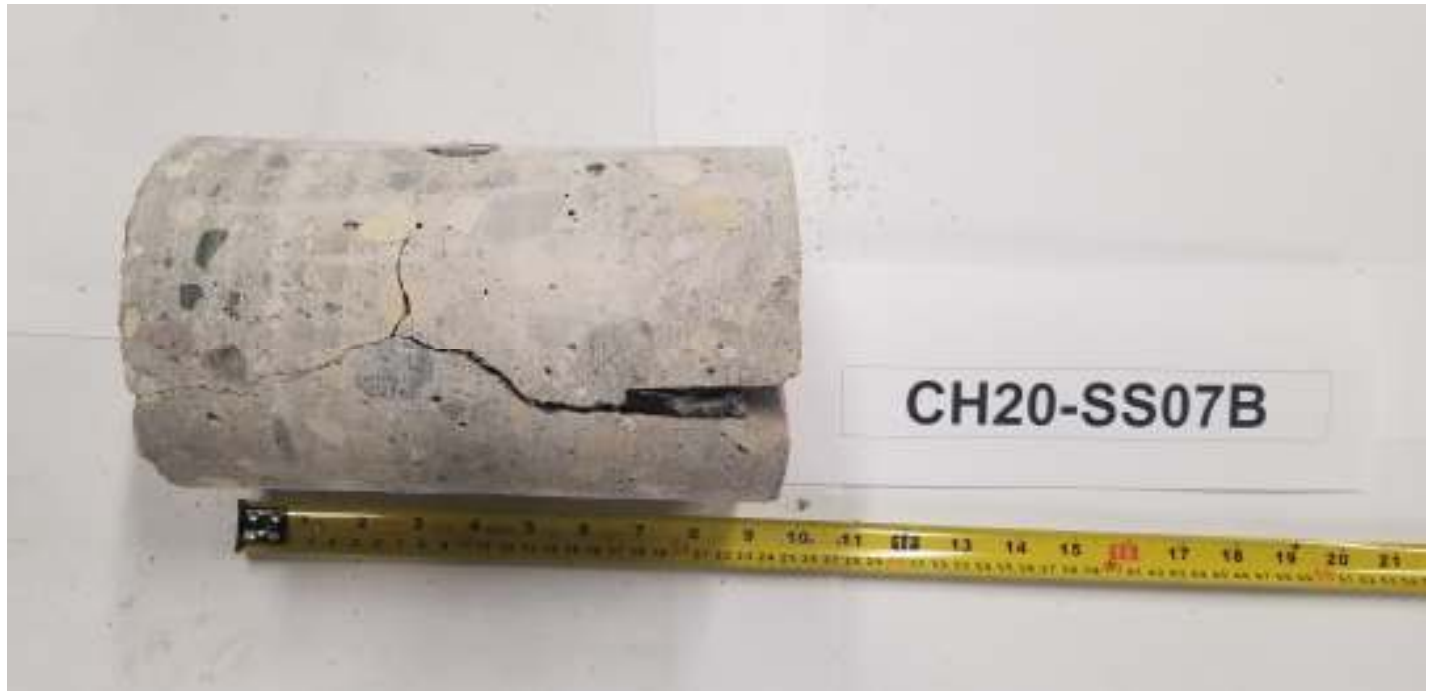
**Granular Structure Below Pavement:** Gravel fill – sandy, poorly graded, fine grained, damp to moist, compact (inferred), light brown

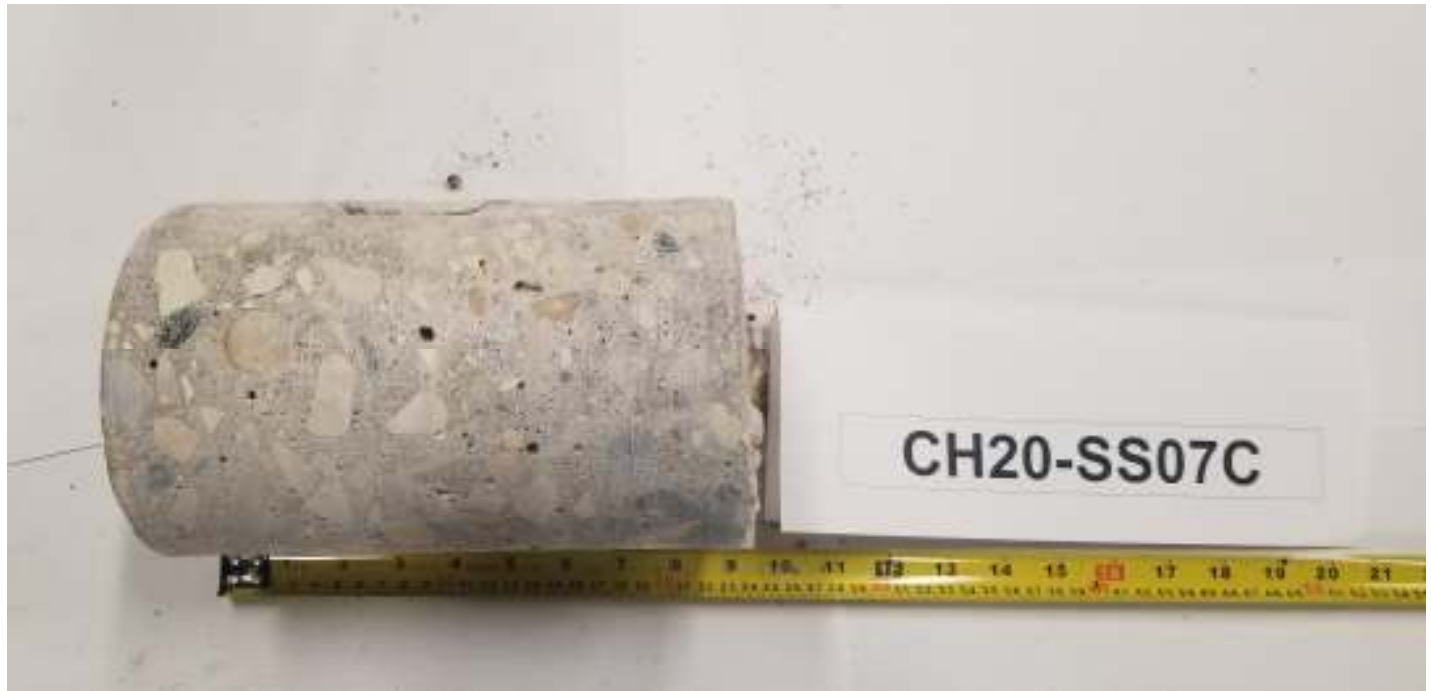
**Granular Structure Below Pavement:** Gravel fill – sandy, poorly graded, fine grained, damp to moist, compact (inferred), light brown

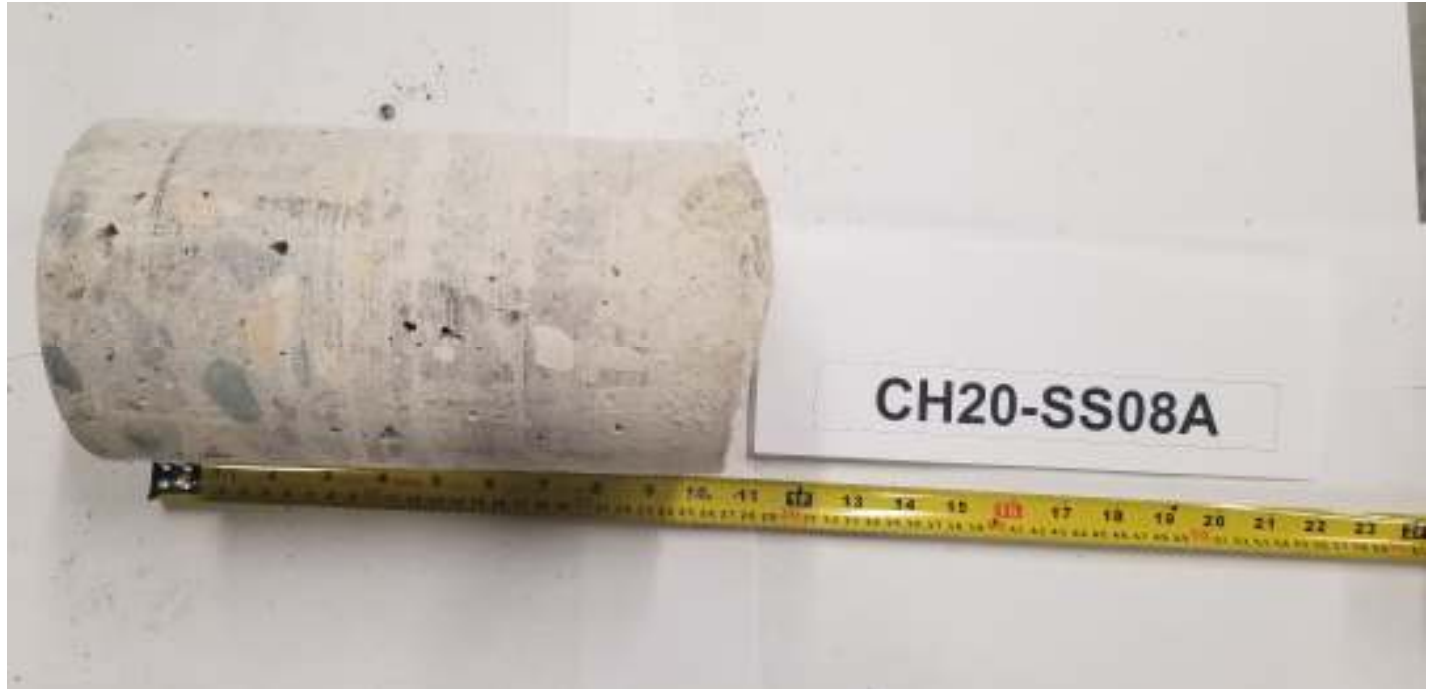
**Granular Structure Below Pavement:** Gravel fill – sandy, poorly graded, fine grained, damp to moist, compact (inferred), light brown

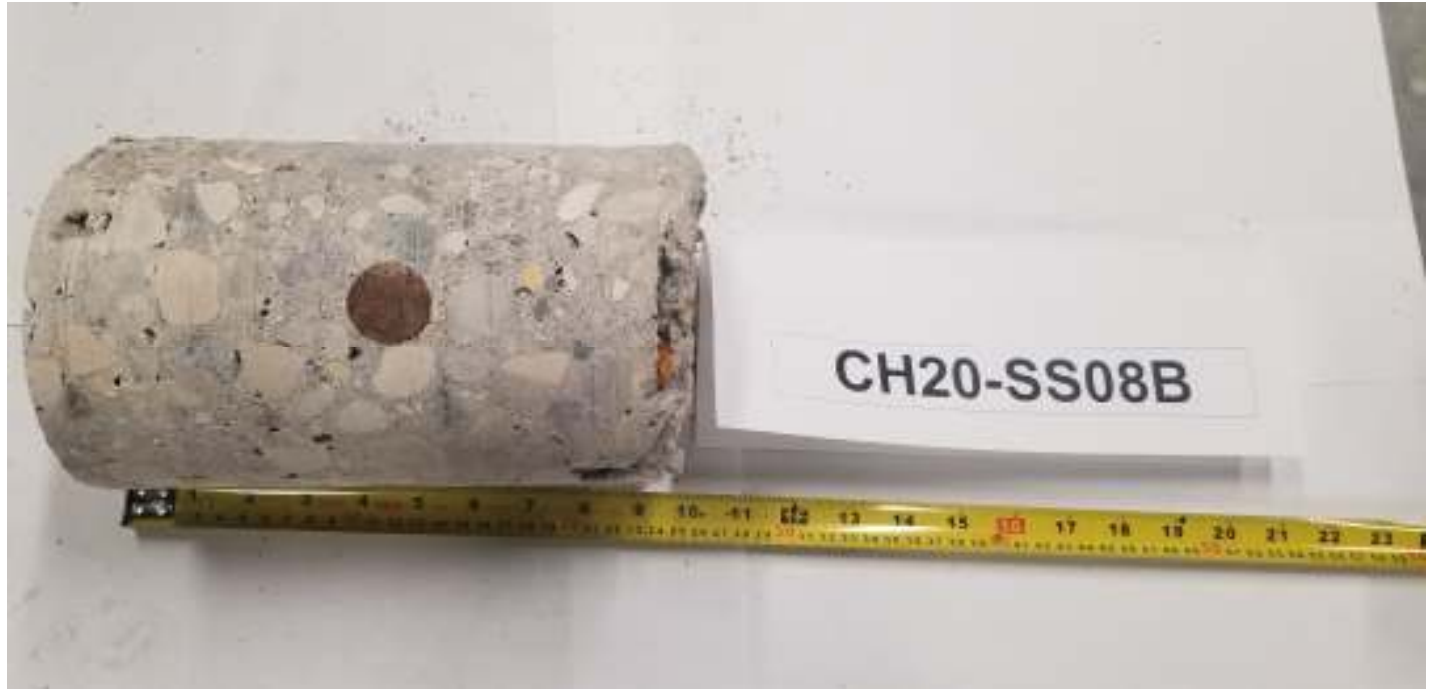
**Granular Structure Below Pavement:** Gravel fill – sandy, poorly graded, fine grained, damp to moist, compact (inferred), light brown

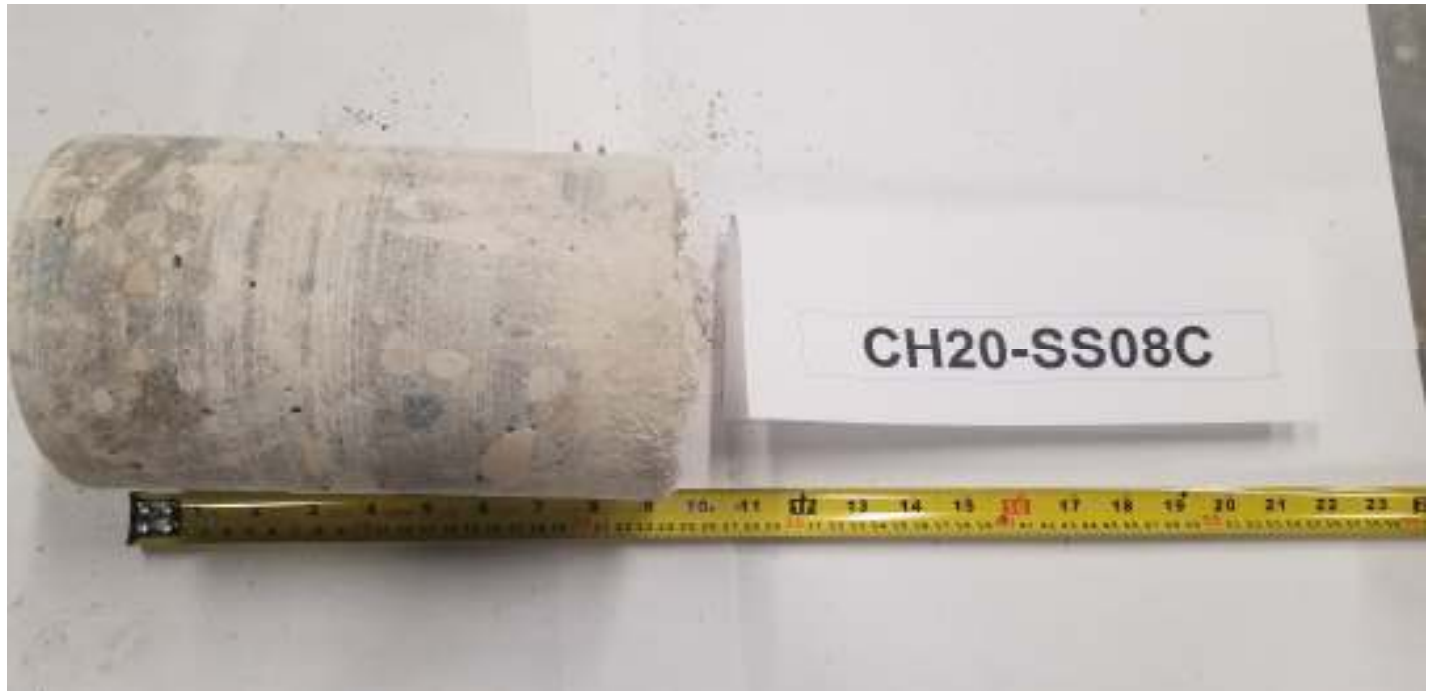
**Granular Structure Below Pavement:** Gravel fill – sandy, poorly graded, fine grained, damp to moist, compact (inferred), light brown

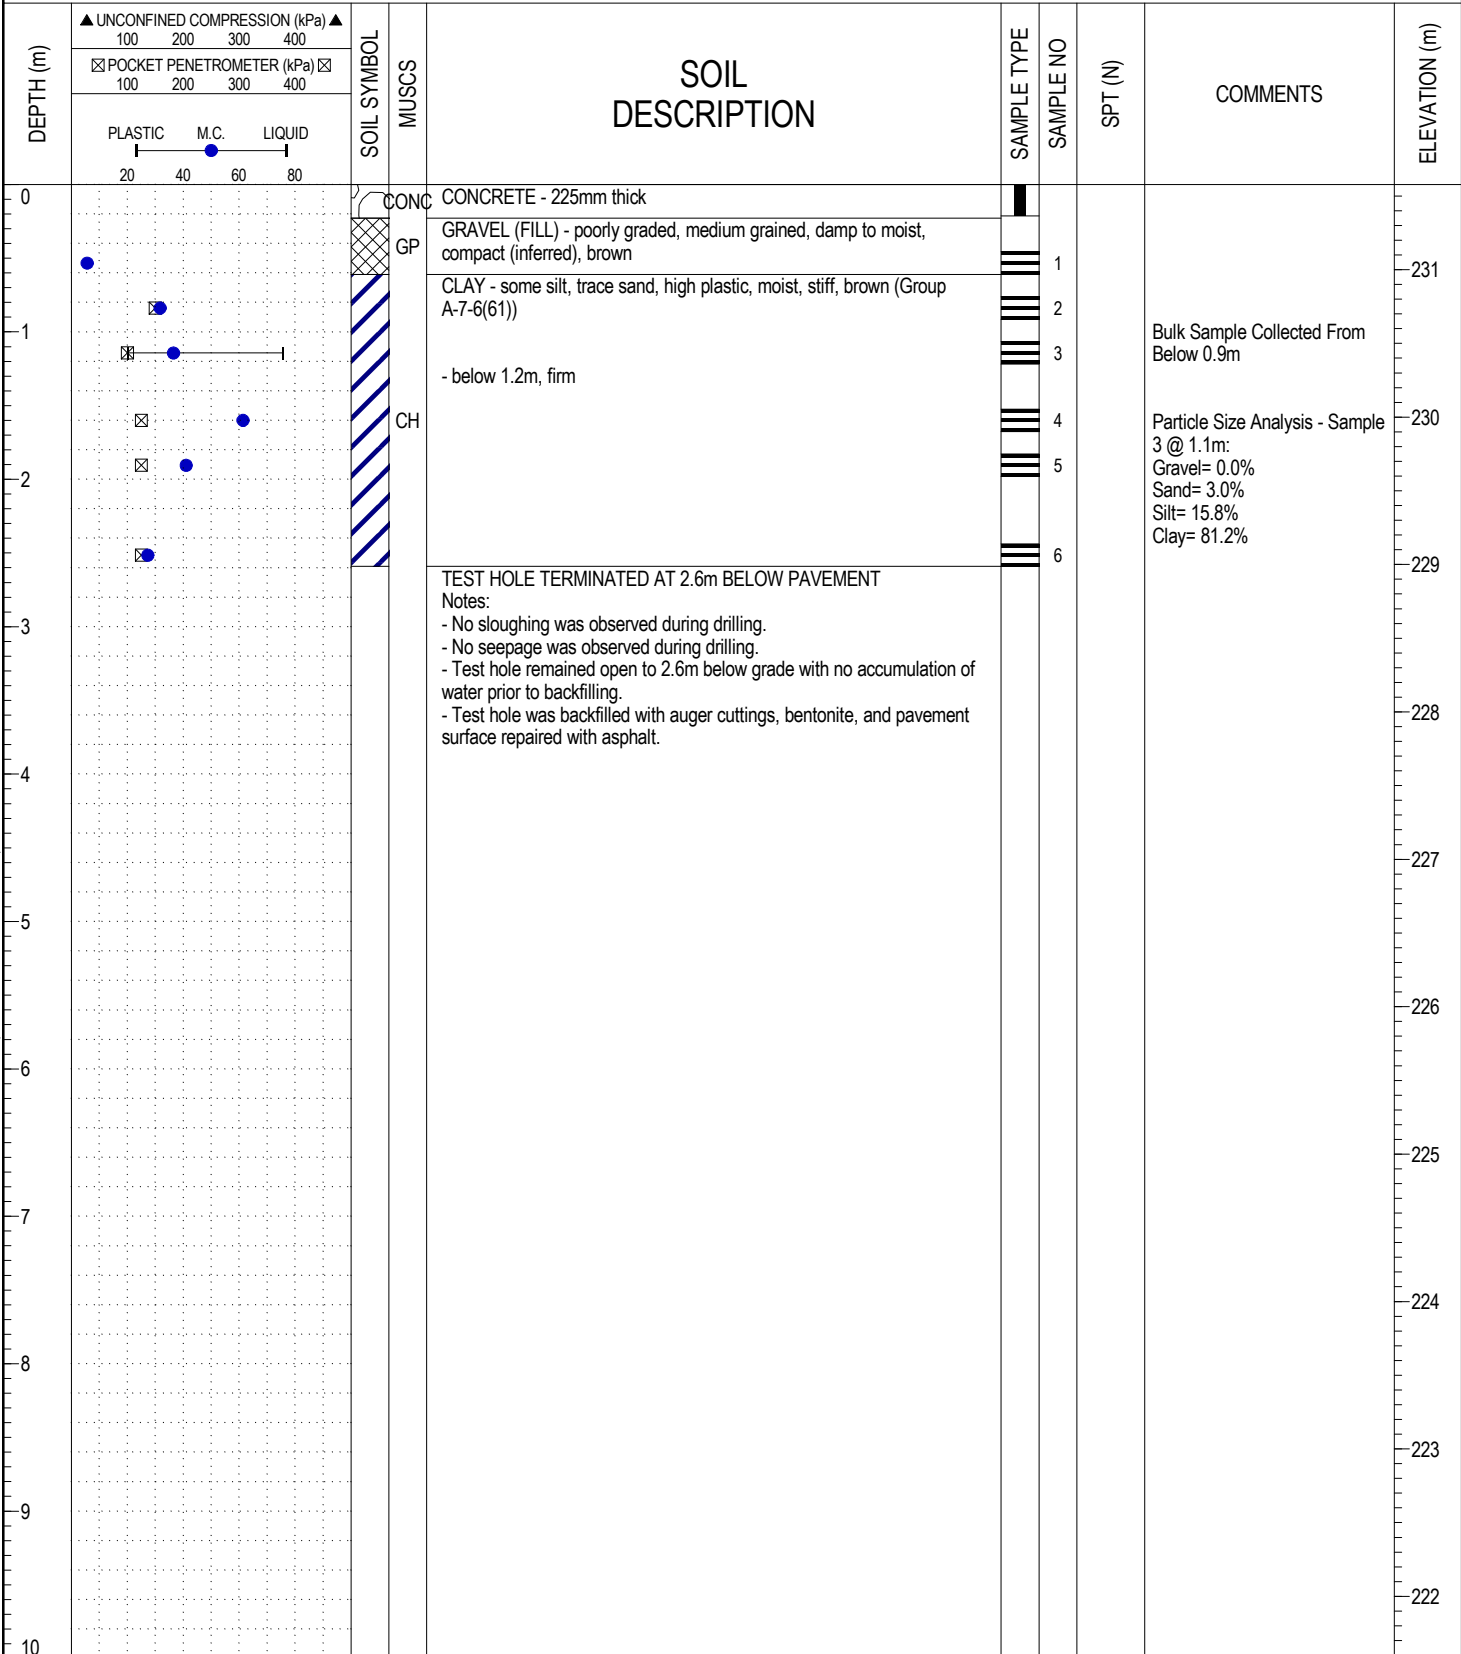
LOGGED BY: JW	COMPLETION DEPTH: 2.6 m
REVIEWED BY: TG	COMPLETION DATE: June 1, 2020
Figure No. A1	Sheet 1 of 1

PROJECT: City of Winnipeg Street Investigation	DRILLER: Maple Leaf Drilling Ltd.	TEST HOLE ID: TH20-SS01
CLIENT: Stantec	DRILL RIG: Truck Mounted B40	PROJECT No: WX19092
LOCATION: 160 Salter Street, NB Curb Lane	DRILL METHOD: 125mm SSA	ELEVATION: 231.58 m
