# **GEOTECHNICAL REPORT**

## Hartford Avenue - McGregor St / Salter St.

ATTENTION:  
PROJECT: Local Streets Package 24-R-05 (751-2023.5)  
Sanford, Winnipeg, MB

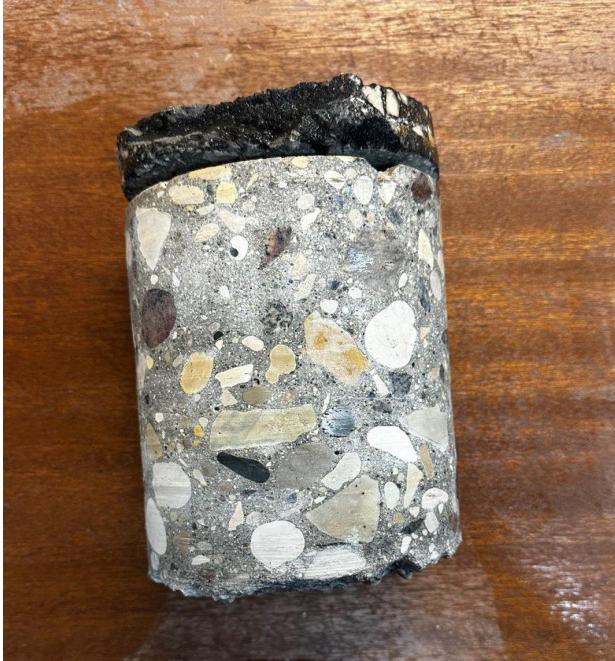
Yarwood Ave, WBL, Core 15  
(Asphalt Thk 30mm; Conc Thk 200)

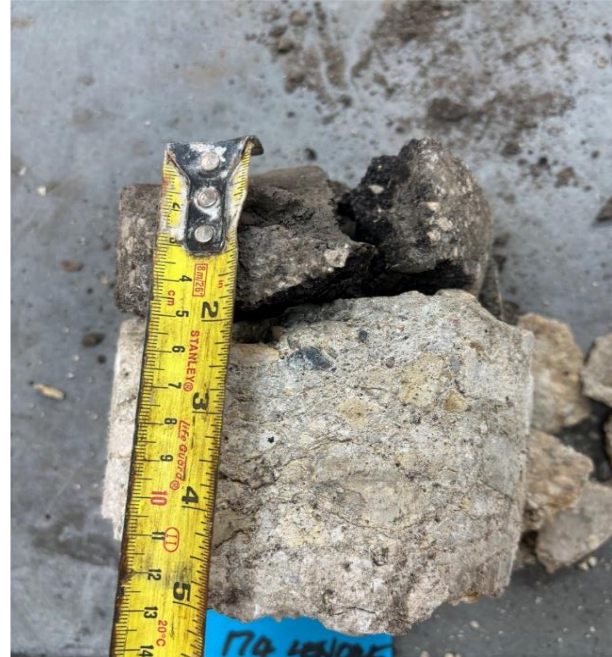
Ruby St - Lenore St Backlane, NBL, Core 38  
(Asphalt Thk 51mm; Conc Thk 102)

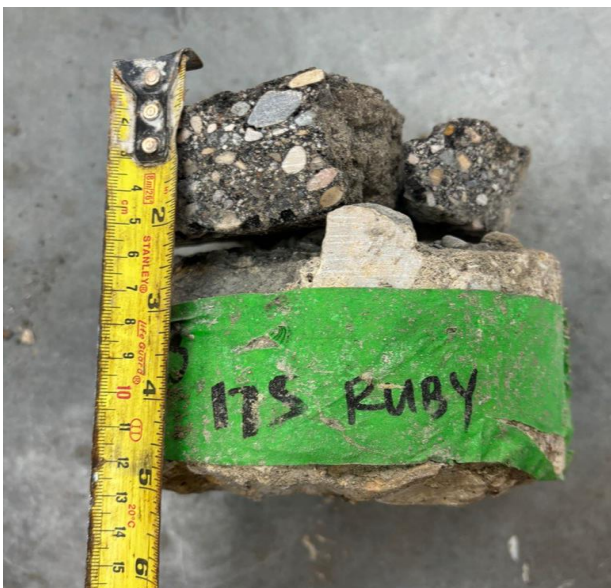
Ruby St - Lenore St Backlane, SBL, Core 39  
(Asphalt Thk 40mm; Conc Thk 80)
