4. City Facility Assessments

4.1 Introduction

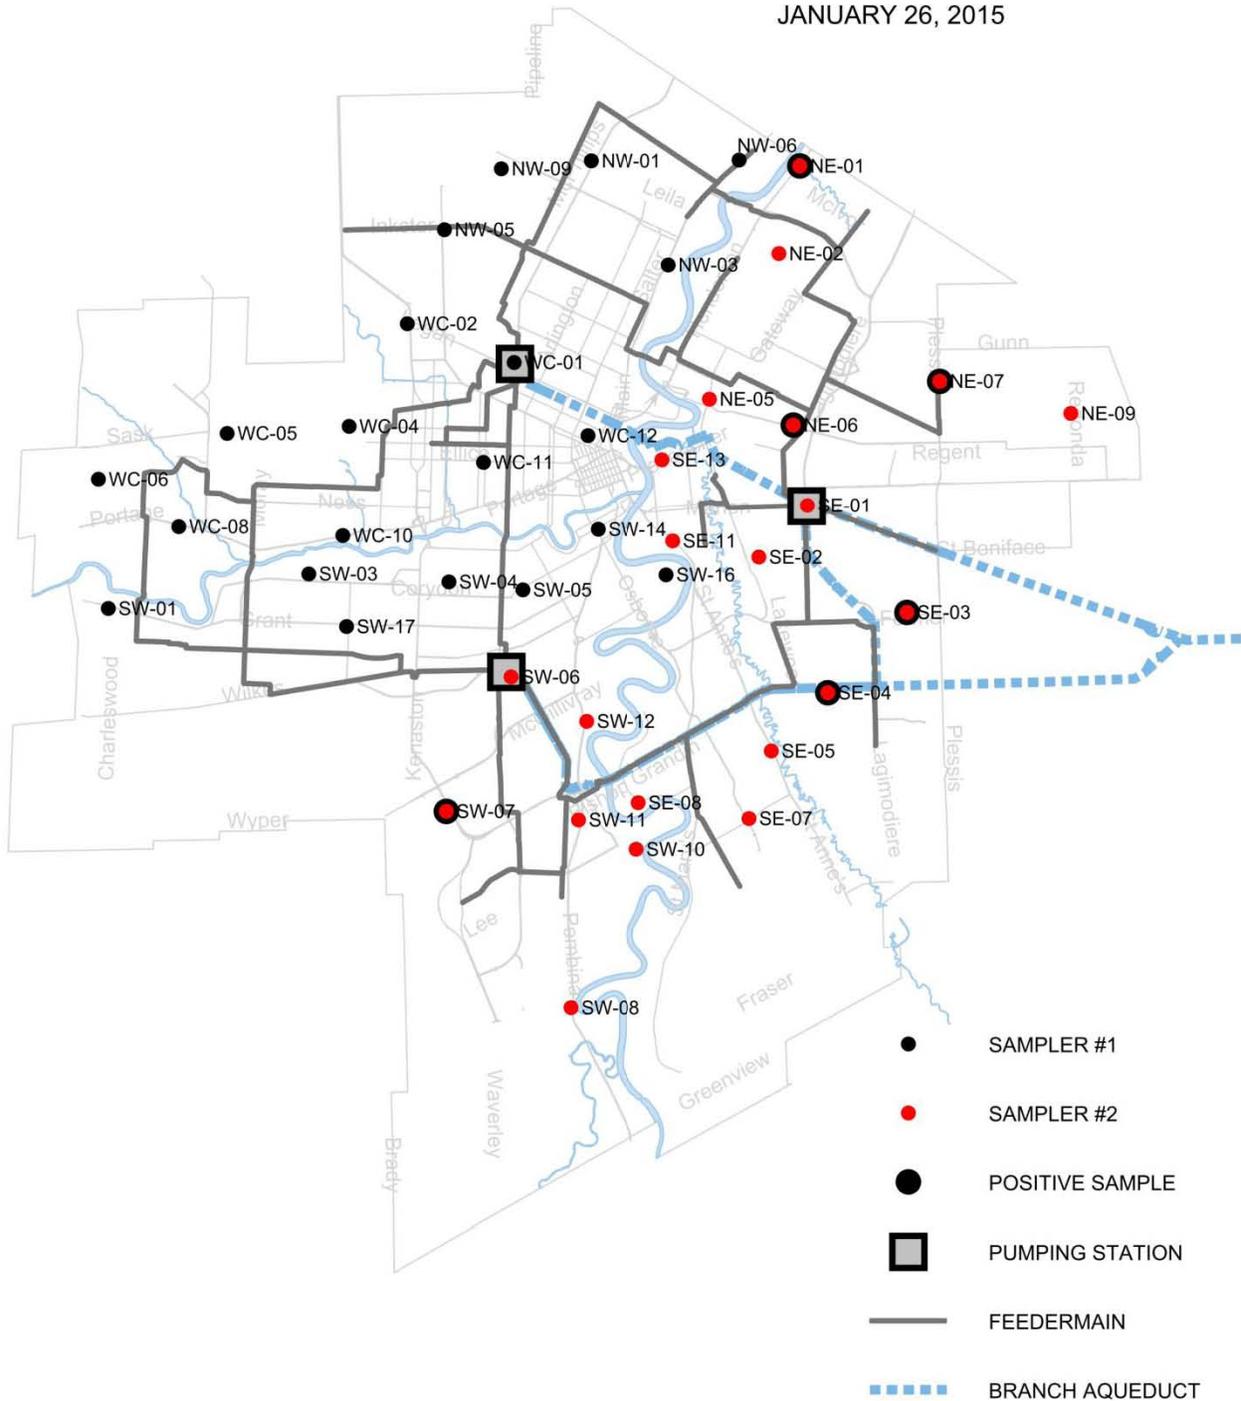
Figure 8: Compliance Sample Locations (by Sample Collector), Jan 26, 2015

Sampling locations testing positive for TC/EC in the City (**Figure 7**) were evaluated by AECOM and City staff. Of note was the correlation between the positive samples attributed to a single sample collector (**Figure 8**). Some of the existing water sampling locations appear to be at risk of contamination due to the following circumstances:

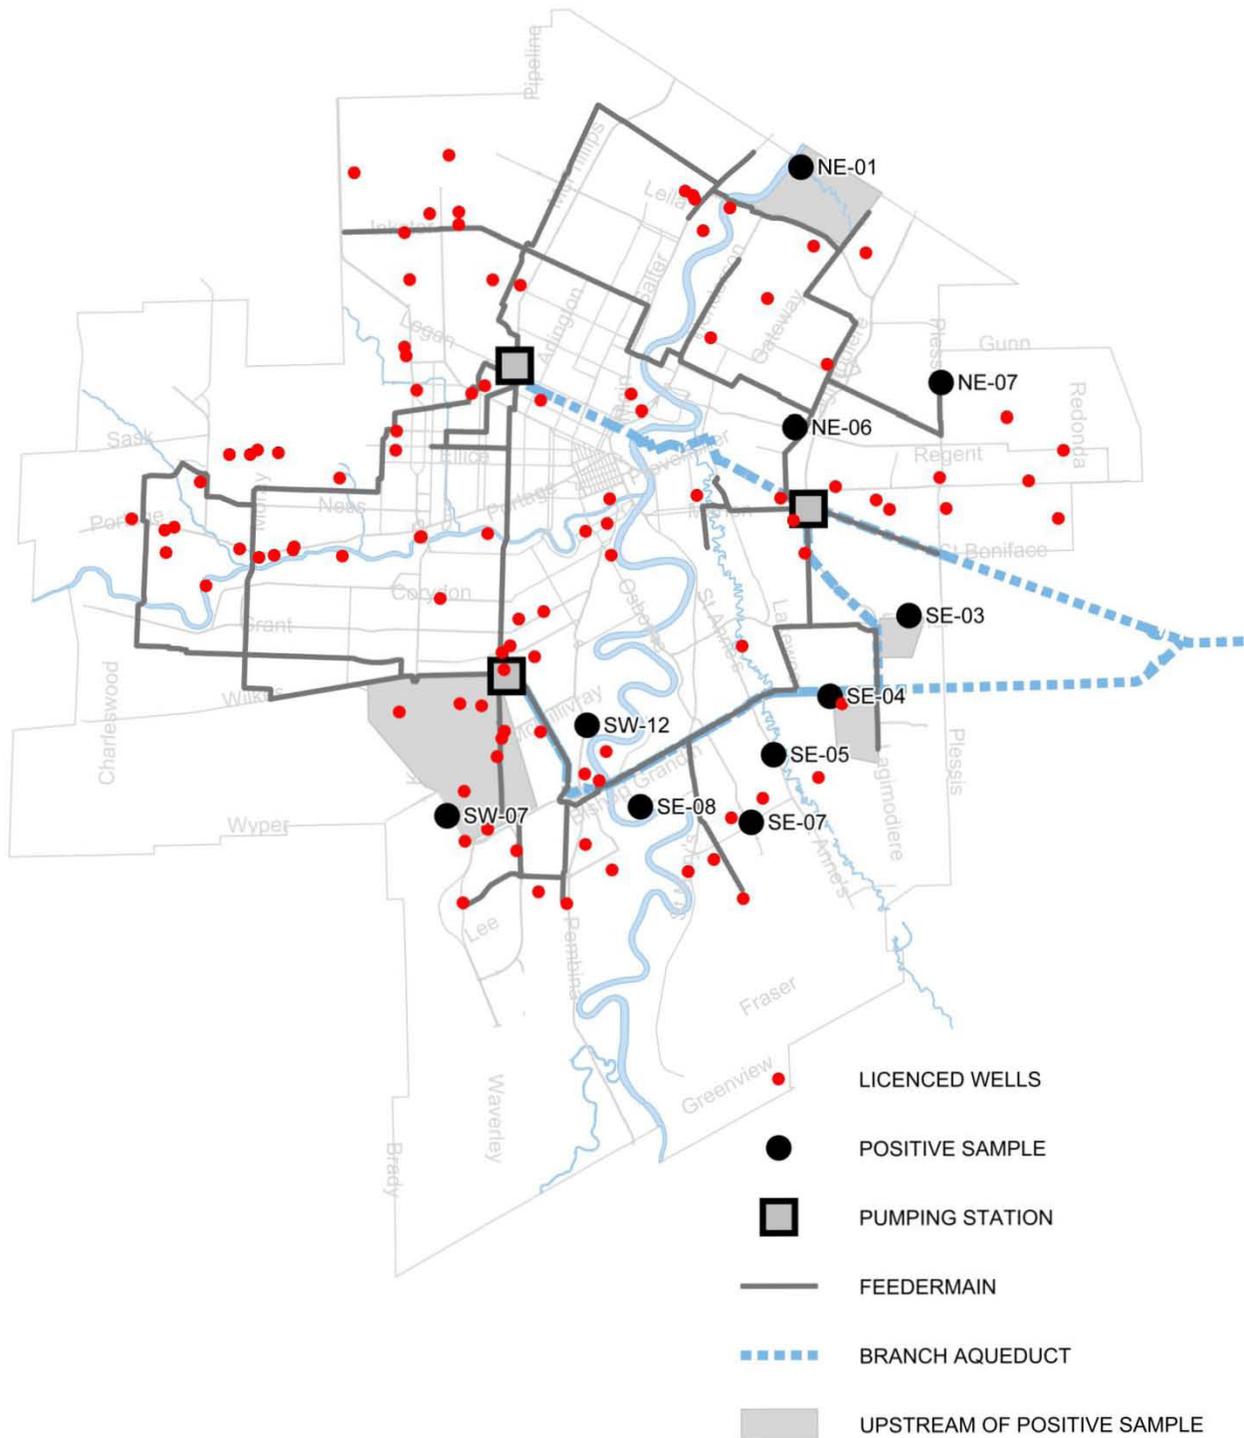
Figure 9: Ground Well Locations

Ninety-nine non-domestic licenced groundwater wells exist within the City limits, as shown in **Figure 9**. In order for a cross connection to occur, an illegal connection from the well to the City of Winnipeg watermain system would be required. Although there are some wells in the upstream vicinity of the some of the sample points, they are not hydraulically connected to the other sample locations that tested positive. In addition, there are several wells that are in the upstream location of other sampling points that did not test positive.

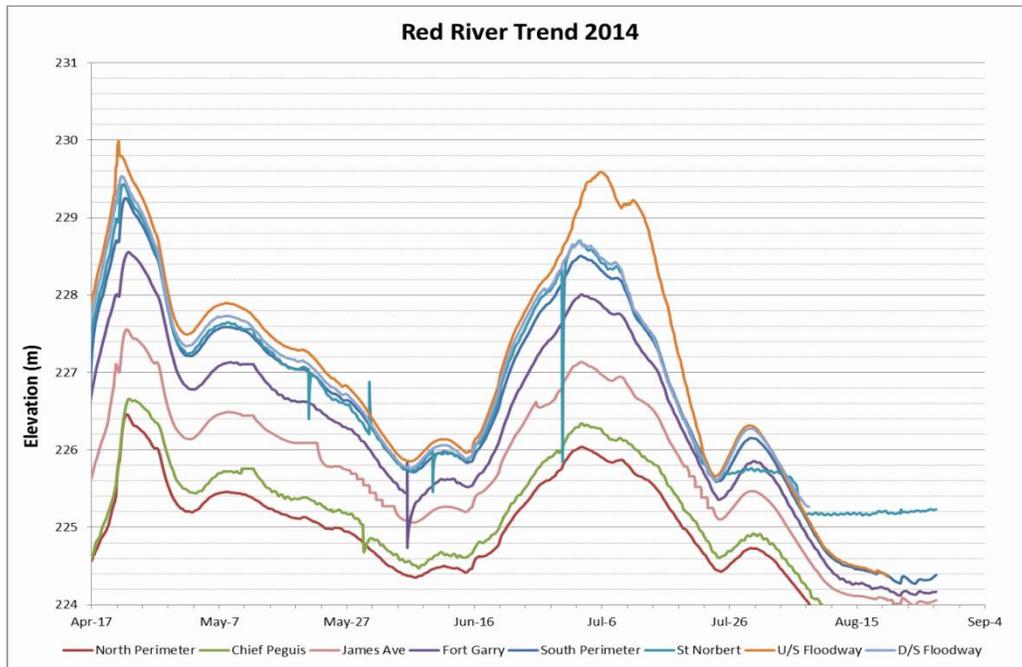
Figure 10: River Elevation Readings, Apr 17-Sep 4, 2014

River data and rainfall level data is collected at various points within the City. These data were analyzed for the three positive sample events specifically looking at spring runoff as a contributing factor. An example of this data is shown in **Figure 10**. Anomalous changes in river levels within the City were not noted during the 2013 and 2014 events. Ice cover during winter months limits the available readings into 2015. As such, sudden changes in river levels are not expected to be a significant factor during the three positive sample events.

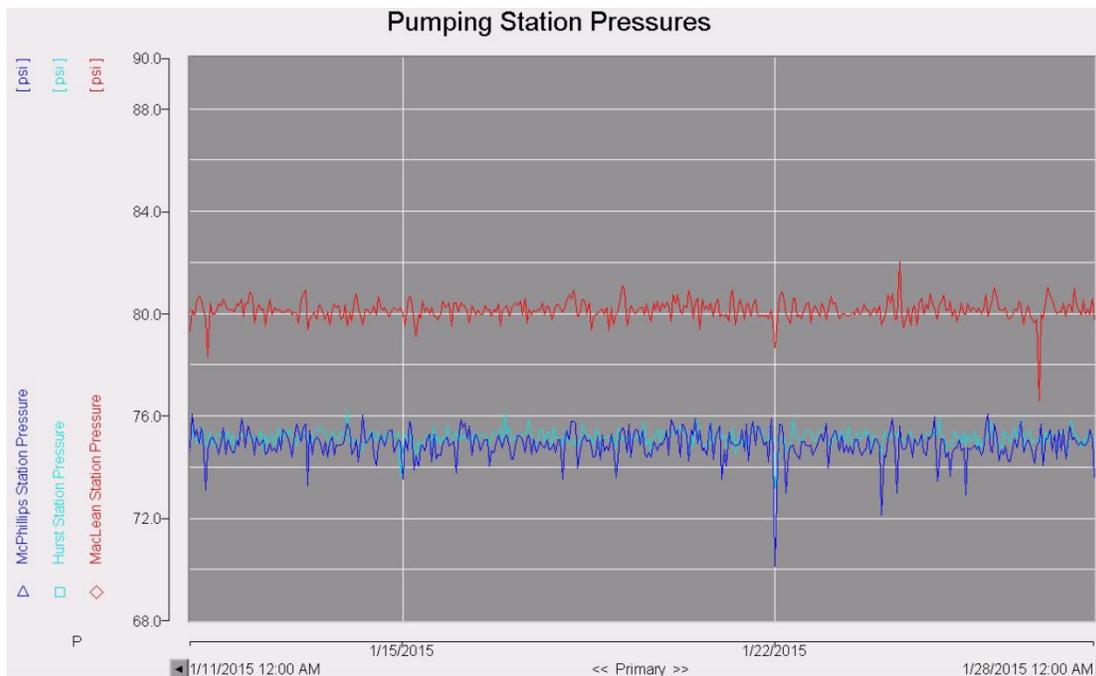
Figure 15: Pumping Station Pressure Readings, Jan 11-Jan 28, 2015

The City continuously monitors pressure readings throughout the distribution system and at each pumping station, as noted in **Figure 14**, **Figure 15** and **Figure 16**. Pressure-monitoring points are calibrated annually at a minimum. If issues arise between calibrations (e.g. loss of signal, erroneous readings, plugged impulse lines), the City will perform maintenance as required.

On January 16, 2015 a power failure occurred at the McPhillips Pumping Station. Gas engines were able to maintain pressure in the system, which never fell below 65 psi at the station.
