# **GEOTECHNICAL REPORT**

## Hartford Avenue - McGregor St / Salter St.

ATTENTION:  
PROJECT: Local Streets Package 24-R-05 (751-2023.5)  
Sanford, Winnipeg, MB

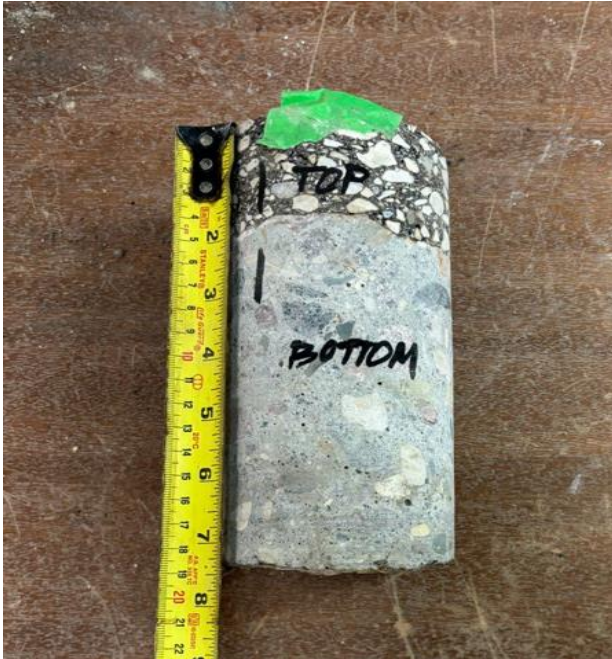
Hartford Ave, EBL, Core 19  
(Asphalt Thk 50.8mm; Conc Thk 133.4)

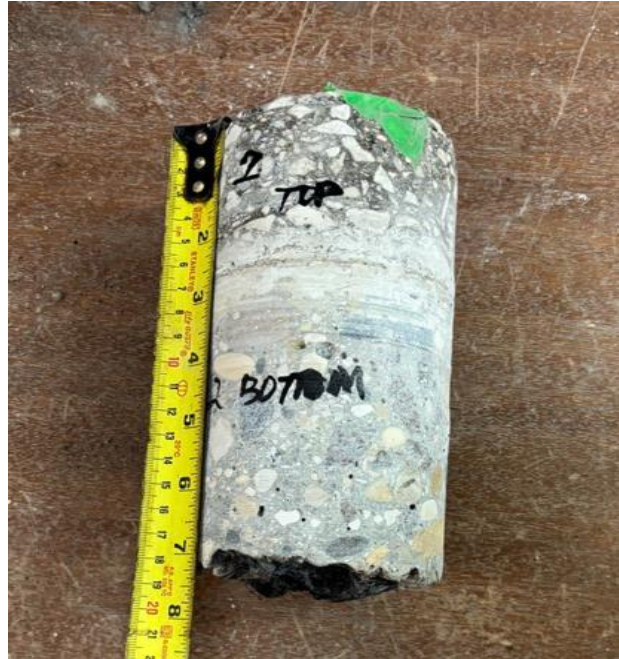
Hartford Ave, WBL, Core 20  
(Asphalt Thk 69.9mm; Conc Thk 87.93)

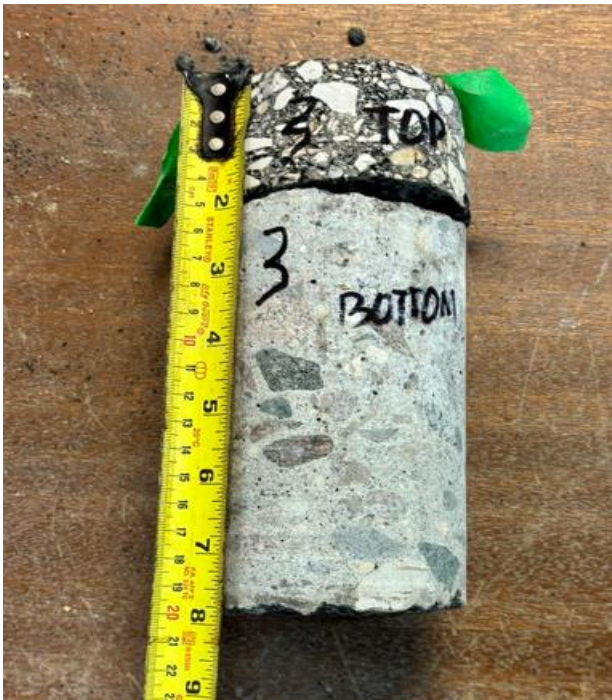
Hartford Ave, WBL, Core 21  
(Asphalt Thk 44.5mm, Conc Thk 152.2mm)

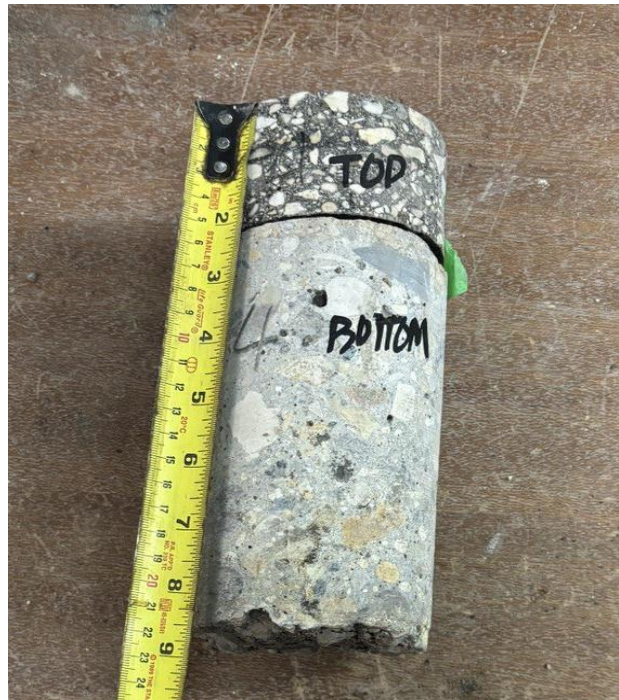
Hartford Ave, EBL, Core 22  
(Asphalt Thk 50.8mm, Conc Thk 165.1)

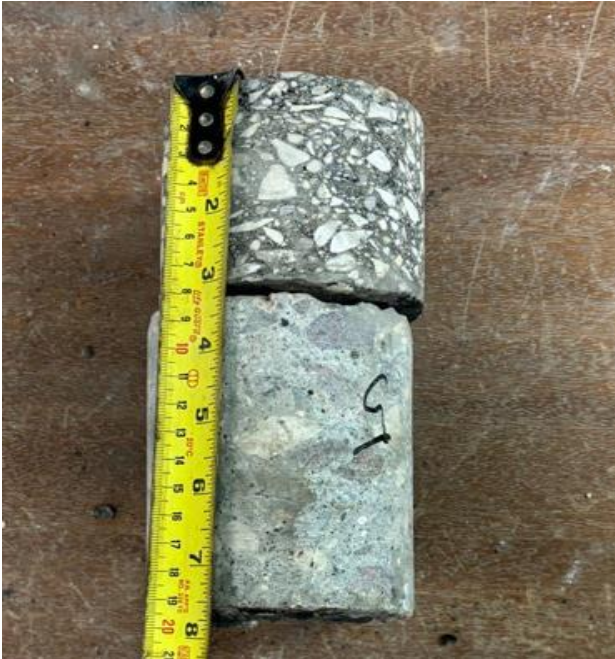
Hartford Ave, WBL, Core 23  
(Asphalt Thk 76.2mm, Conc Thk 120.7mm)

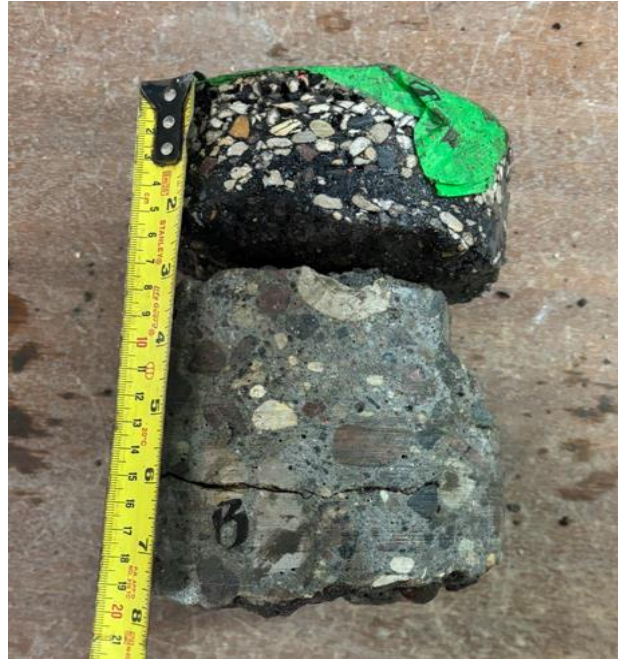
Hartford Ave, EBL, Core 24  
(Asphalt Thk 57.2mm, Conc Thk 139.7mm)

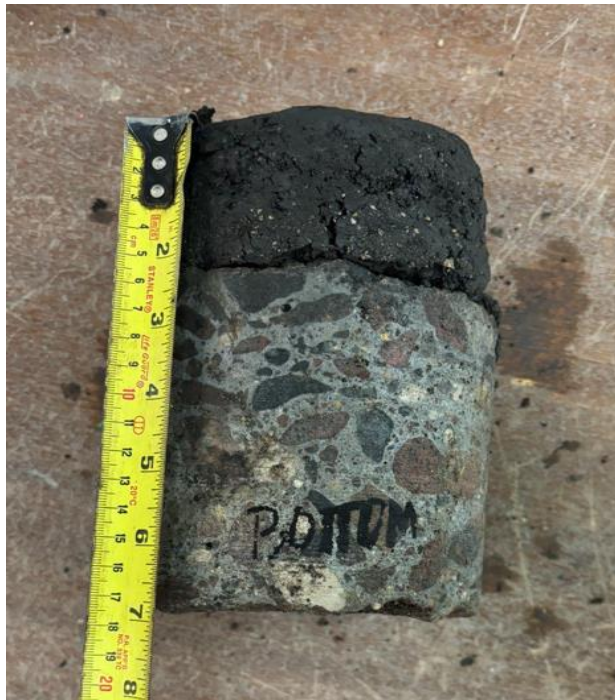
Hartford Ave, EBL, Core 25  
(Asphalt Thk 50.8mm, Conc Thk 127mm)

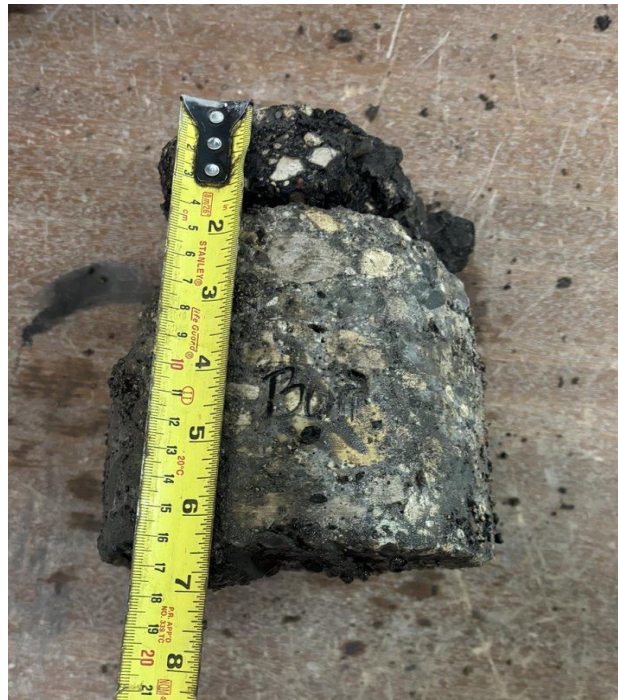
Hartford Ave, WBL, Core 26  
(Asphalt Thk 50.8mm, Conc Thk 127mm)

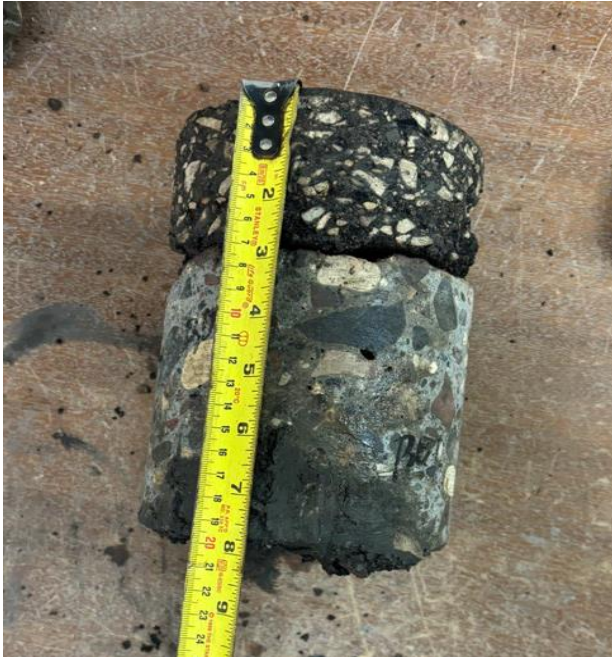
Hartford Ave, WBL, Core 27  
(Asphalt Thk 63.5mm; Conc Thk 139.7mm)

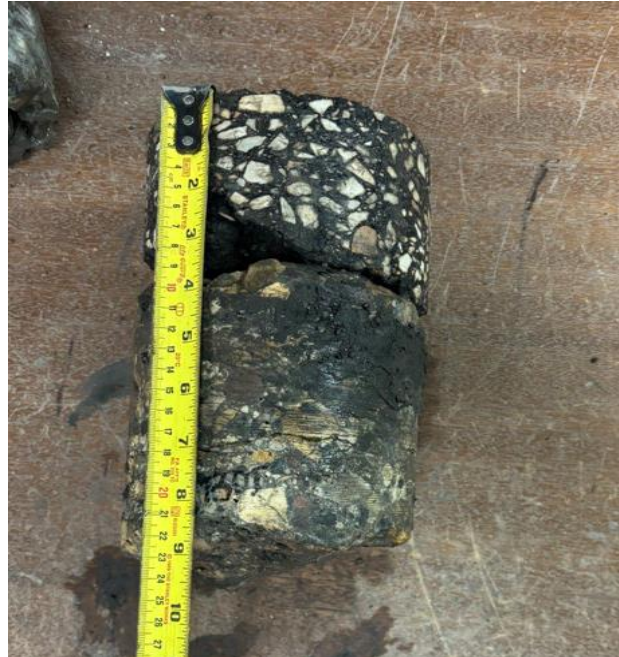
Hartford Ave, WBL, Core 28  
(Asphalt Thk 82.6mm; Conc Thk 158.7mm)

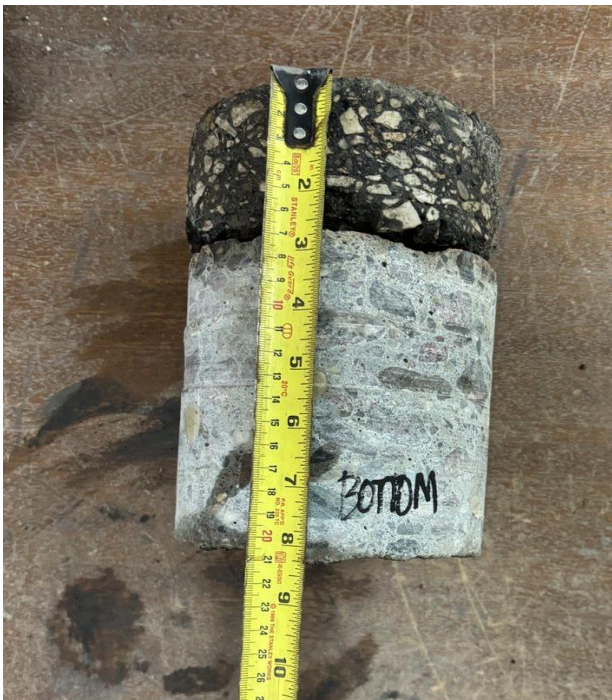
Hartford Ave, WBL, Core 29  
(Asphalt Thk 63.5mm; Conc Thk 146.1mm)

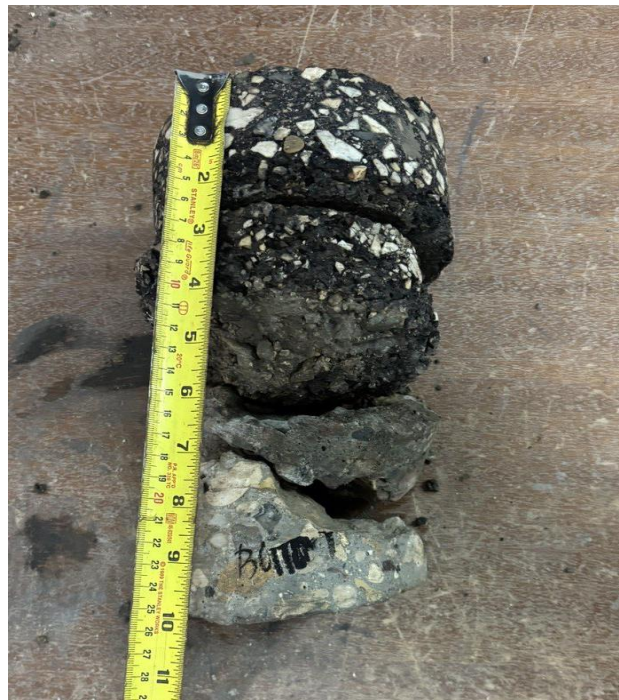
Hartford Ave, WBL, Core 30  
(Asphalt Thk 114.3mm; Conc Thk 139.7)

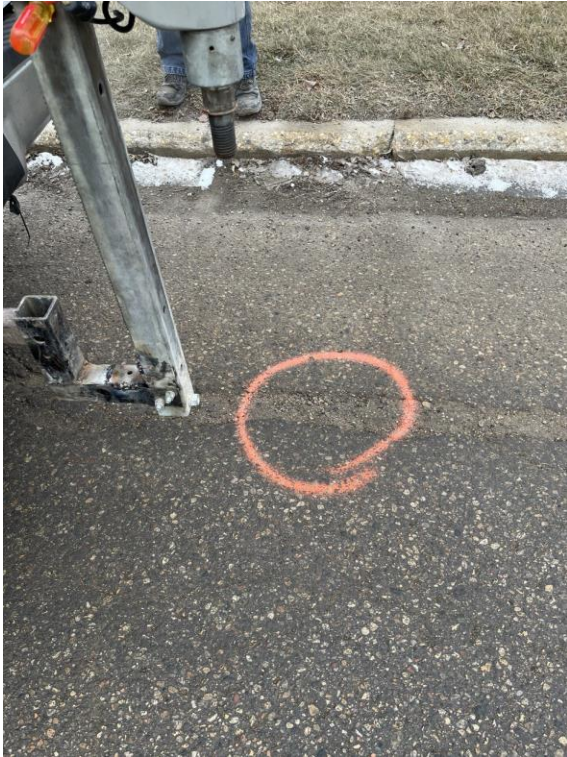
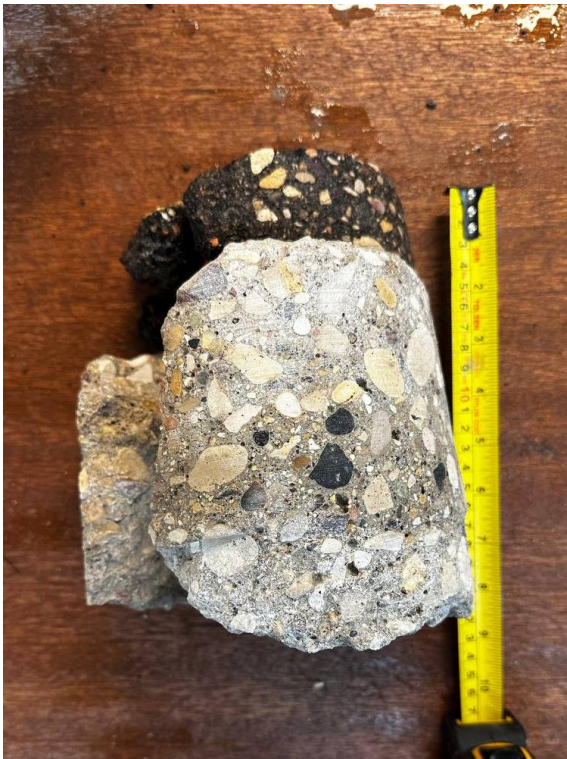
**Core 1 – Sanford (SBL)**

Figure 1. Core 1 pavement surface showing void existed between pavement and subsurface

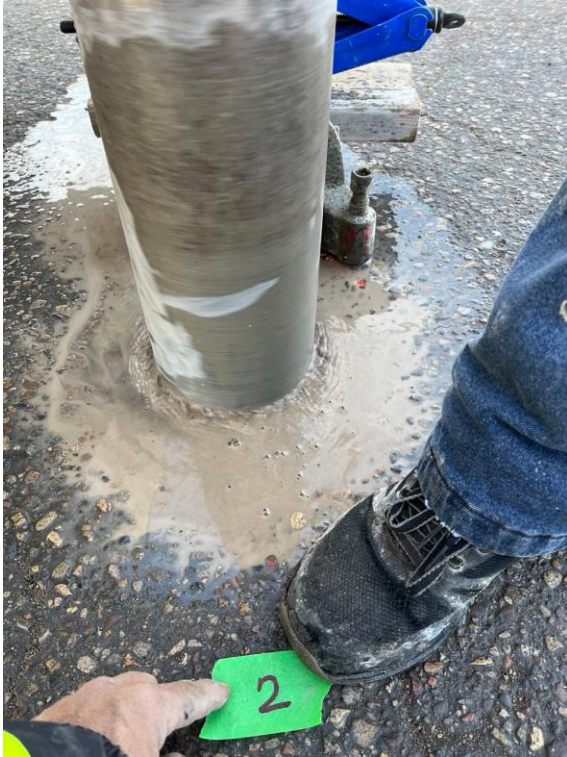
**Core 2 – Sanford (SBL)**

Figure 2. Photos showing Core 2 pavement surface for compressive strength

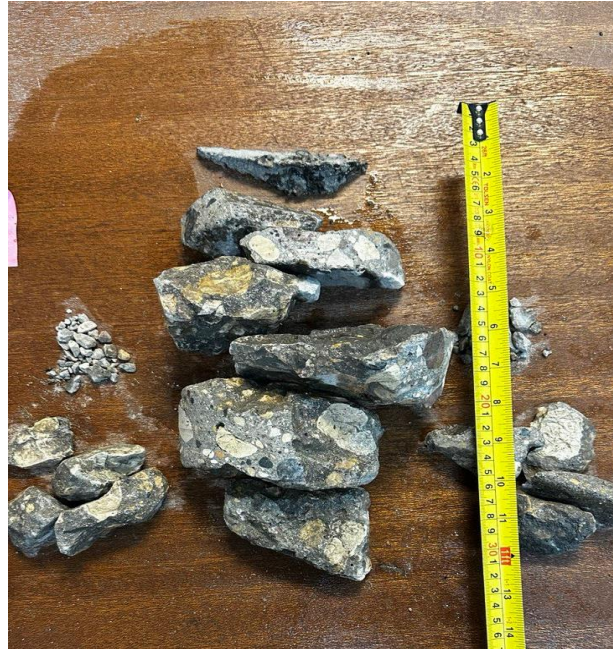
Yarwood Ave, EBL, Core 16  
(Conc Thk 175)

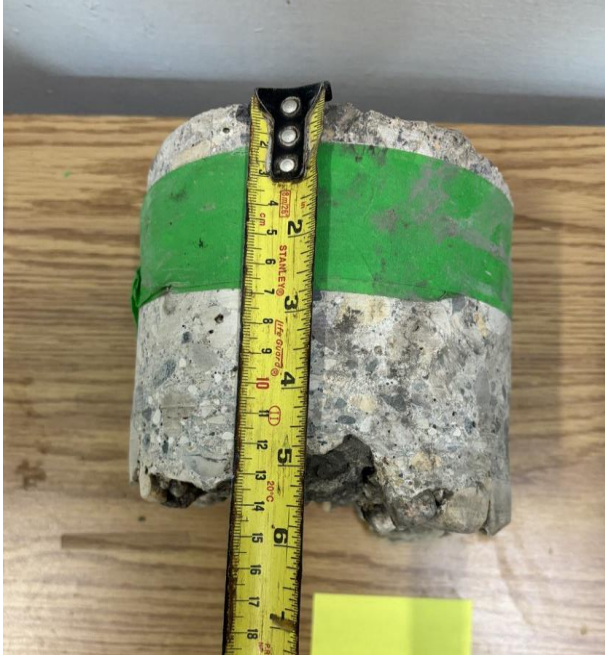
Langside St and Young St Backlane NBL,  
Core 40 (Conc Thk 140mm)

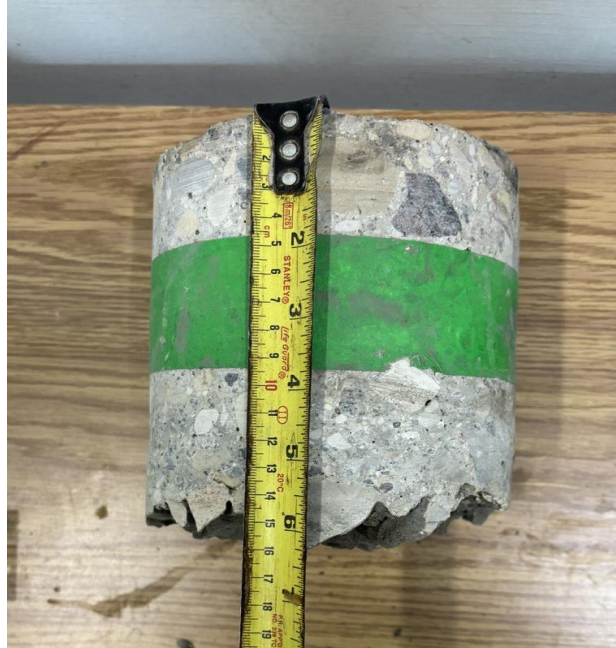
Langside St and Young St Backlane SBL,  
Core 41 (Conc Thk 140mm)

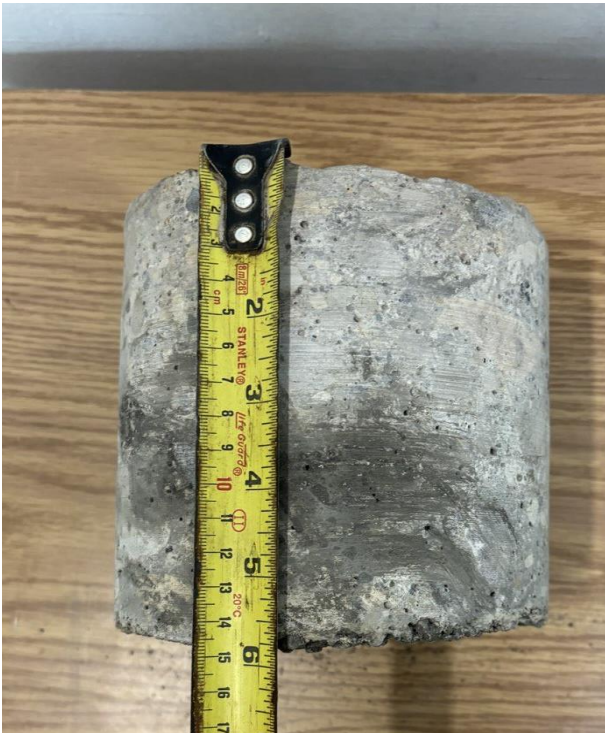
Langside St and Young St Backlane NBL,  
Core 42 (Conc Thk 140mm)

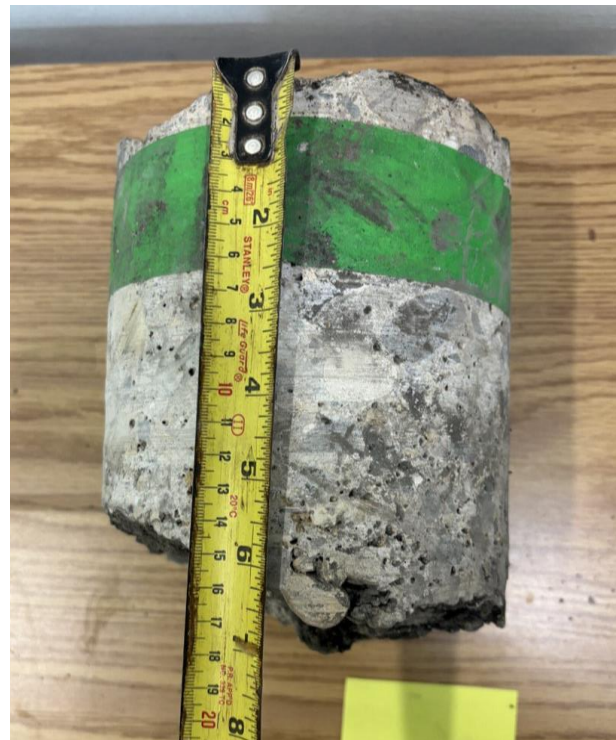
Langside St and Young St Backlane SBL,  
Core 43 (Conc Thk 170mm)

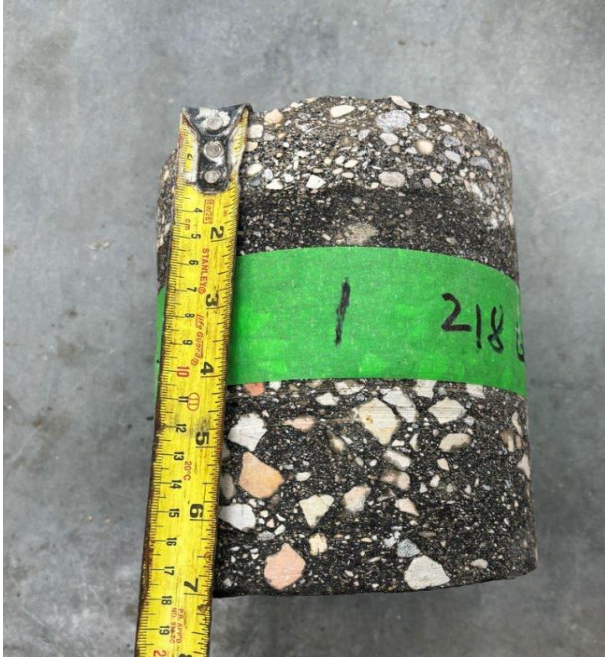
Ruby St - Lenore St Backlane, NBL, Core 37  
(Asphalt Thk 180mm)
